The Oroville Dam Spillway Incident

International Workshop on
Overflowing Erosion of Dams
and Dikes

John W. France, PE, D.GE, D.WRE
AECOM, Forensic Team Leader

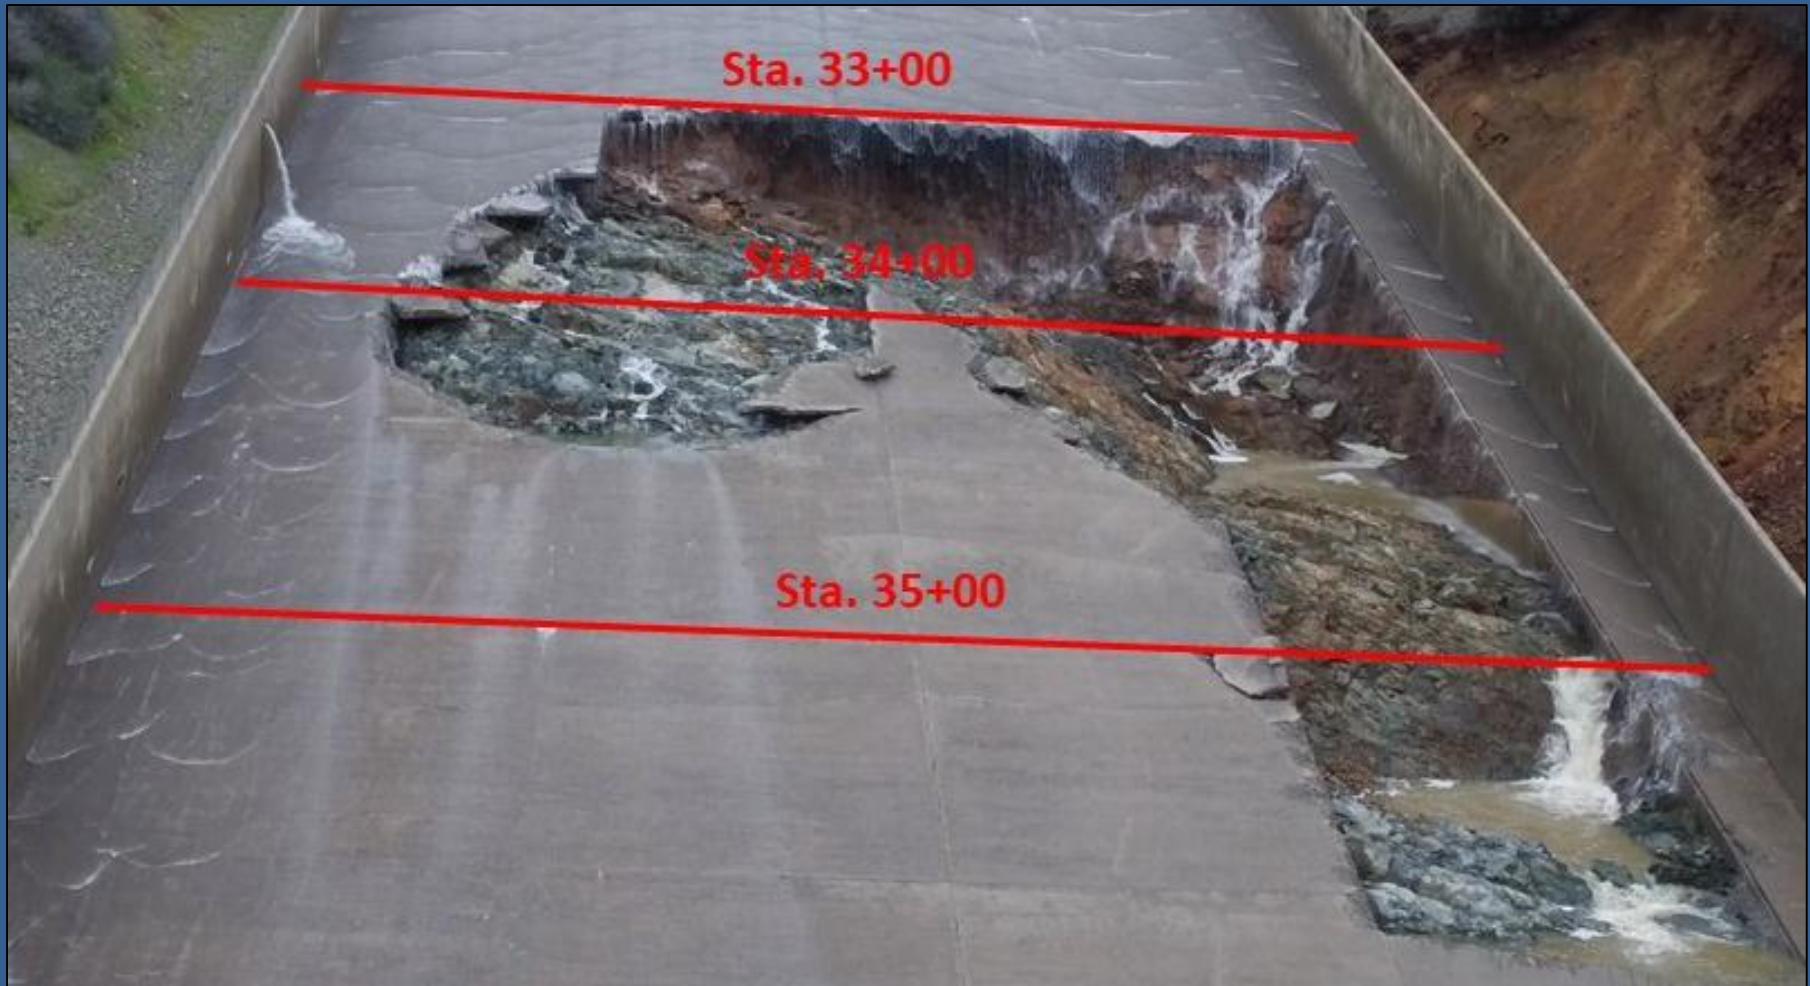
Physics of SS Damage

- Foundation conditions (geology)
- Cracks in the slab
- Joints without waterstops
- Leakage through chute slab
- Corrosion and failure of reinforcing
- Slab delaminations

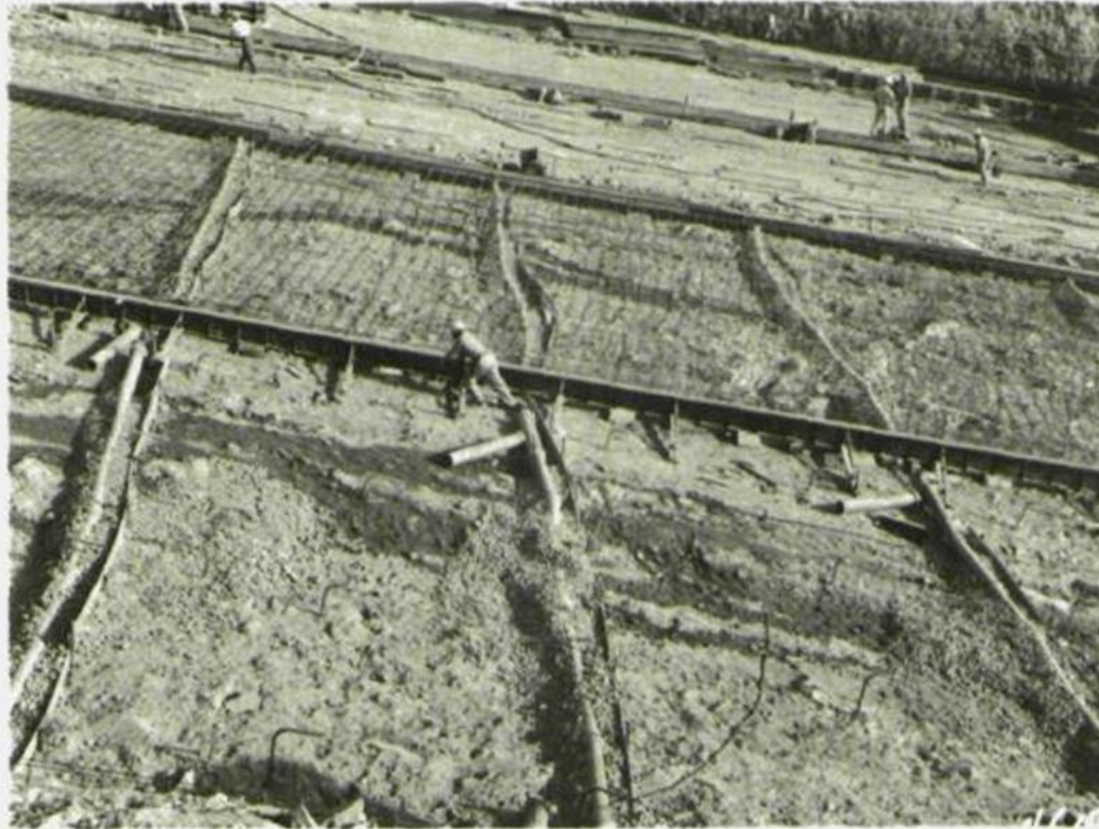
Foundation Preparation

Photo 39. Chute foundation in vicinity of Sta. 33+60. Tile and gravel underdrains in lanes 2 and 3, rebar in lane 3. View southeast.
Neg. No. 4644

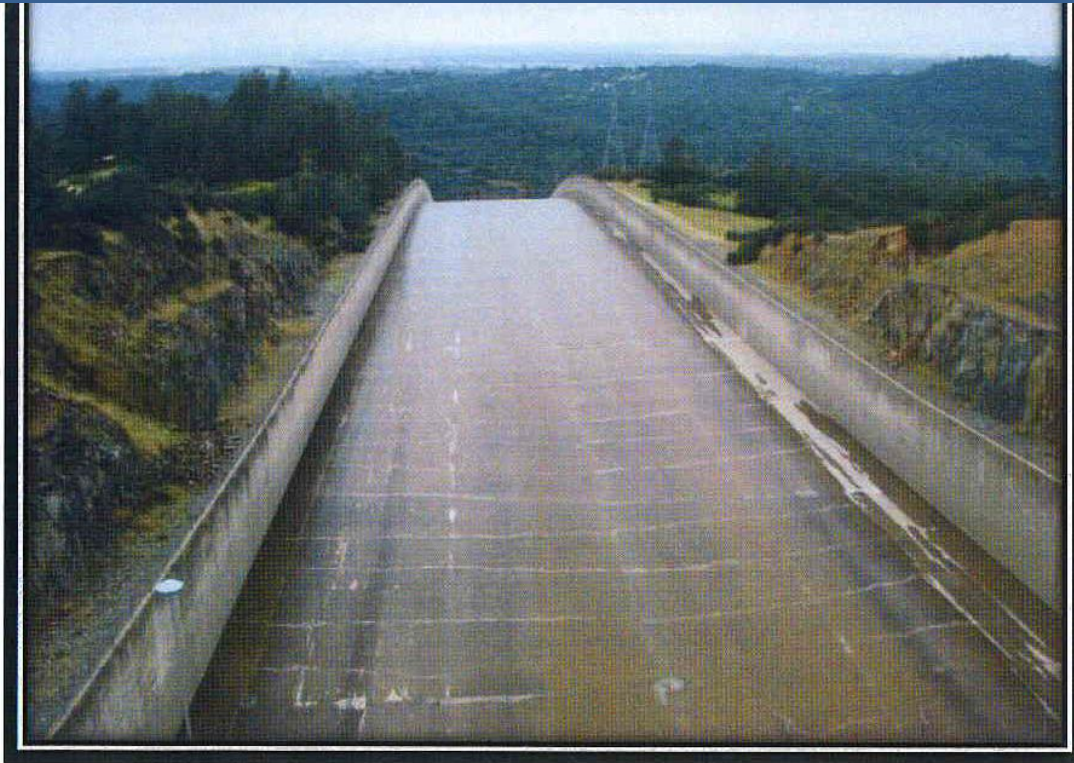
Crack Pattern

12. The concrete along the spillway chute has been repaired. The repaired herringbone crack pattern is said to reflect the underlying drain system.
