# Rock Erosion in Spillways – Norwegian perspective

Research approach, case studies and key findings

Prof. Leif Lia

Norwegian University of Science and  
Technology  
NTNU

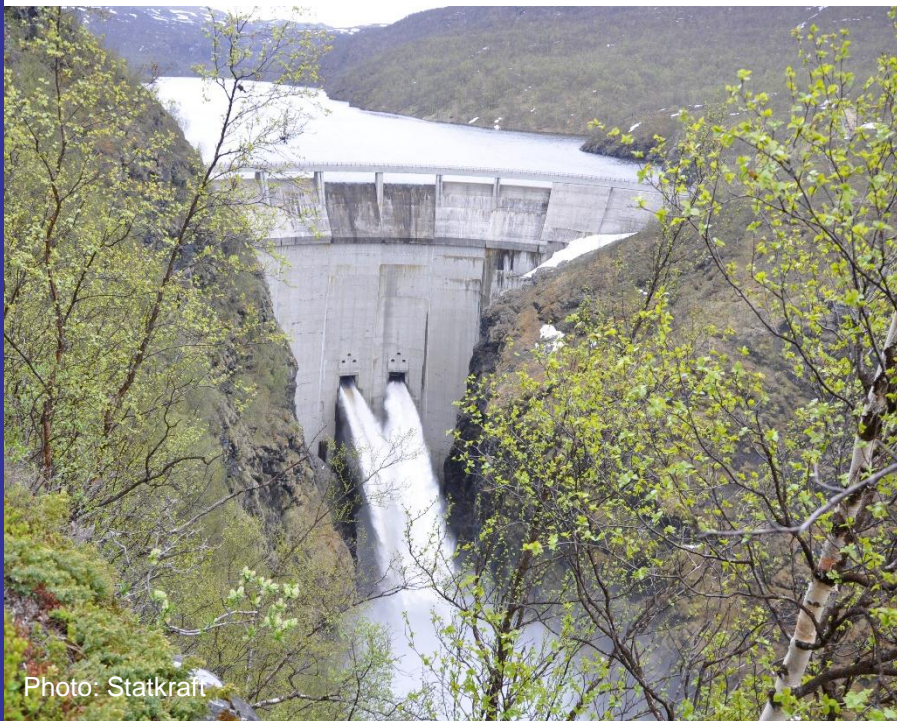
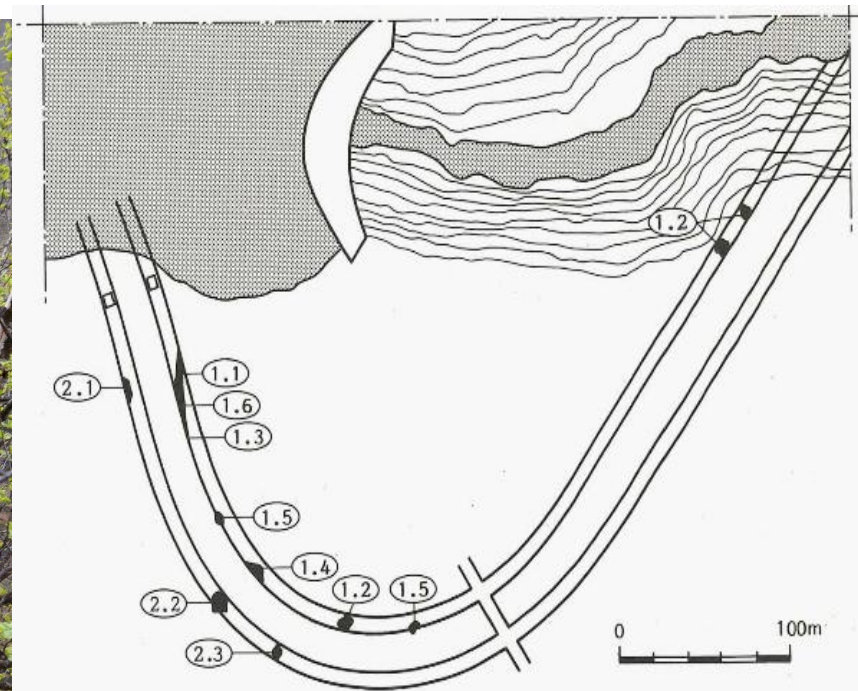
# Dam Virdnejavri, tunnel spillways

$Q = 650 \text{ m}^3/\text{s}$  in each tunnel,  $v = 30 - 20 \text{ m/s}$ ,  $\mathbf{F} = 3$

Severe erosion first year of operation

Maximum erosion discovered  $L = 40 \text{ m}$ , depth  $4 \text{ m}$ , >  
10 scouring pits

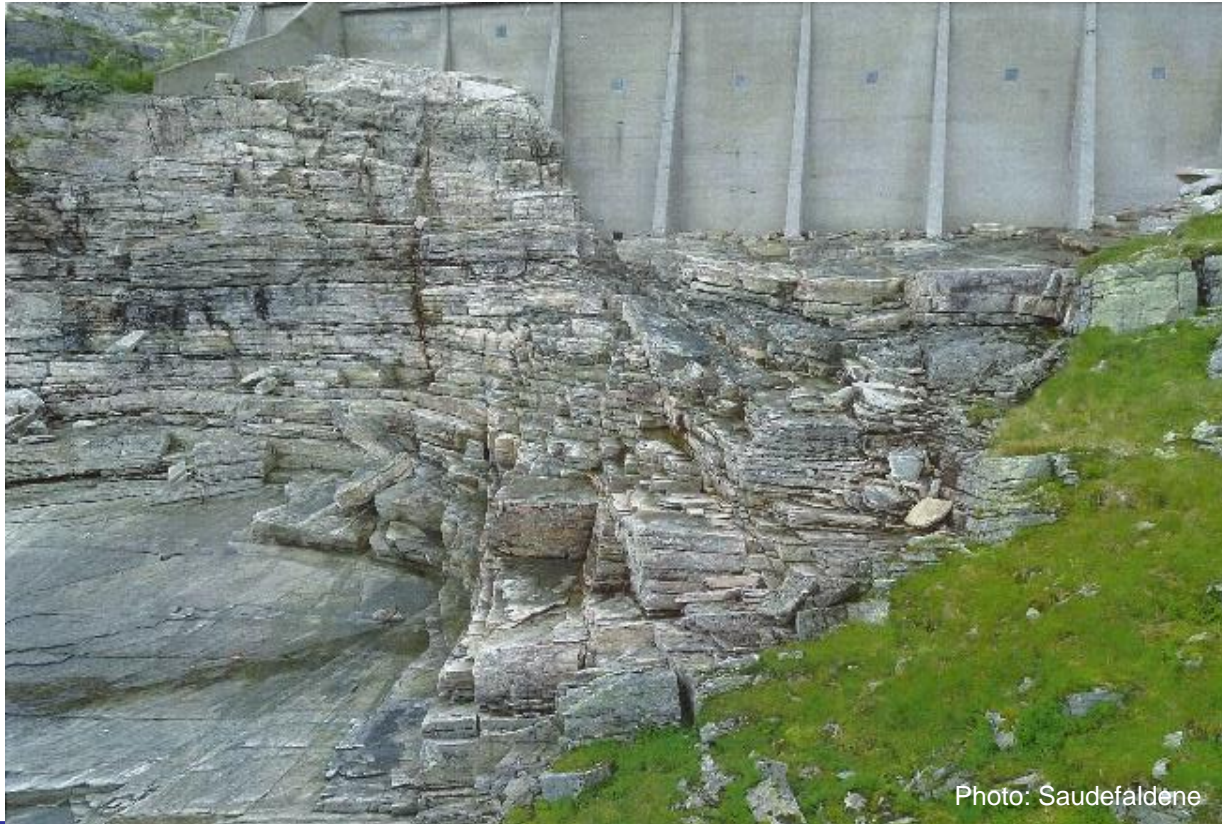
# Dam Sandvatnet

Free crest overfall spillway

Foliated rock, spilling during wintertime, erosion propagating towards the dam toe

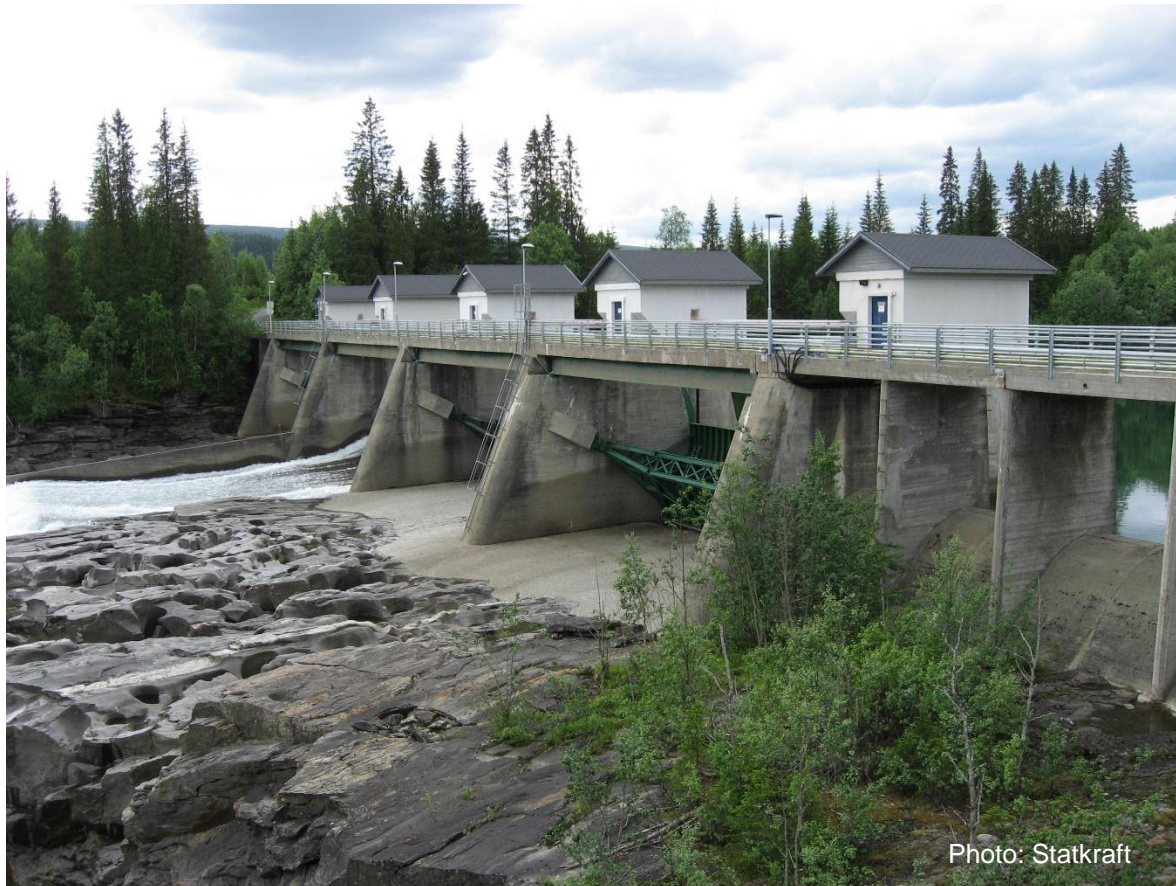
# Dam Fallforsen, ROR, gated spillway

Minor erosion, scouring holes, composite geology

No measures, slow process

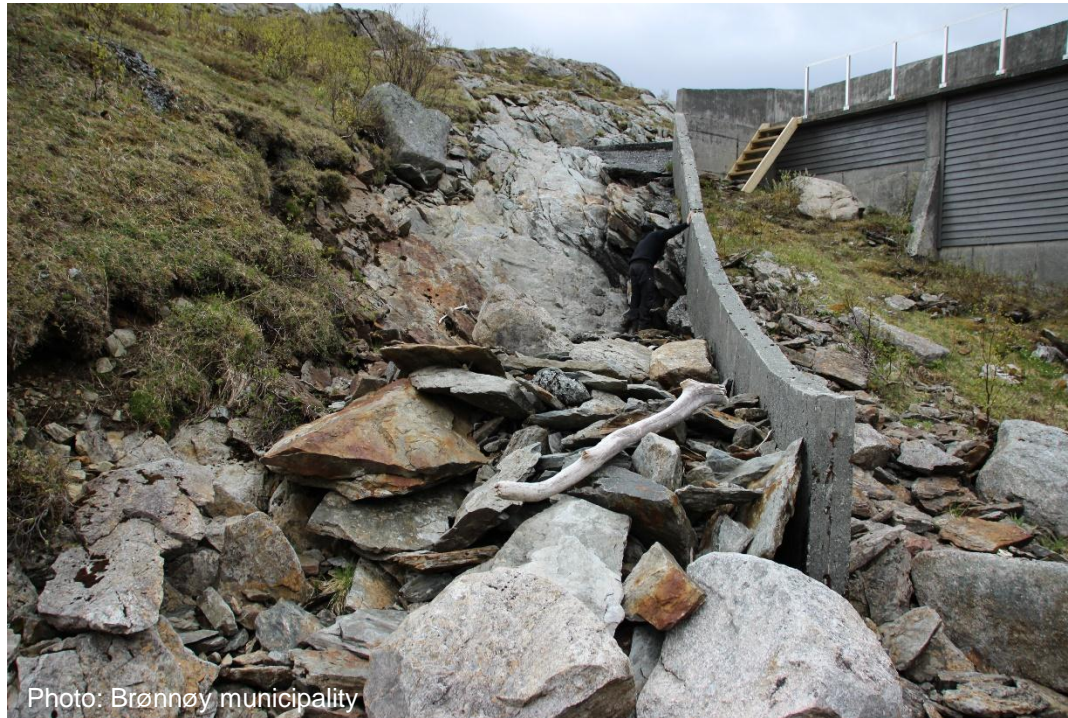
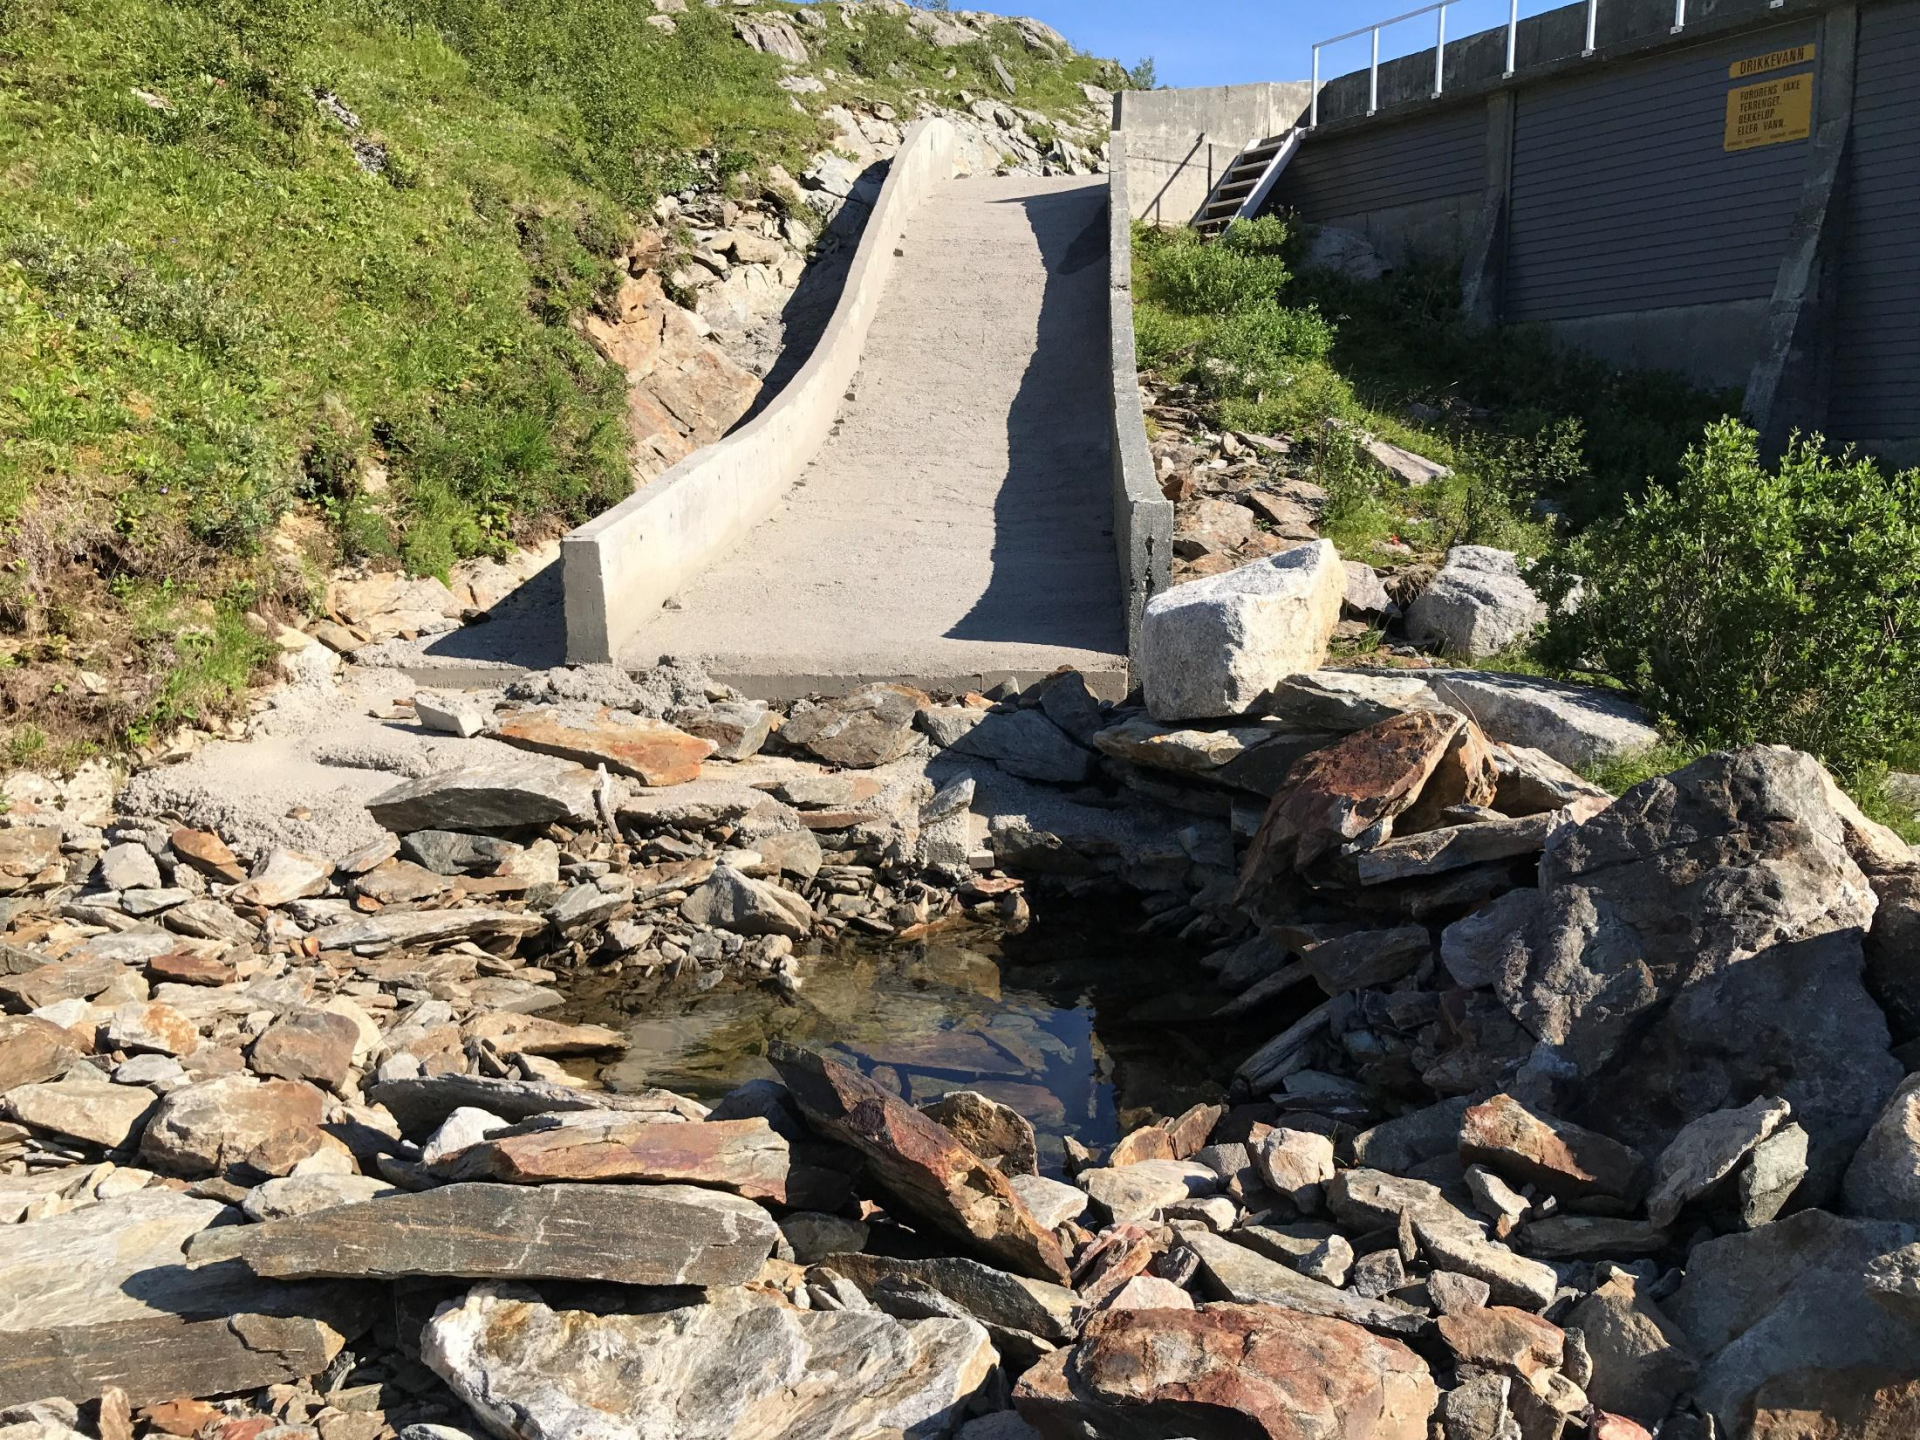
# Dam Sæterstivatnet, small is beautiful?

Small unlined chute, no initial measures

Severe erosion occurred in foliated rock

Lined chute constructed

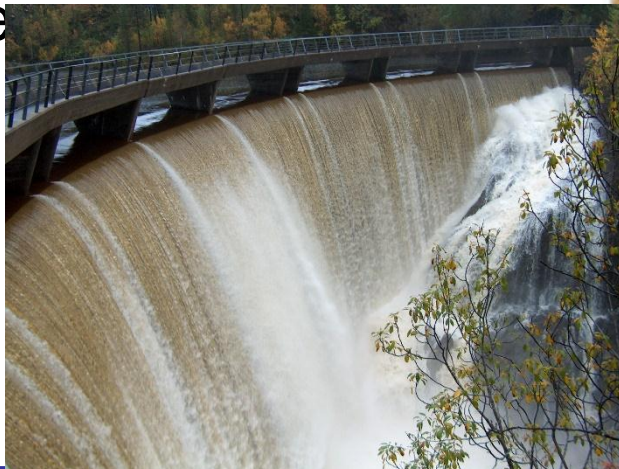
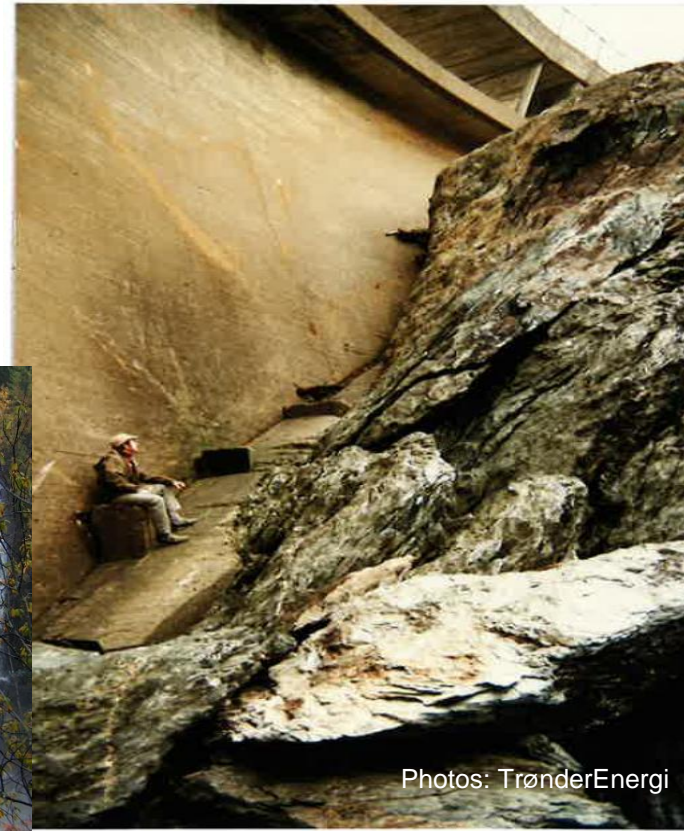
Urgent situation at Dam Sokna and Dam Storfossen

Two large concrete dams experienced severe rock erosion after the 1983 spring flood

Pulsating forces from the water jet recognized as the main problem source

Measures had to be taken
