CONCRETE DAMS OVERTOPPING EROSION

Hydro-Québec Perspectives : Issues and Engineering Needs

Marco Quirion, P. Eng., Ph.D

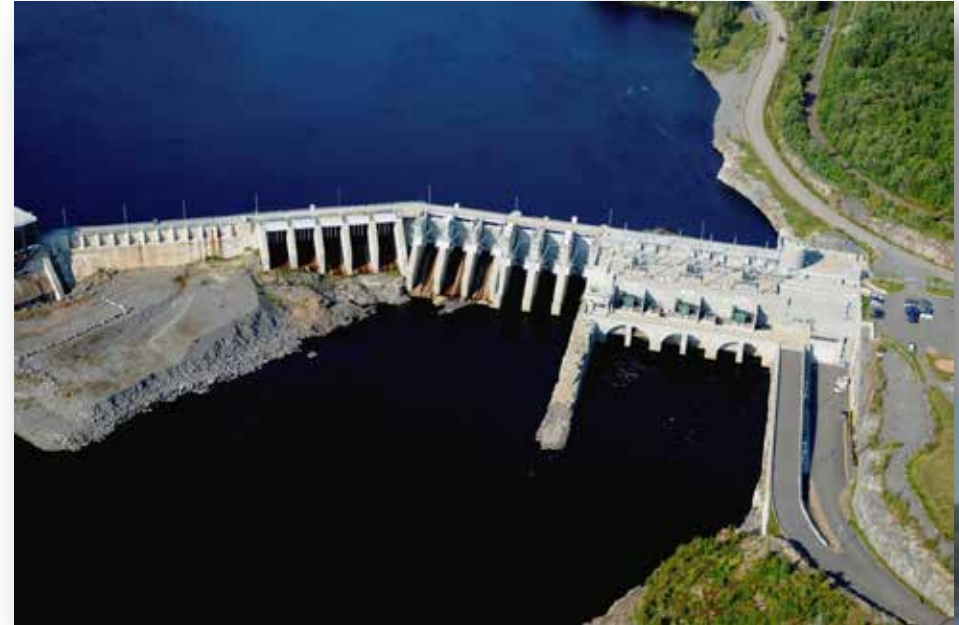
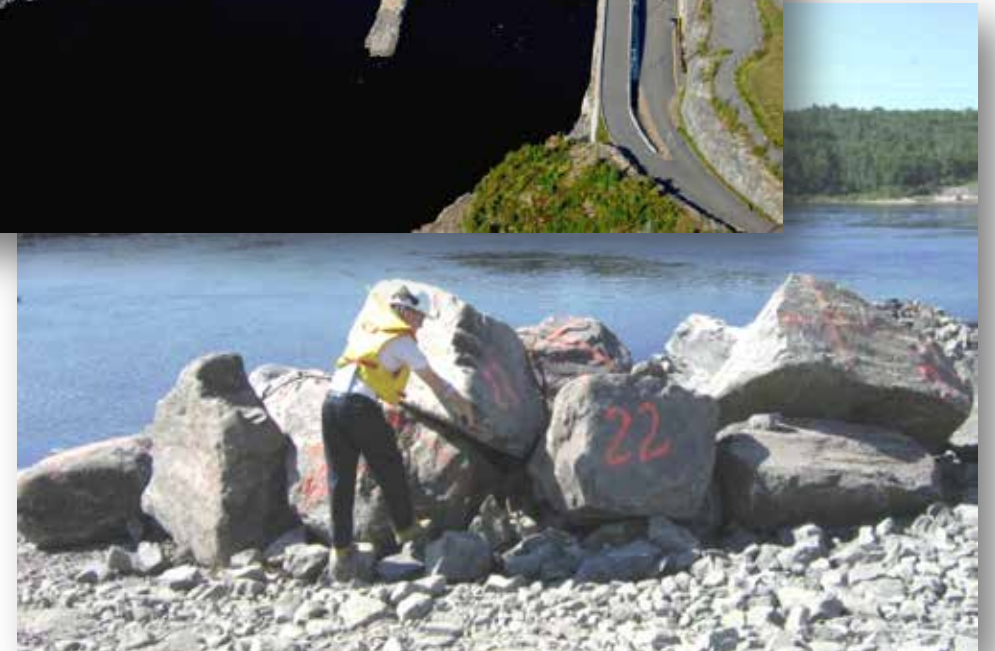
St-Maurice River [1] (2004)

- Rock erosion downstream of spillway channel
- Accumulation of sediments, gravel and blocks downstream of the powerhouse's tailrace
- Highlights
 - Underwater blasting
 - High Explosive loads
 - Significant subdrillings

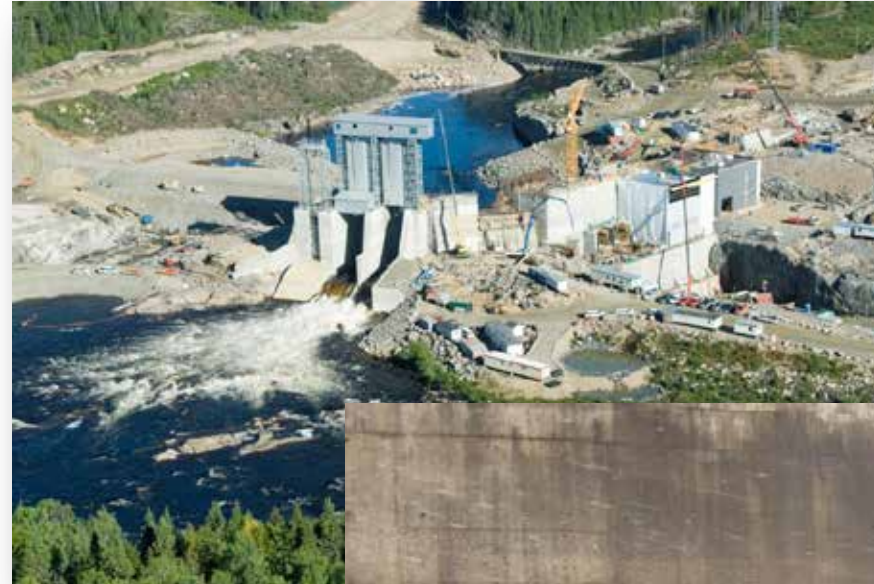
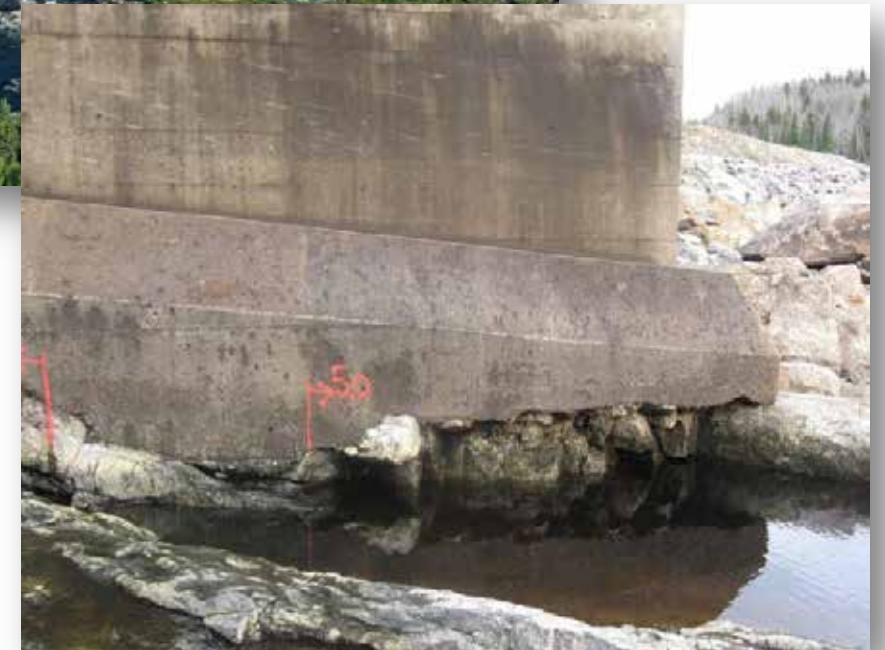
St-Maurice River [2] (2008)

- During design, the rock downstream of the spillway was considered vulnerable (pegmatite)
- Highlights
 - Concrete protection at the foot of the sidewalls
 - 2008 Hydraulic Testing – Signs of erosion observed at the downstream end of the protection
 - 2010 Inspection indicates no further erosion

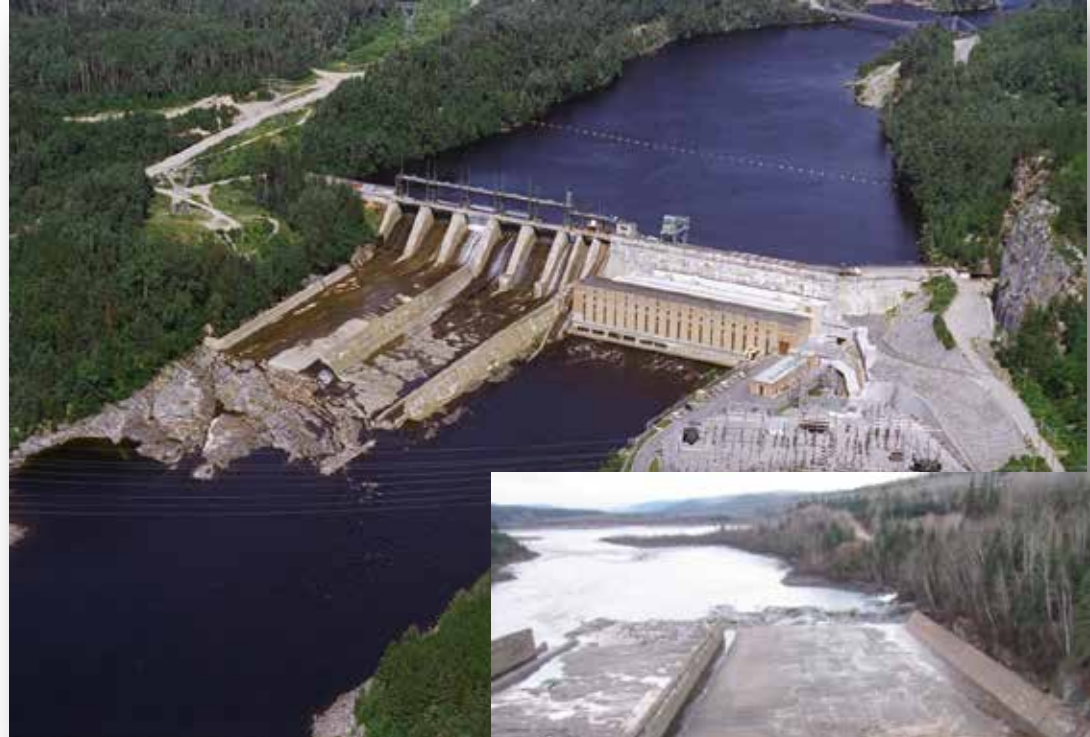
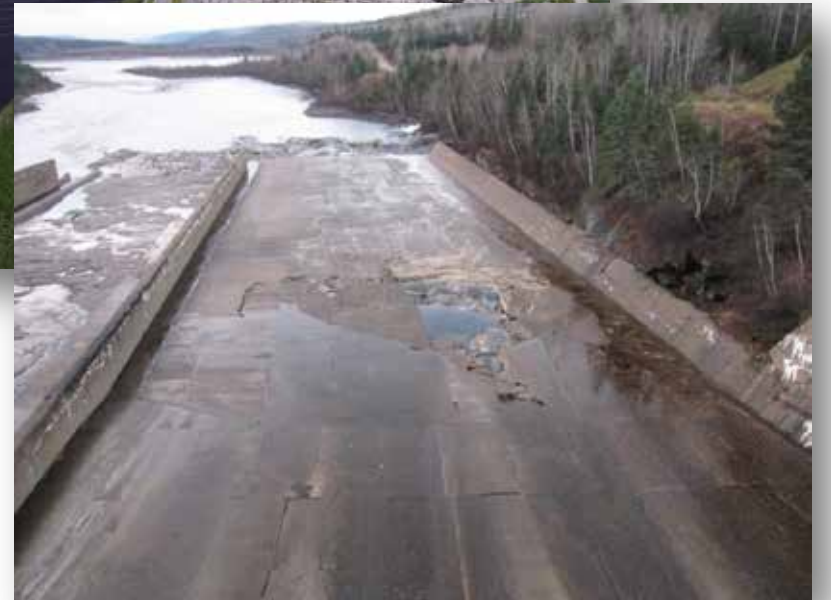
St-Maurice River [3] (2010)

- Autumn flood 2010 evacuated through one gate (VE4)
- Outflow of 470 m³/s for 86 hours
- Significant damages at the spillway's apron
- Highlights
 - Construction in the 1940's
 - Low concrete thickness
 - Many concrete construction joints

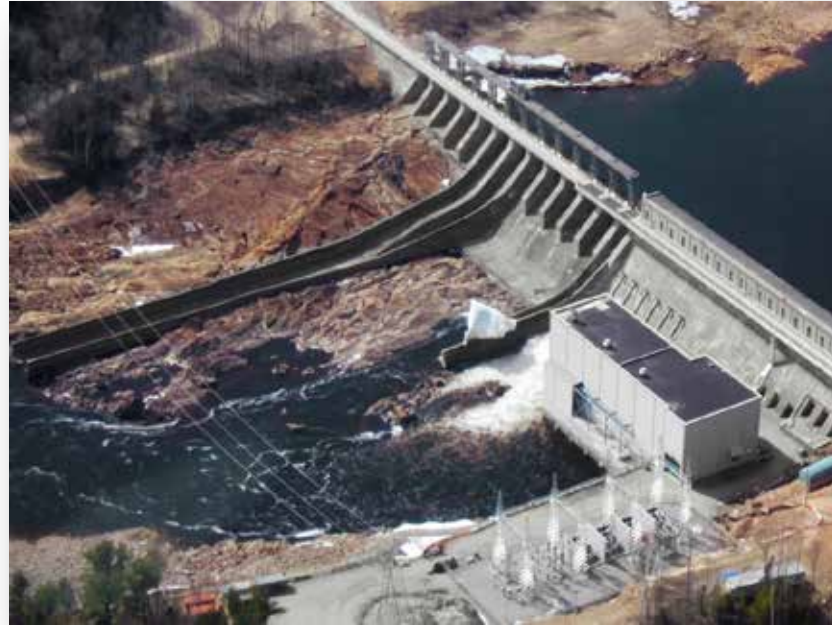
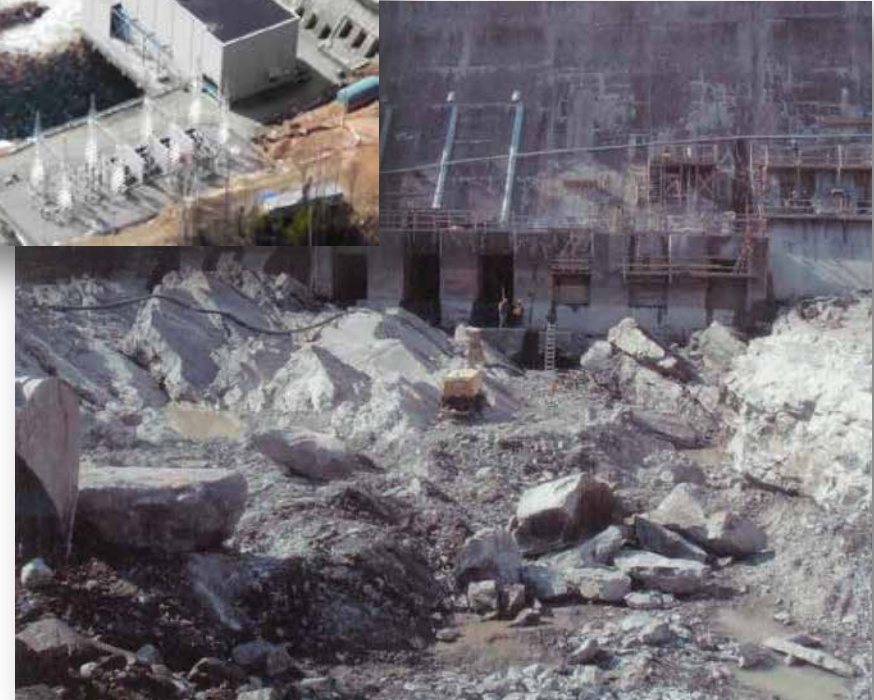
Baskatong Reservoir (2007)

- Addition of a powerhouse starting in 2004
- Flood in 2007 evacuated by the bottom outlet during construction
- Boulders accumulation downstream
- Highlights
 - Outflow $400 \text{ m}^3/\text{s}$ during 4 months
 - Velocities above 20 m/s
 - Described as exceptional

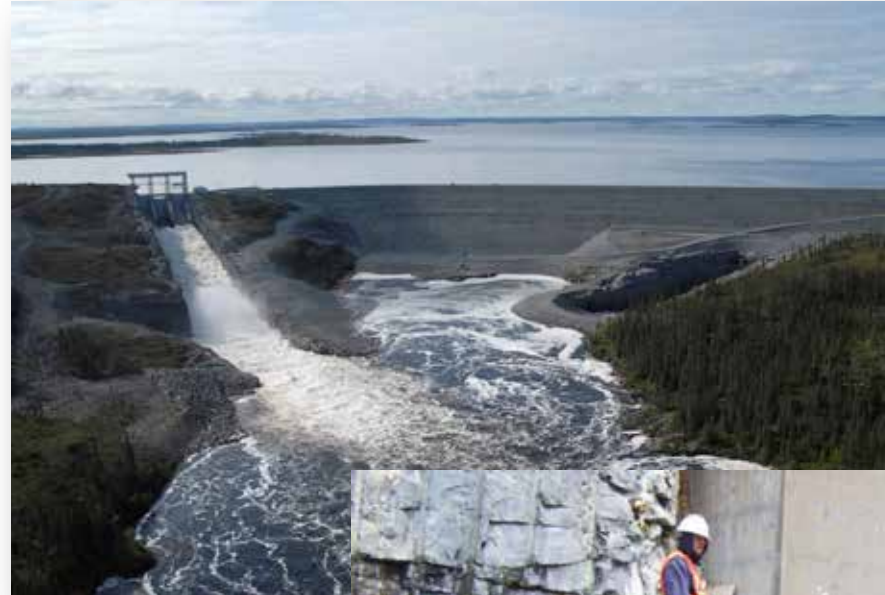
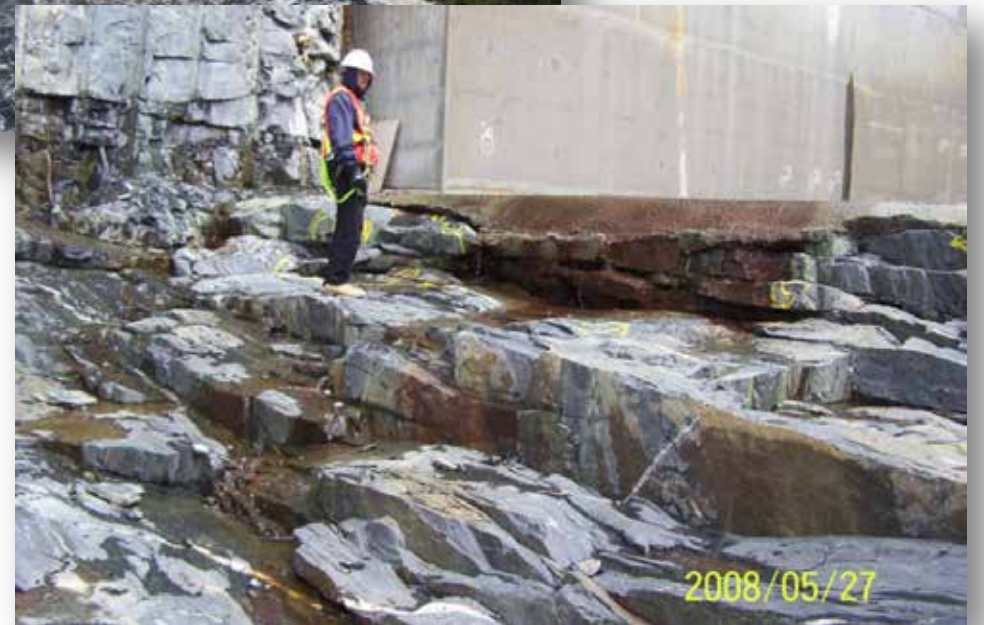
James-Bay Region (2008)

- About 2 m thick of rock eroded following the opening of the gates
- Corresponds to the thickness of rock affected by blasting
- Highlights
 - Shear zone
 - Significant subdrillings

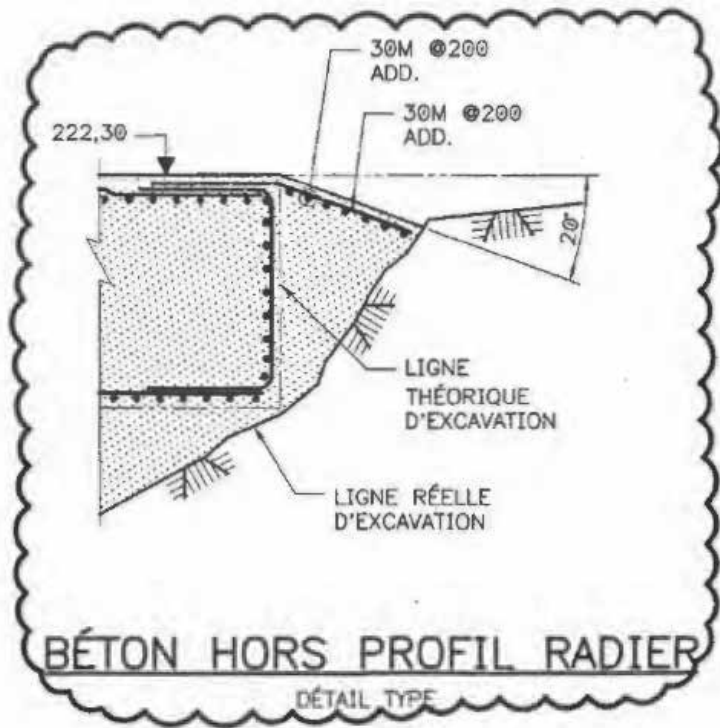
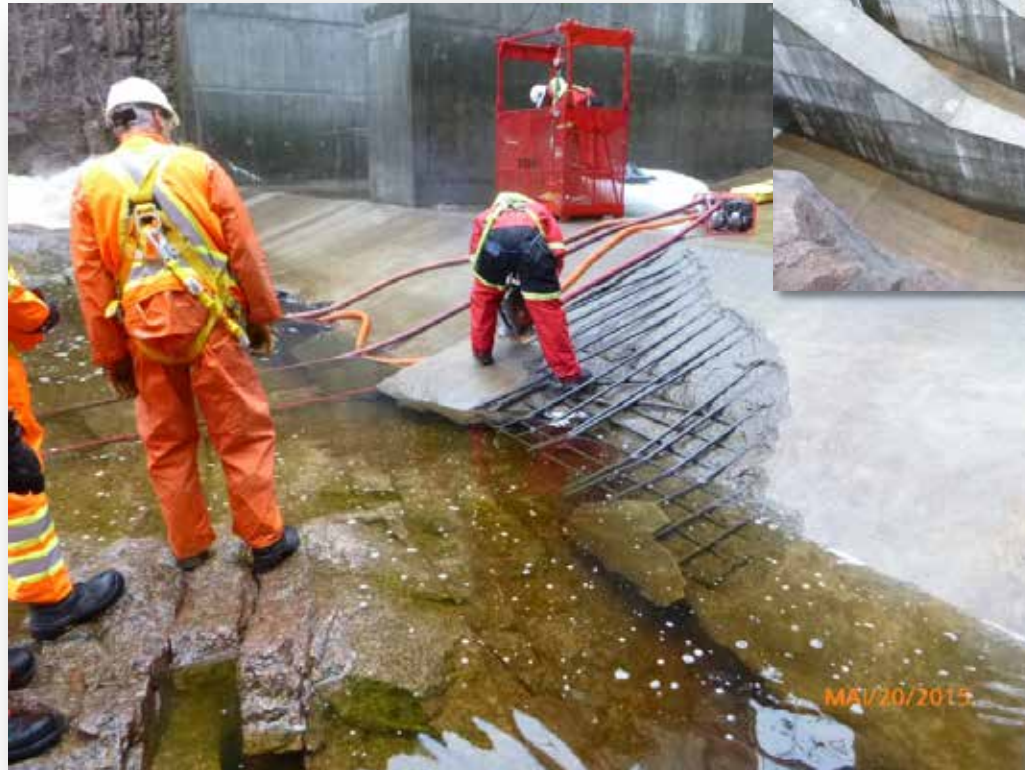
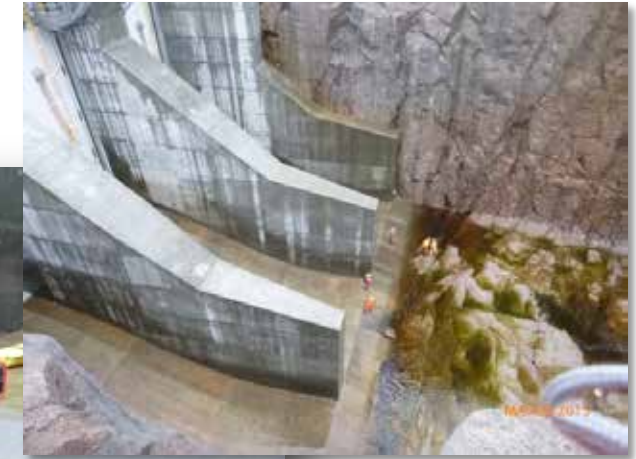
Lower North Shore Region

- Excavation profile not as planned
- Loss of reprofiling concrete
