Contact erosion detection and rehabilitation: a case study

**ICOLD BULLETIN 164: INTERNAL EROSION
WORKSHOP**

Contact erosion detection and rehabilitation : a case study

ICOLD Annual Meeting, Ottawa, June 14 2019

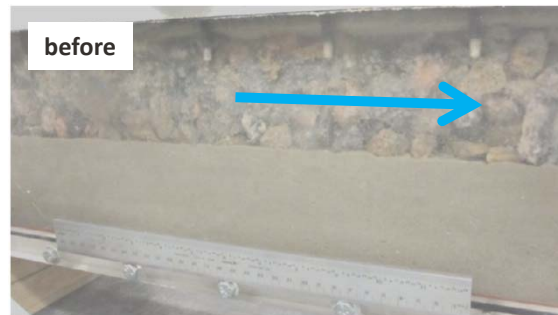
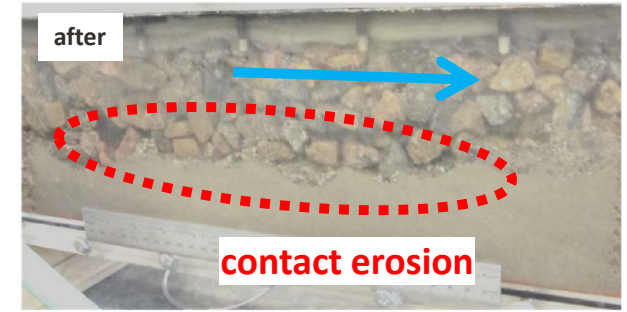
Erosion of finer particles in rockfill window and/or of grouting material ?

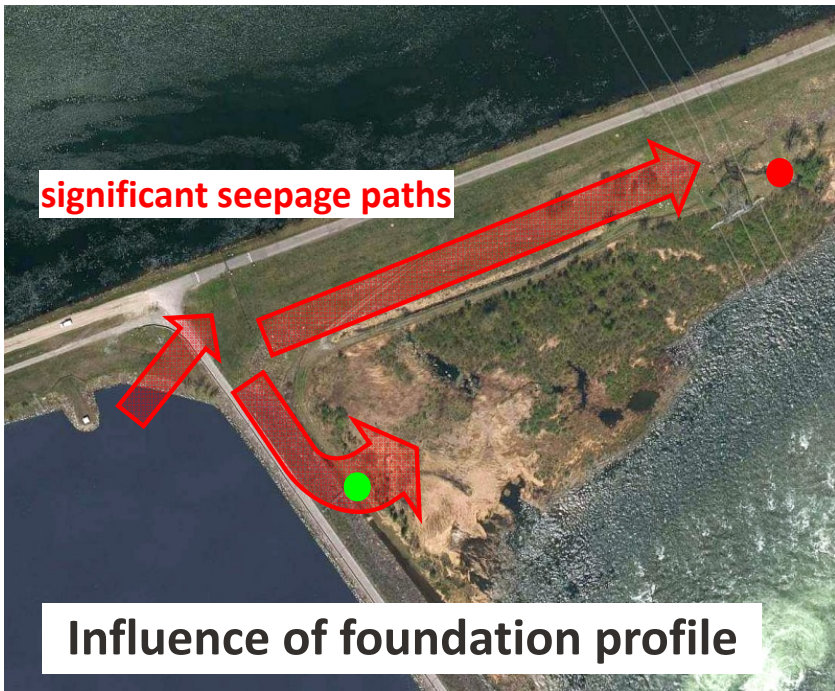
« Perfectly straight » seepage paths

Buried metal debris ?

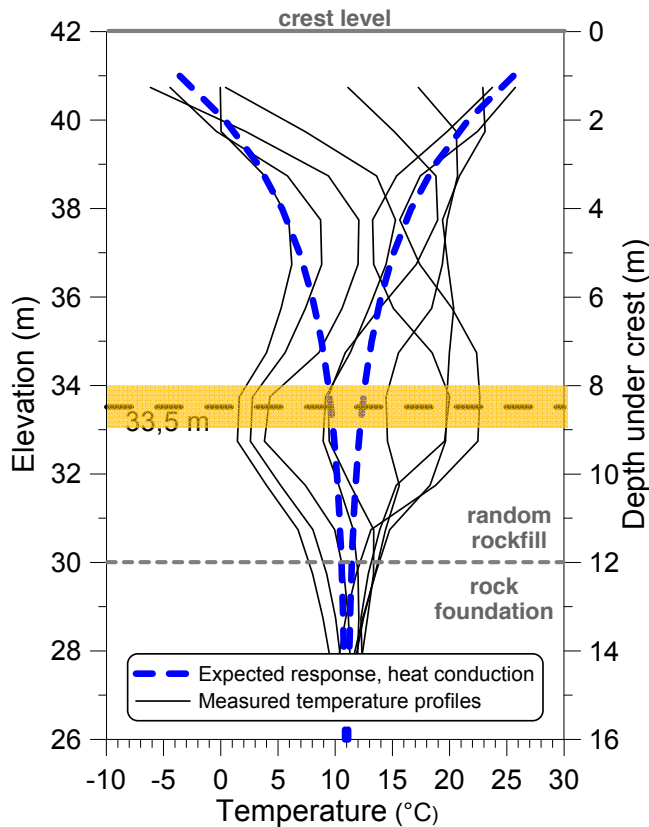
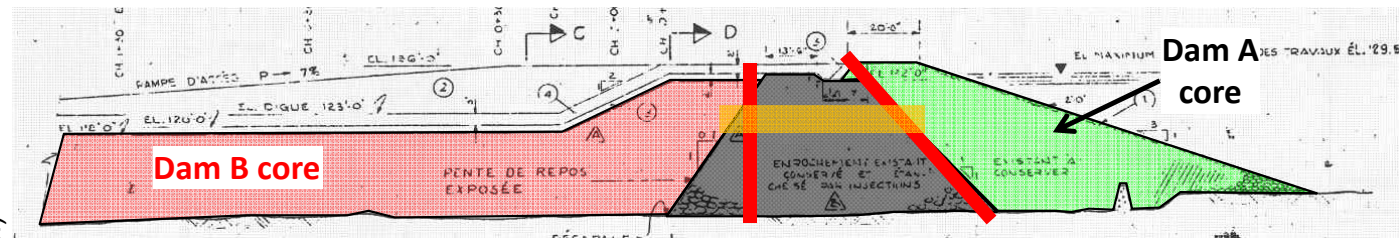
Seepage detection : passive thermometry

absence of grout material

Detection of seepage by thermometry confirmed by boreholes and optical televiewer images

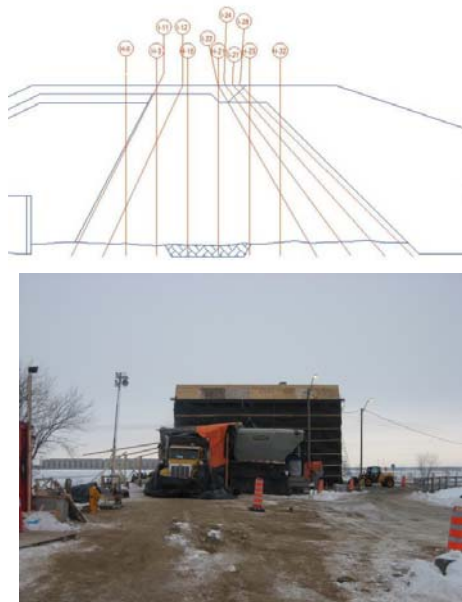
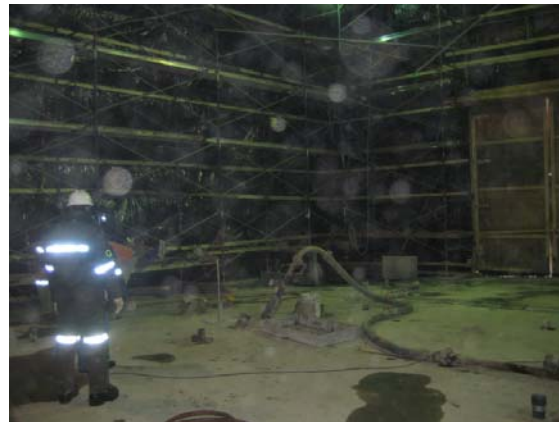
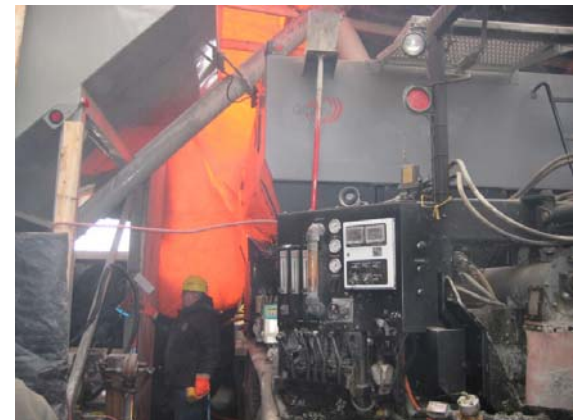
Rehabilitation (2009-2010)

Monitoring results, global survey (electromagnetic) as well as local surveys (televviewer and thermometry) confirmed the presence and extent of contact erosion : 2nd grouting of rockfill window at the junction of both dams

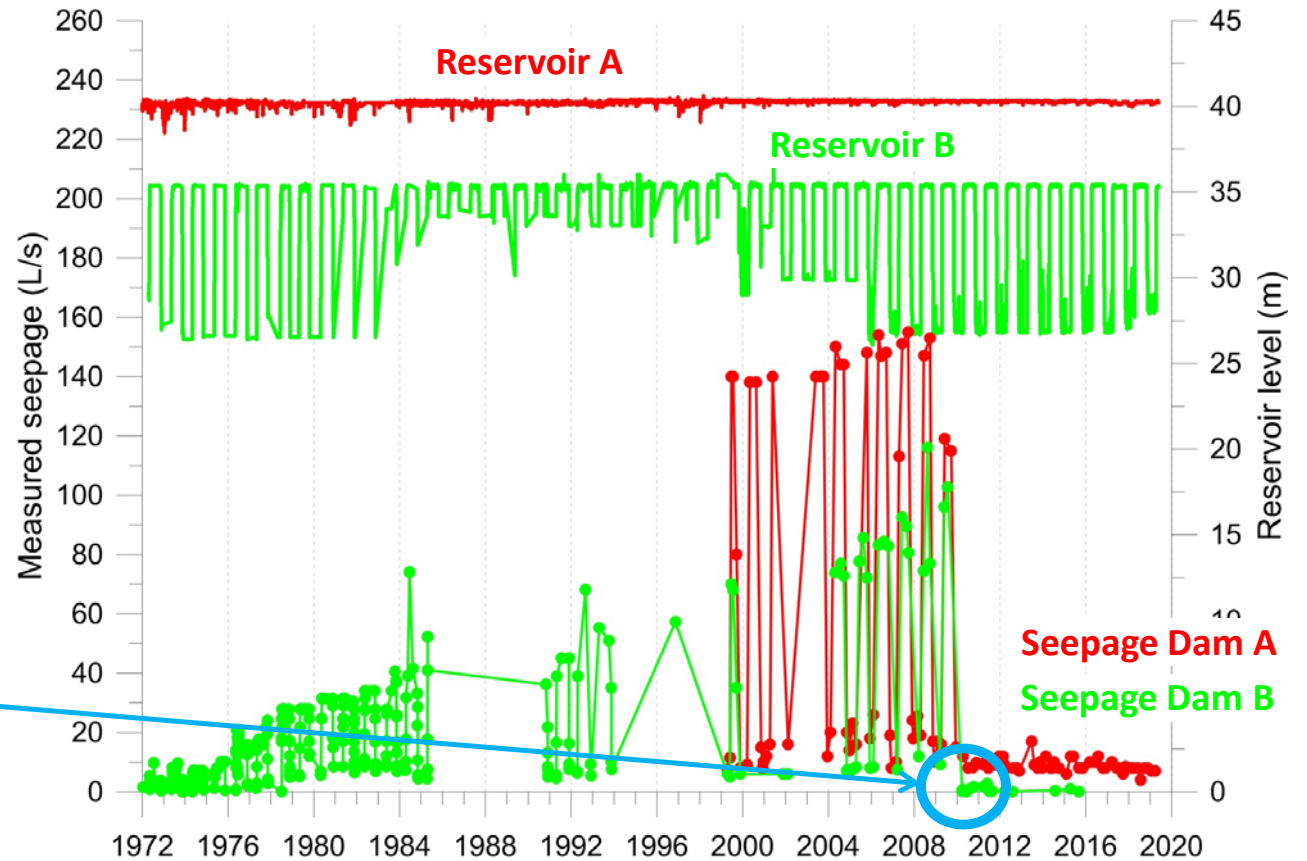
Effects of rehabilitation

The random rockfill was grouted shortly after these investigations. The contact erosion phenomena was stopped thus reducing significantly the seepage quantities.
