International Workshop on Embankment and Concrete Dams Overflowing Erosion

Dams in Vietnam Overflowing Erosion

M.Ho Ta Khanh (mhotakhanh@yahoo.com) CFBR- VNCOLD

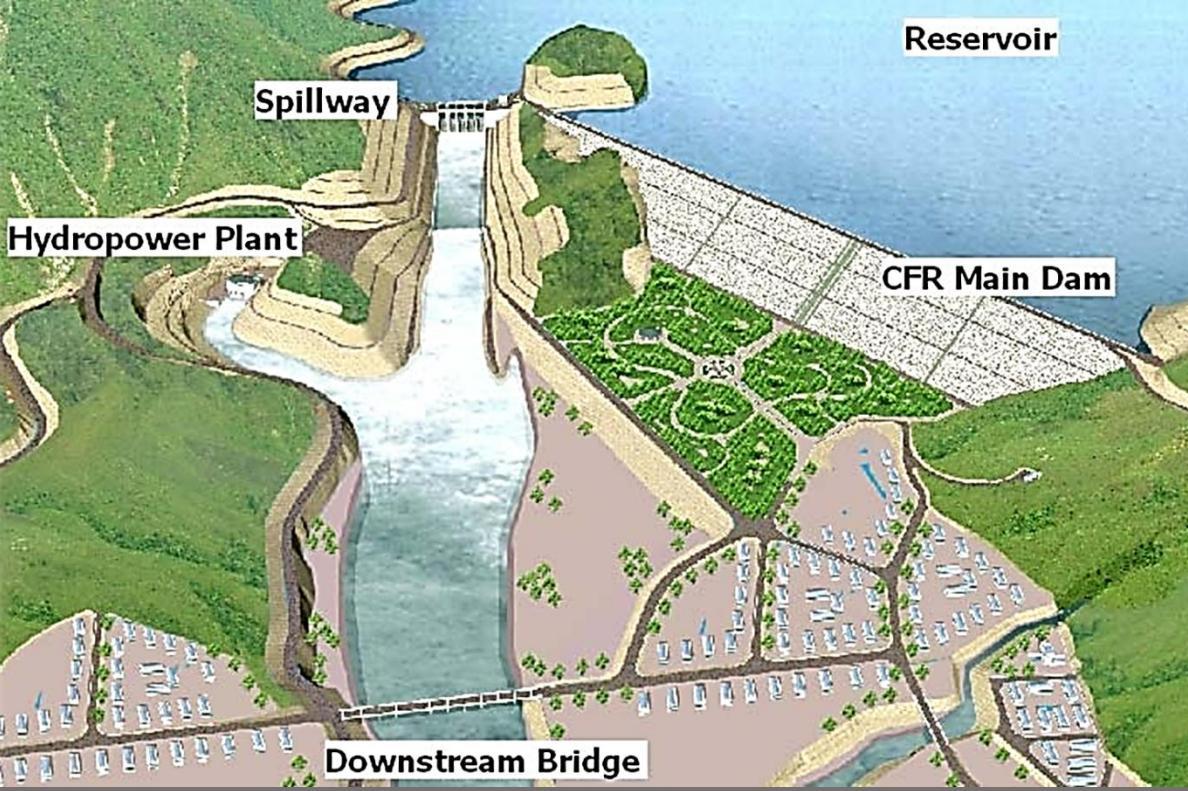
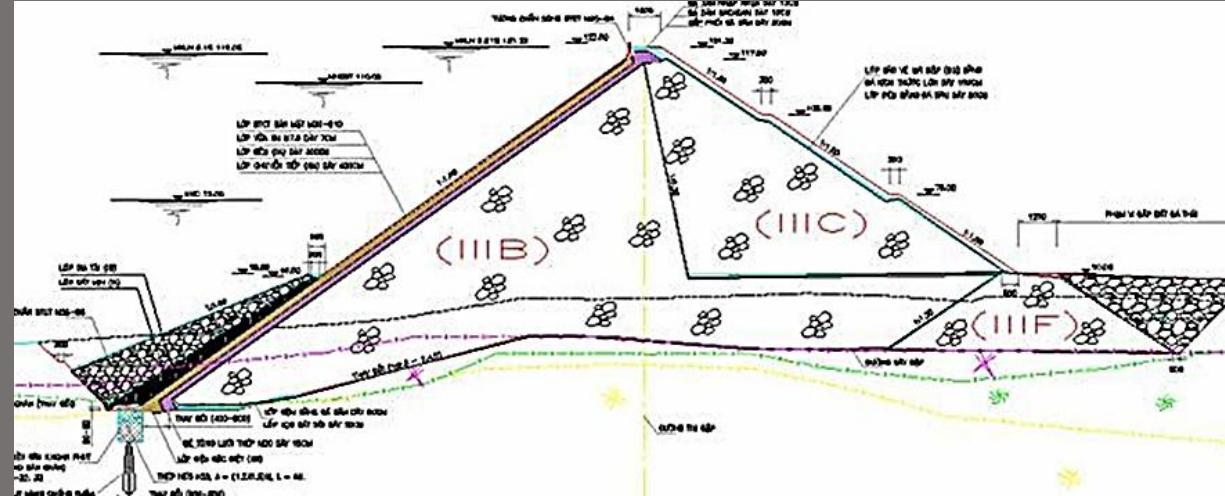
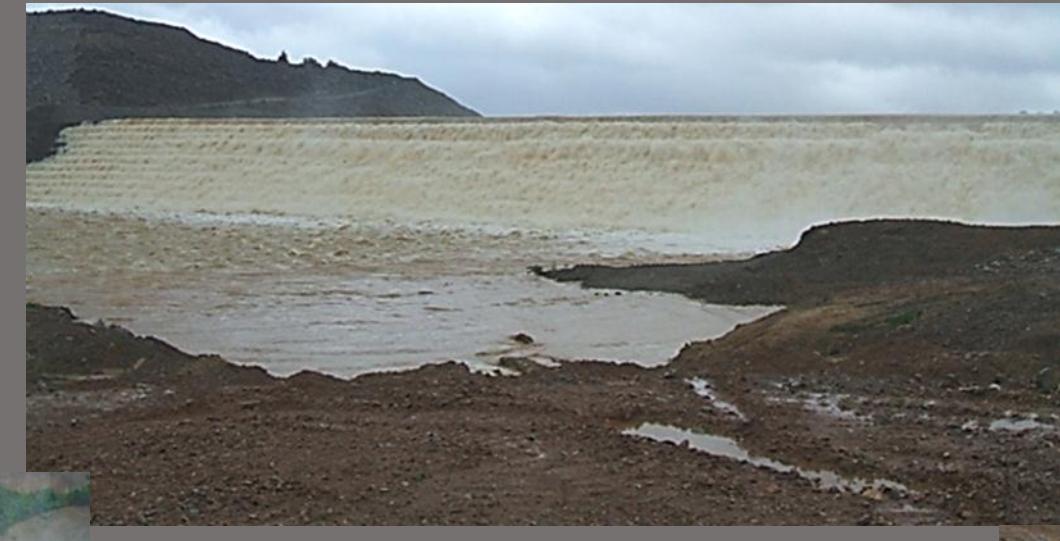
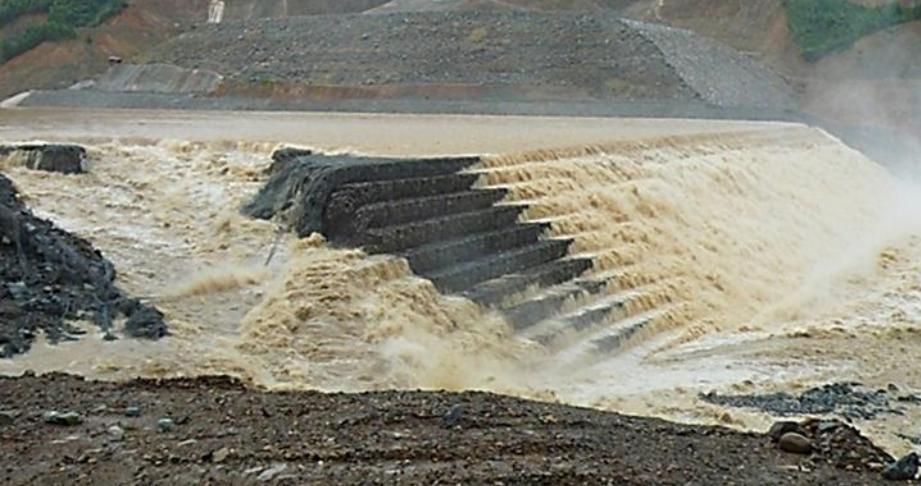
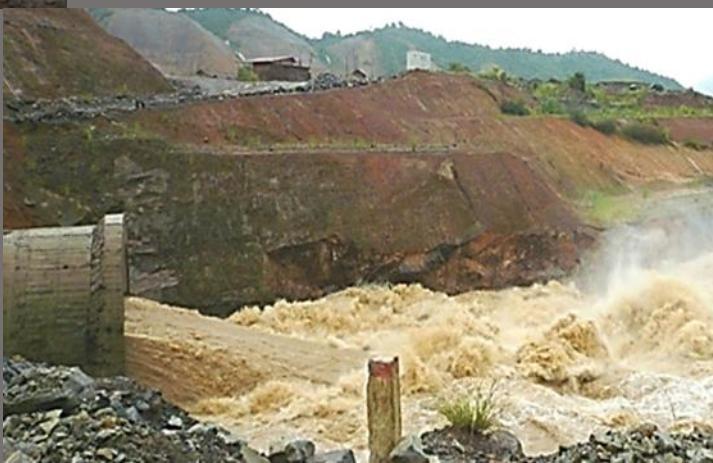
In October 2007, a typhoon centred above the site, with an exceptional flood, has submerged and destroyed the partial dam, however its repair in 2008 was finally less expensive and time consuming than the initial design with a traditional diversion by a high cofferdam and 2 large tunnels. The dam was finally commissioned in 2009 with a delay of 3 months.

- A portion of the dam collapsed during the typhoon Lekima, with a peak discharge of 7300 m³/s. The flood lasted 48 hours.
- The erosion begun when the discharge was over 2200 m³/s, with a overflow depth of 1.5 m, the destruction lasted 24 hours, with the opening of a breach from d/s to u/s on one third of the dam portion in the channel and with about 350 000 m³ of displaced rockfill. The diversion tunnel was partially clogged during the flood. *This failure would be probably avoided if the protection lining was provided by a thick RCC layer in place of the gabions.*

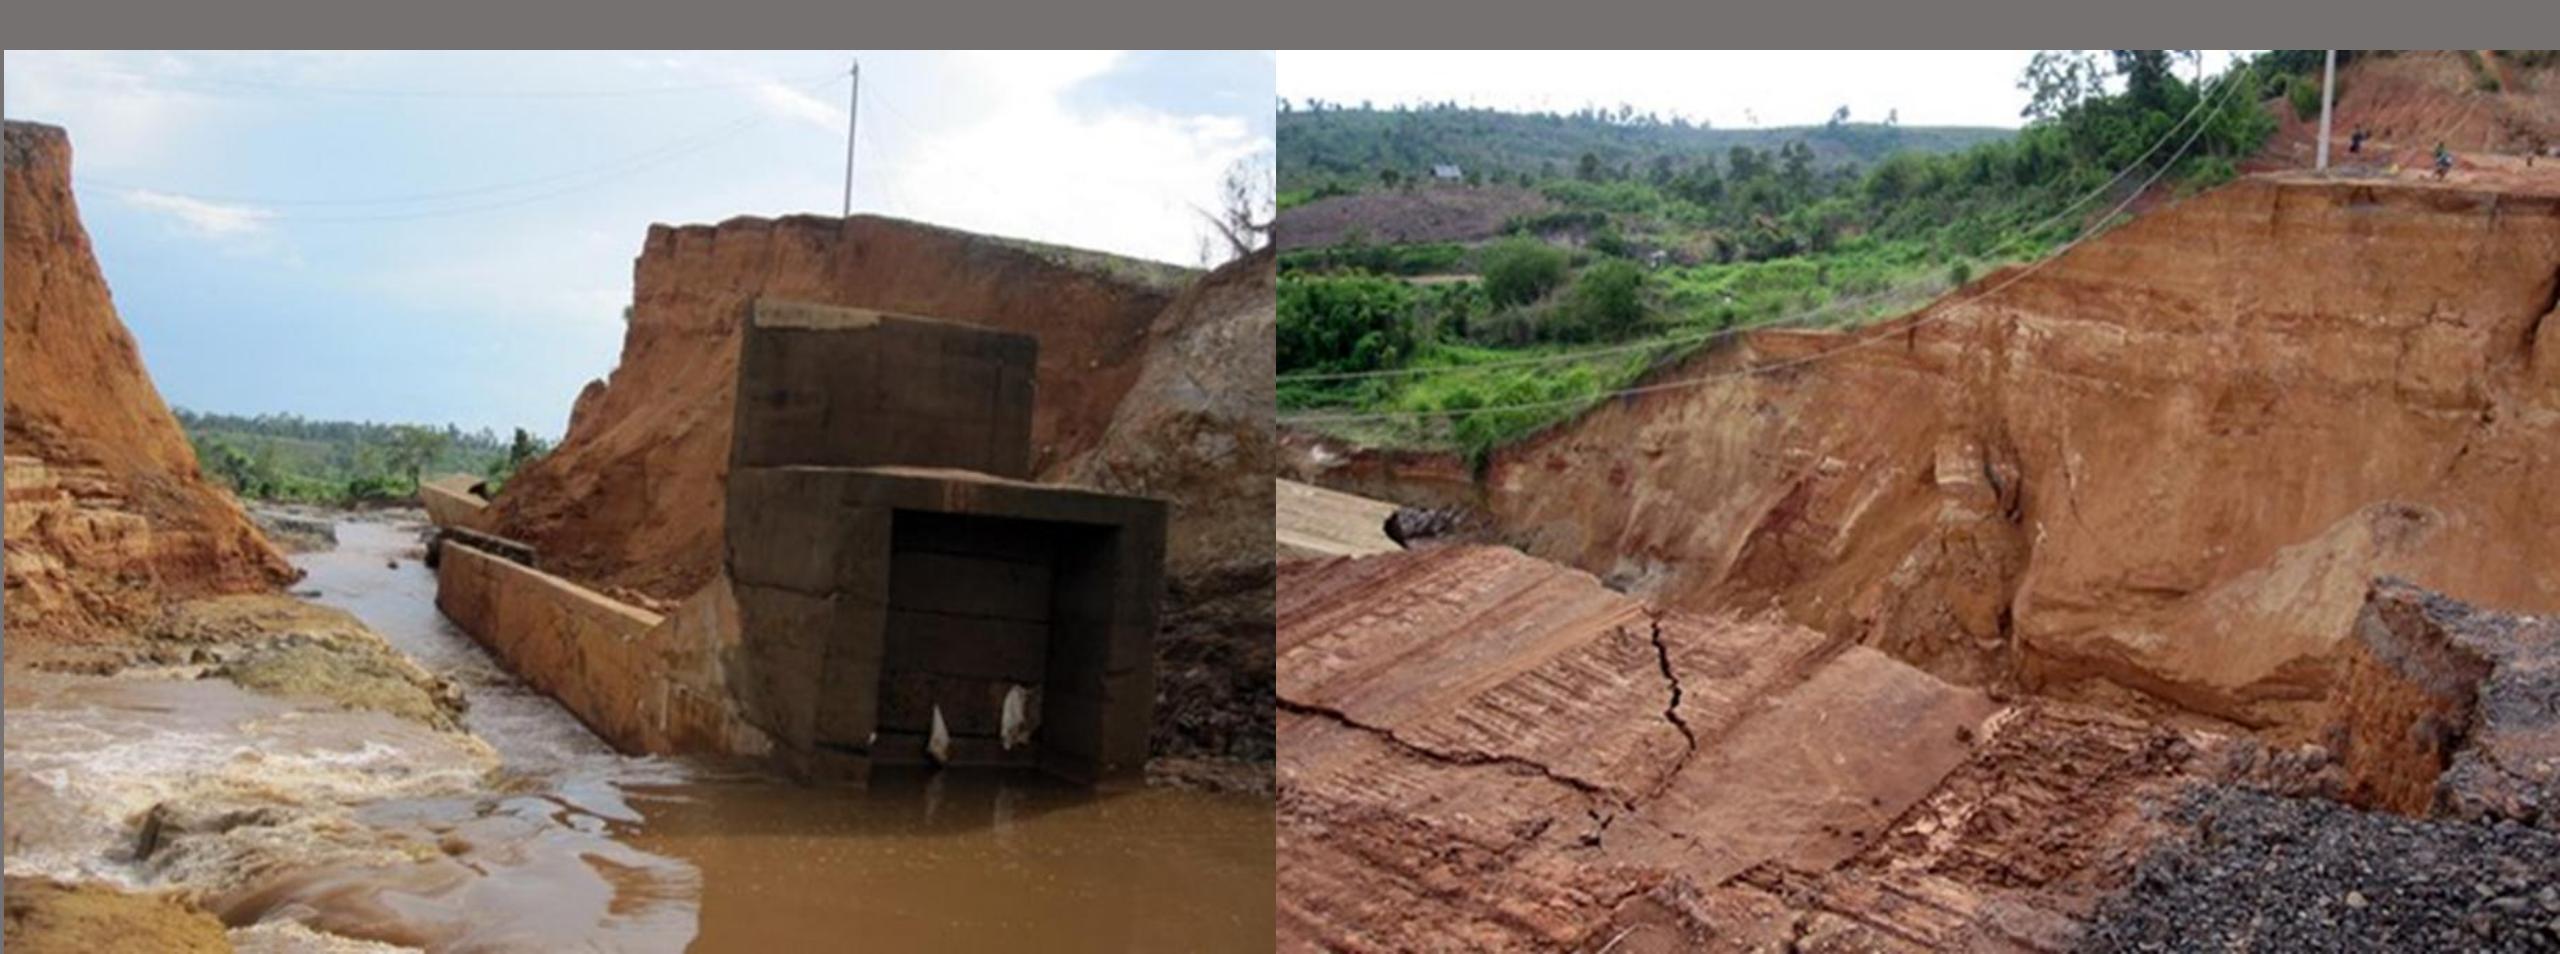
4.1 During construction : La Krel 2 dam

Two failures in 06/2013 and in 08/2014, due to internal erosion and overtopping during the flood.

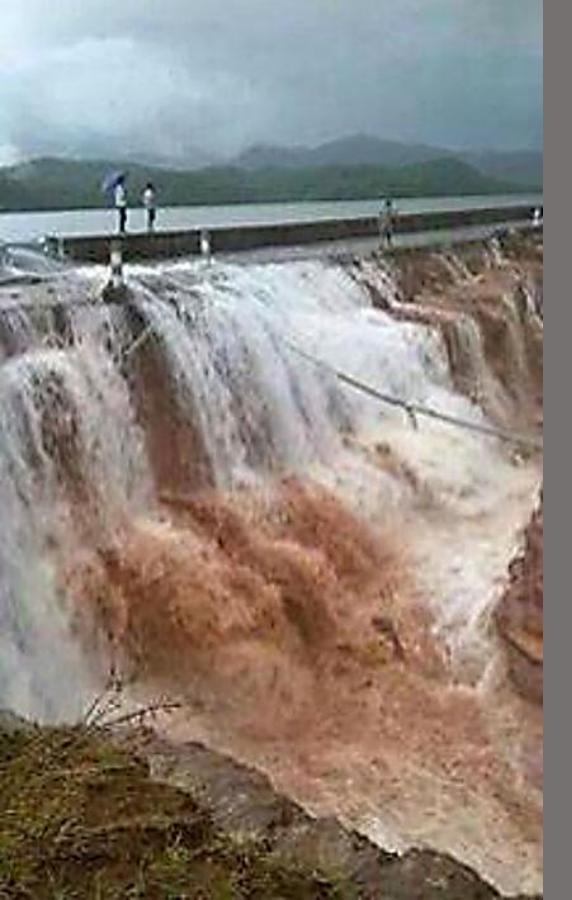
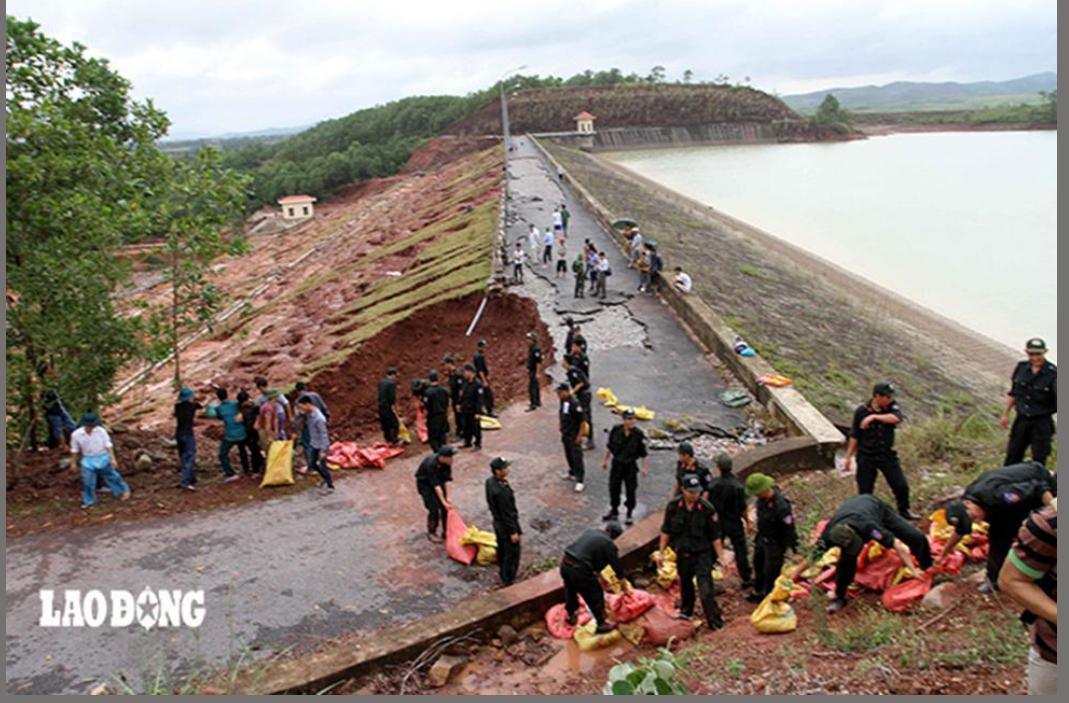
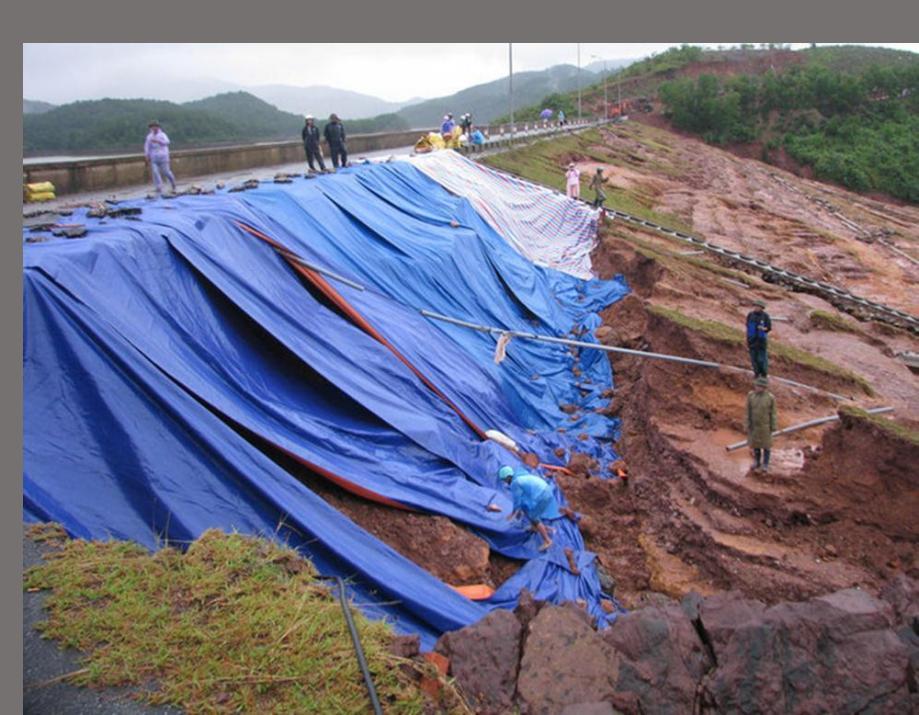
- Ha Dong dam incident (October 2014)

Overflowing on the main dam and the 2 saddle dams during the flood.

The highest water head over the dam crest was 1.15 m and over the parapet crest 0.35 to 0.40 m. Two dam abutments were severely eroded. Entire downstream slope was eroded 0.20 to 0.40 m.

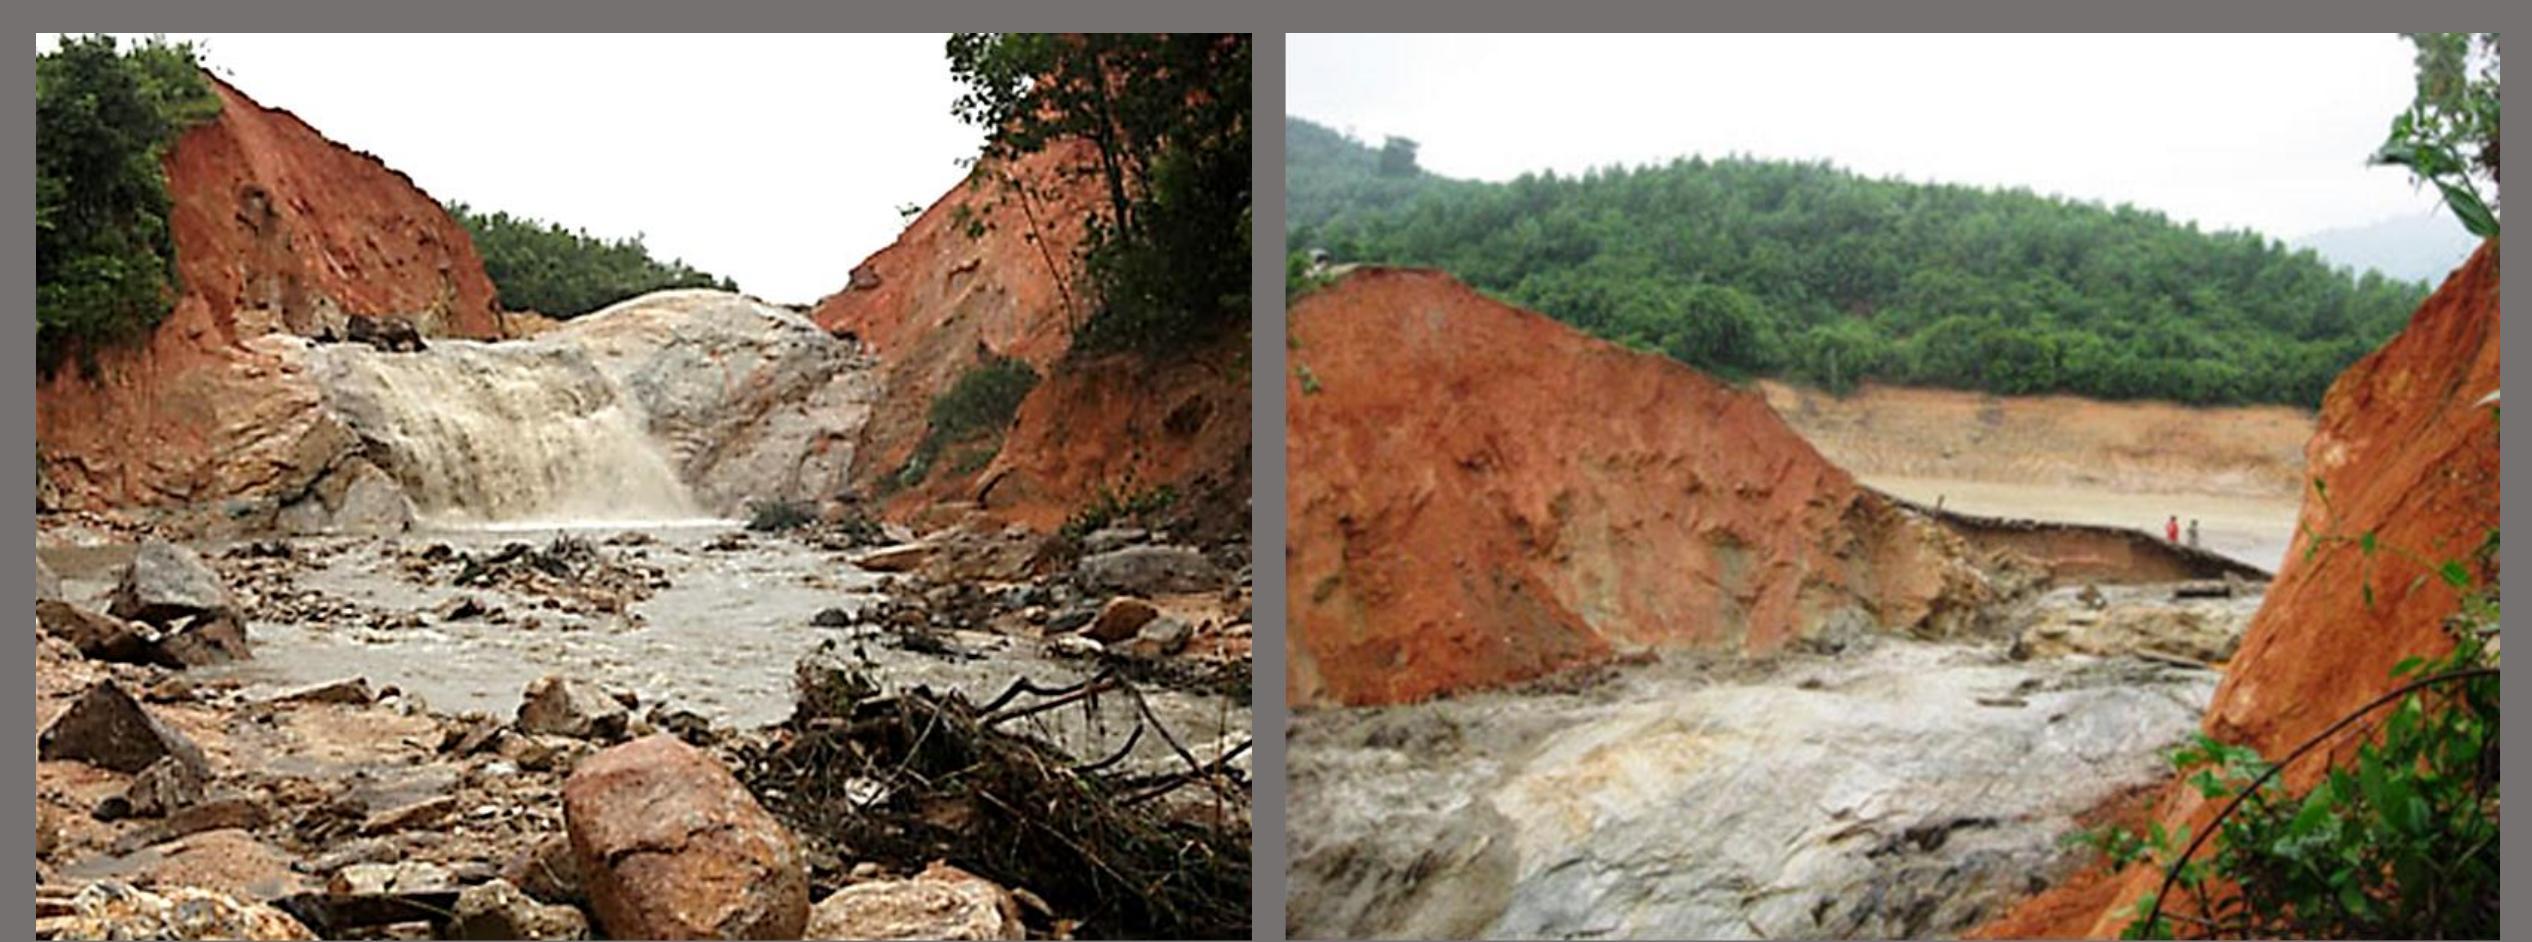
- Khe Mo dam accident (16/10/2010)

Dam failure by submersion following a high flood.

1000 houses inundated, 5000 families to be evacuated.

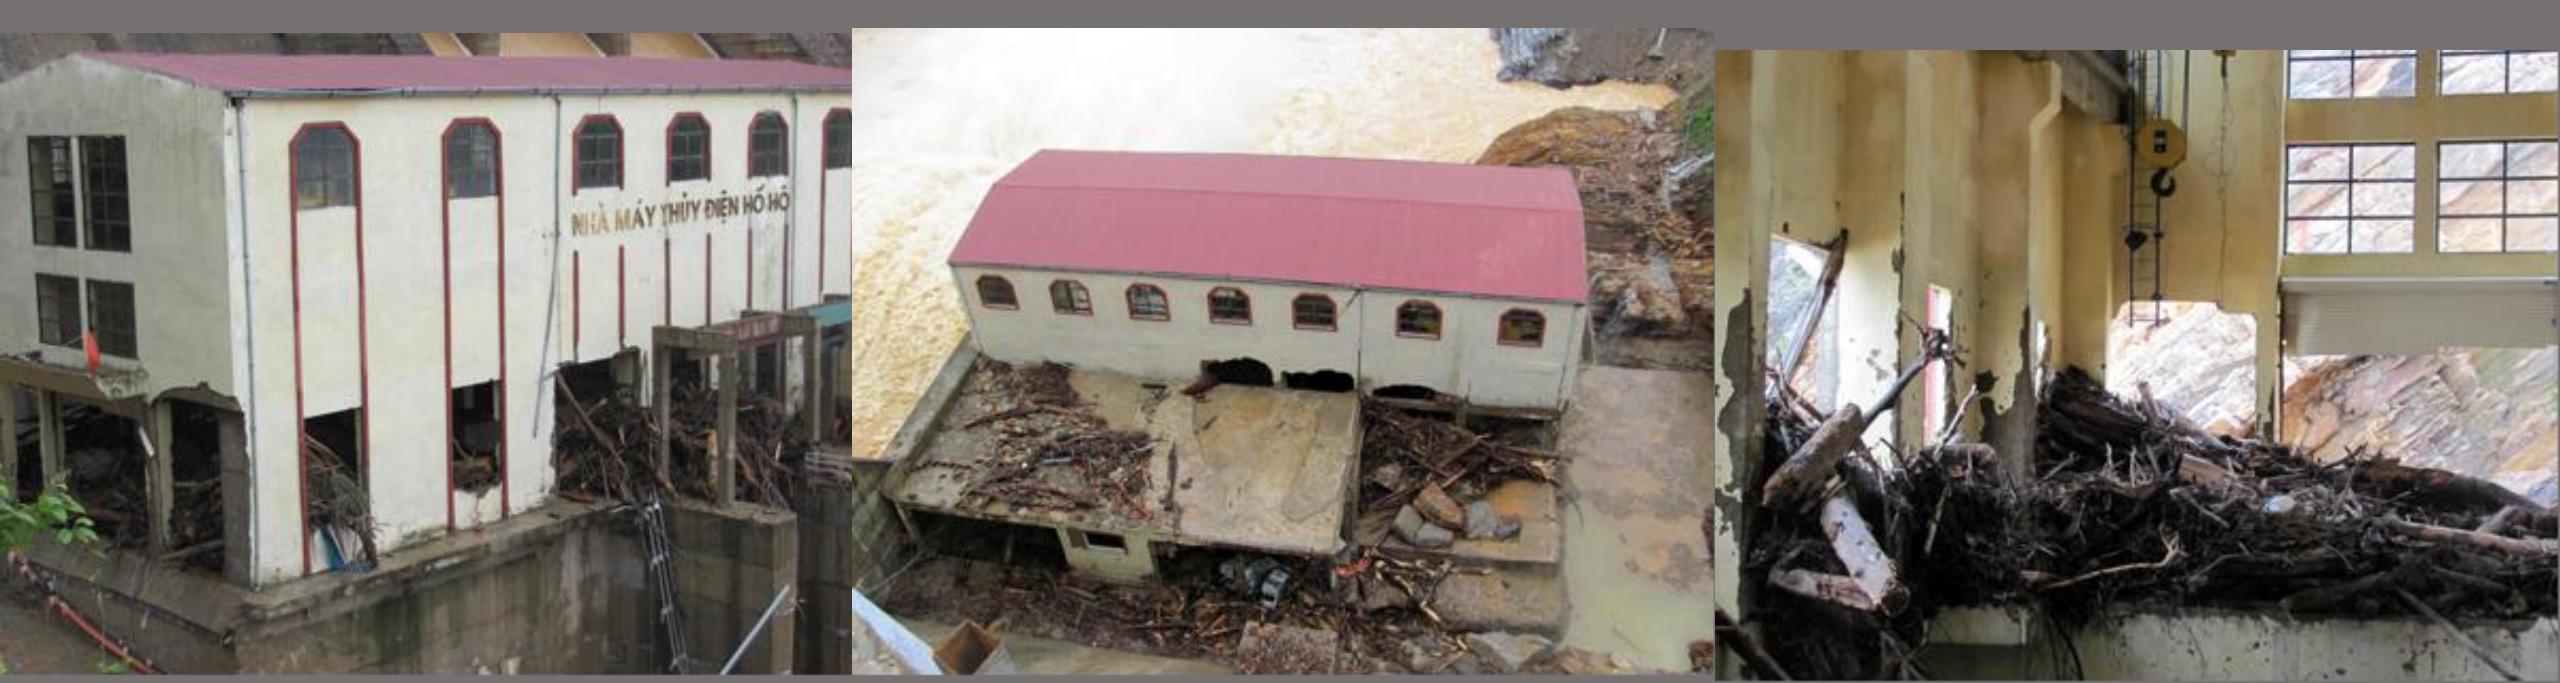
During the extreme rain events (October 2010) several days ago, the all three spillway gates could not be opened for hours because the power station was buried by a land slide and the grid power failed.

Lot of floating logs were trapped on the crest and in front of hand rails.

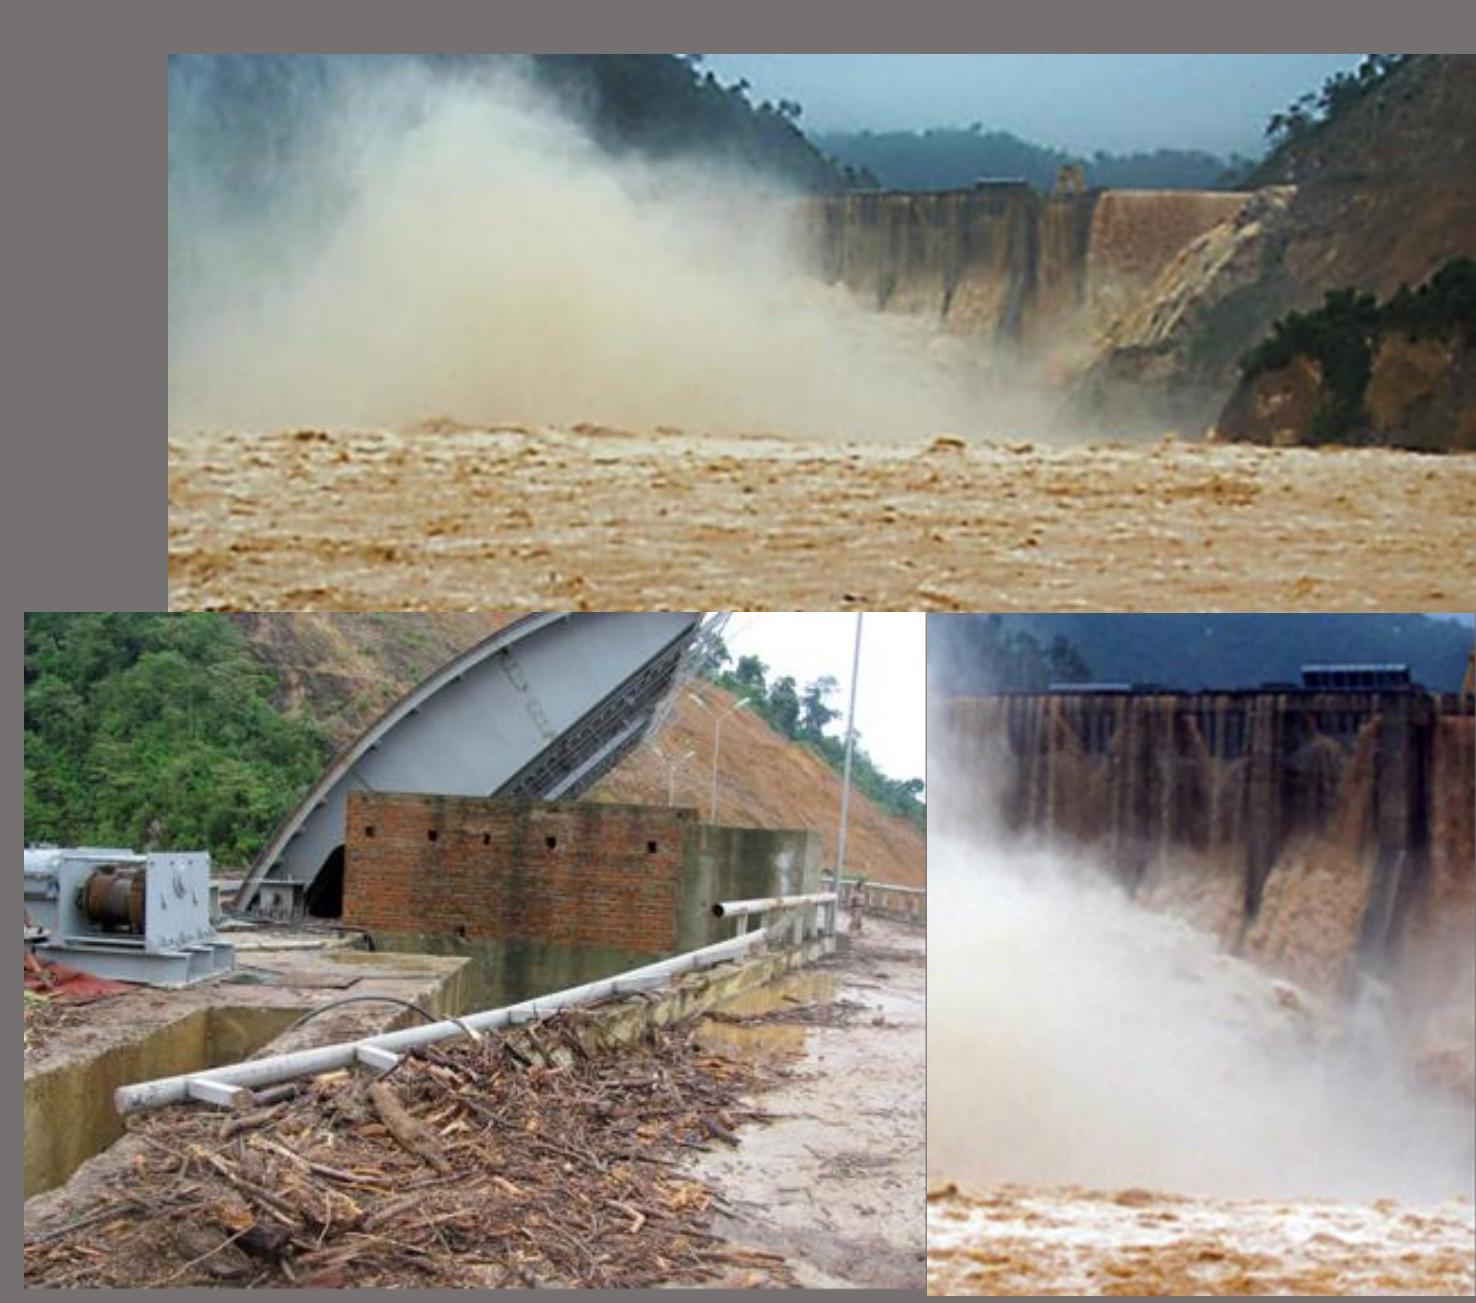
Overflowing of the Hoho dam and abutments

Flood flow spilled over the dam crest by 2 m.

Mobile generators were brought to the site with much difficulty by flooded road in heavy rain after more than 20 hours and the gates were finally opened.

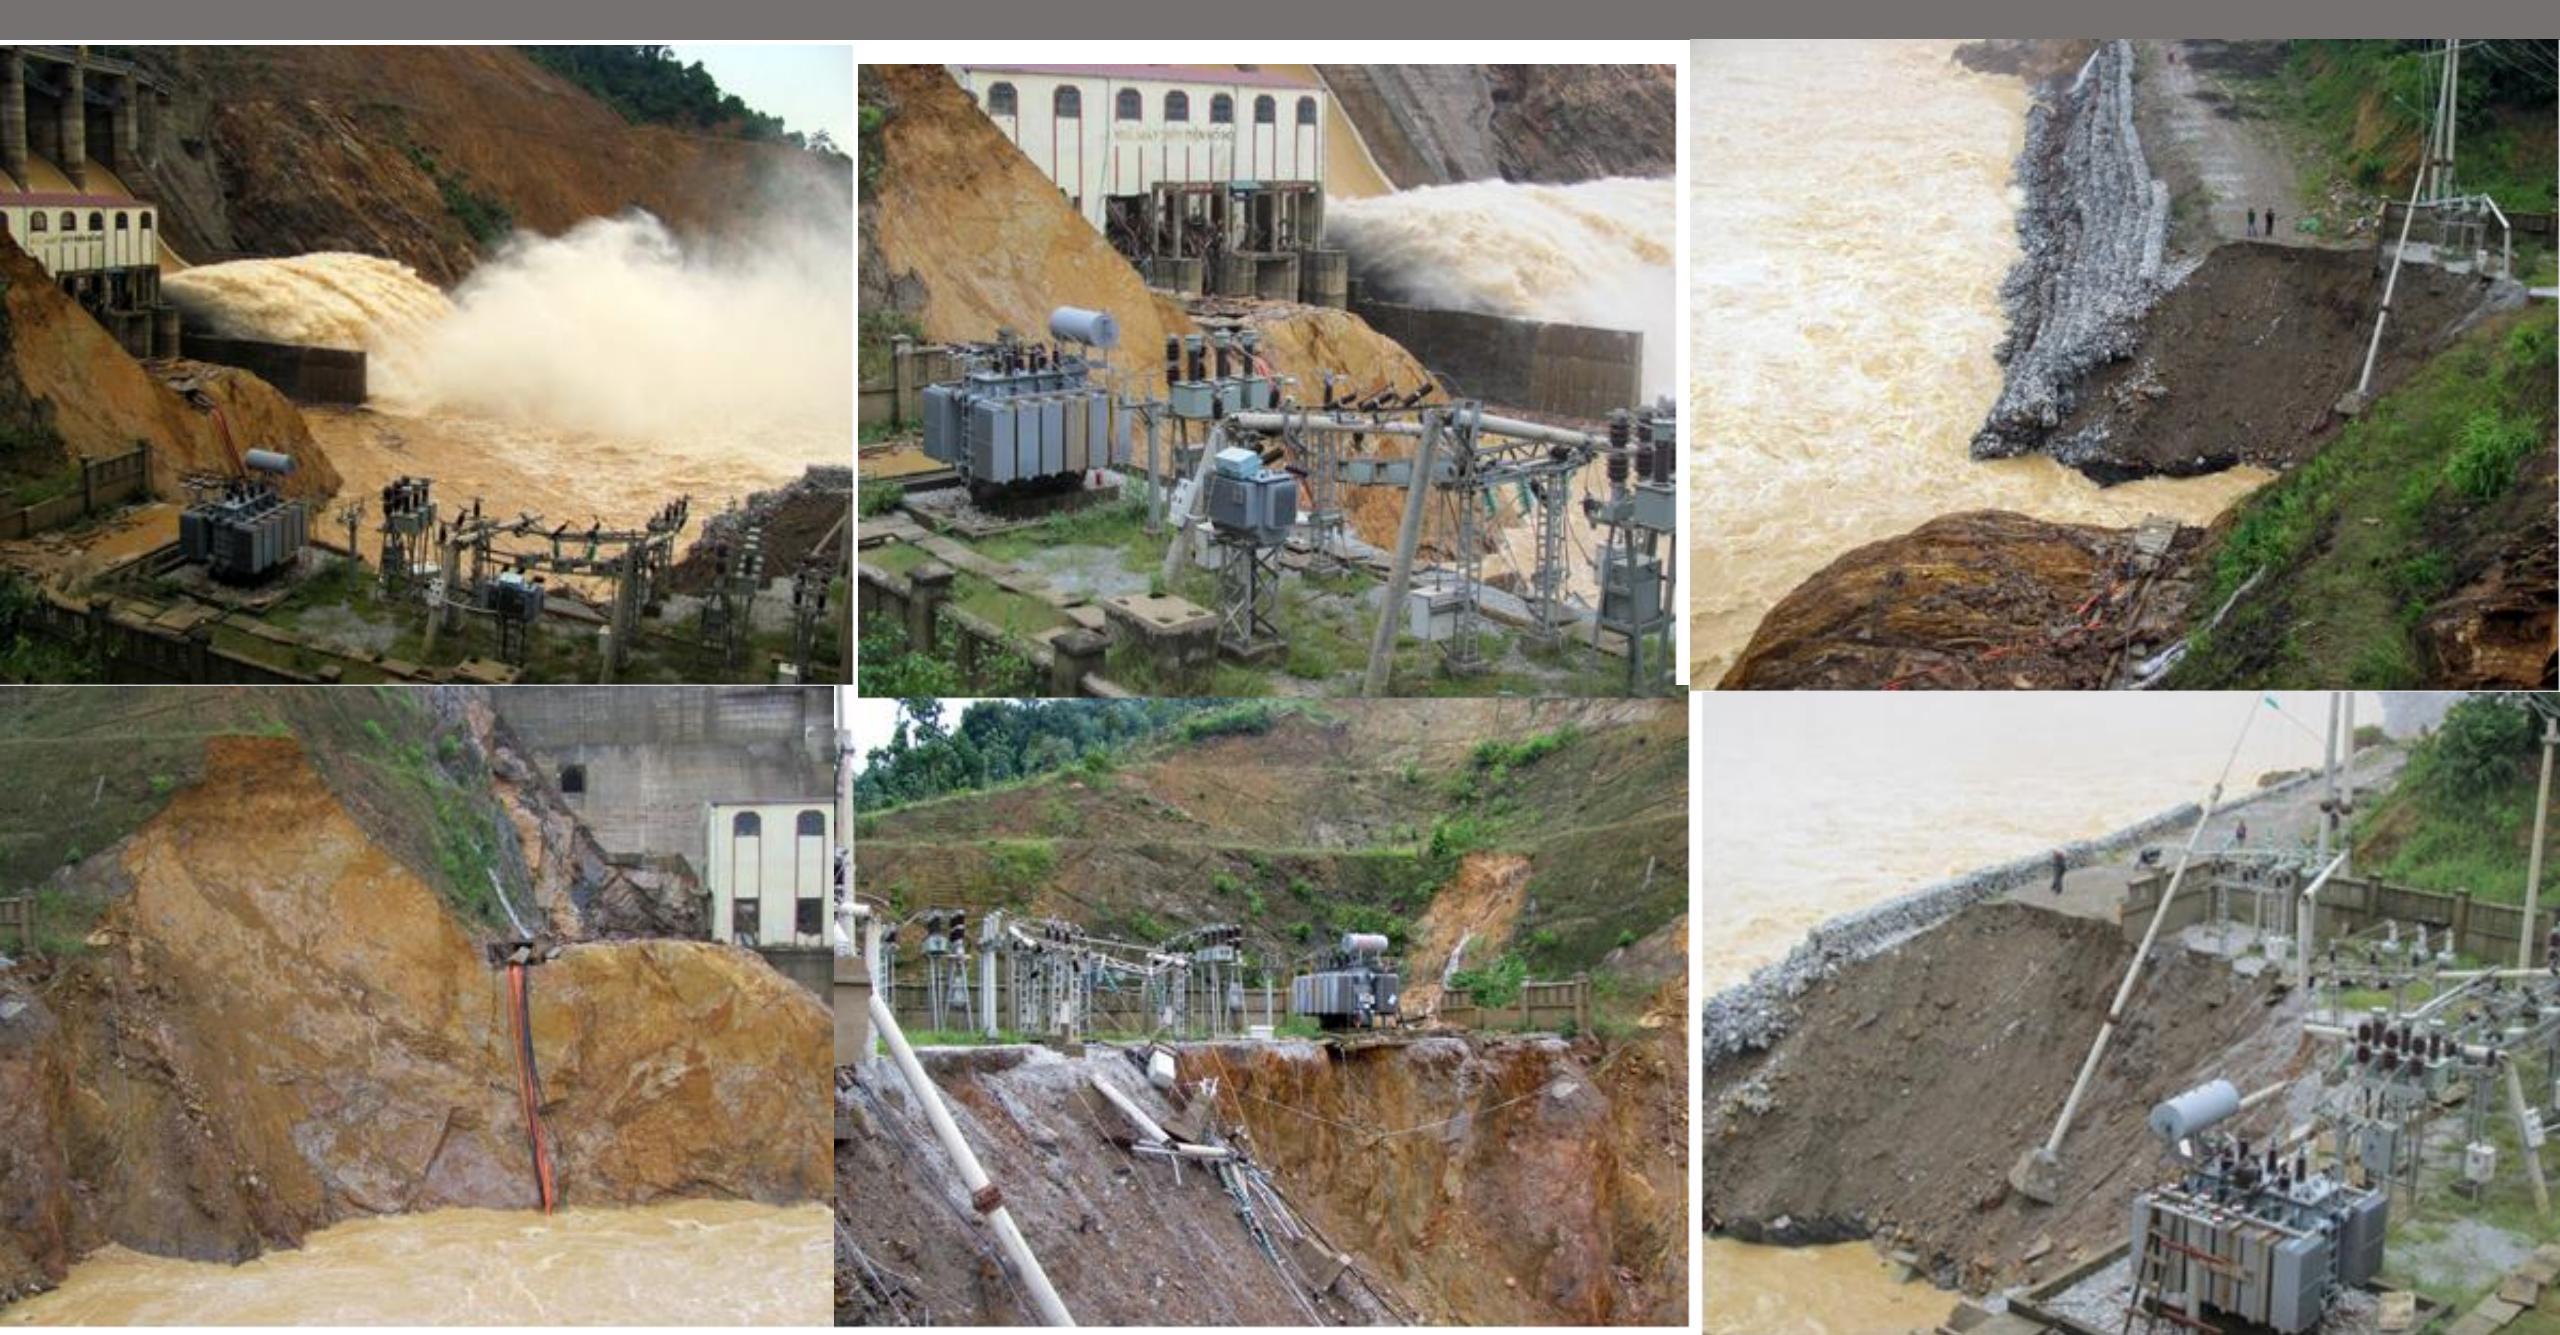
Erosion of the abutments downstream the Hoho dam

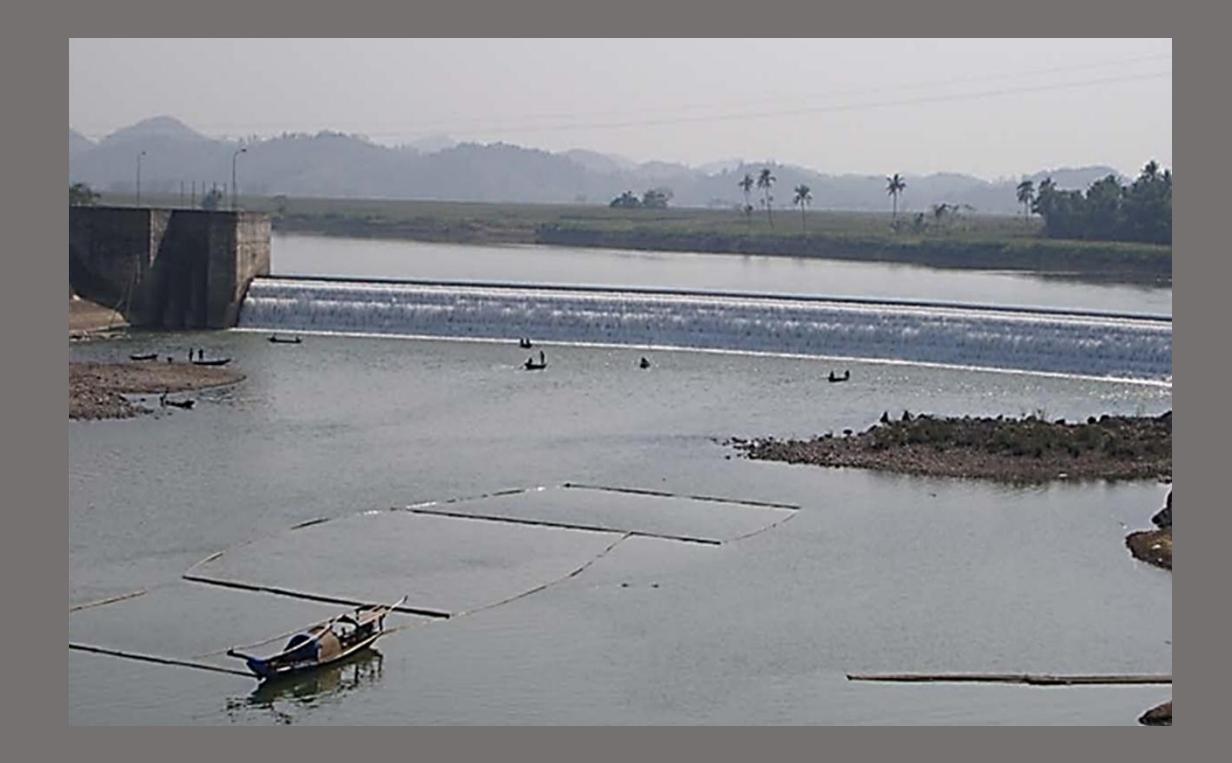
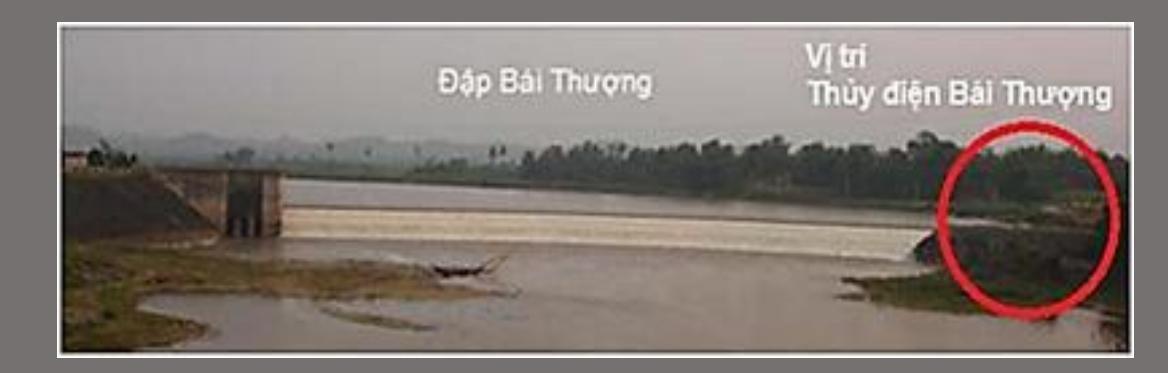
6.1 The Bai Thuong dam

The Bai Thuong dam (H \sim 14 m) is a masonry gravity dam built in 1930, with a fixed crest weir without special protection of the dam toe.

In 1992, a subwater inspection of the dam's toe detected a scour that can endanger the stability of the dam and favour the seepage trough the foundation.

In 1998, the dam was repaired with a grouting curtain upstream and the unloading of large size rockfill downstream.

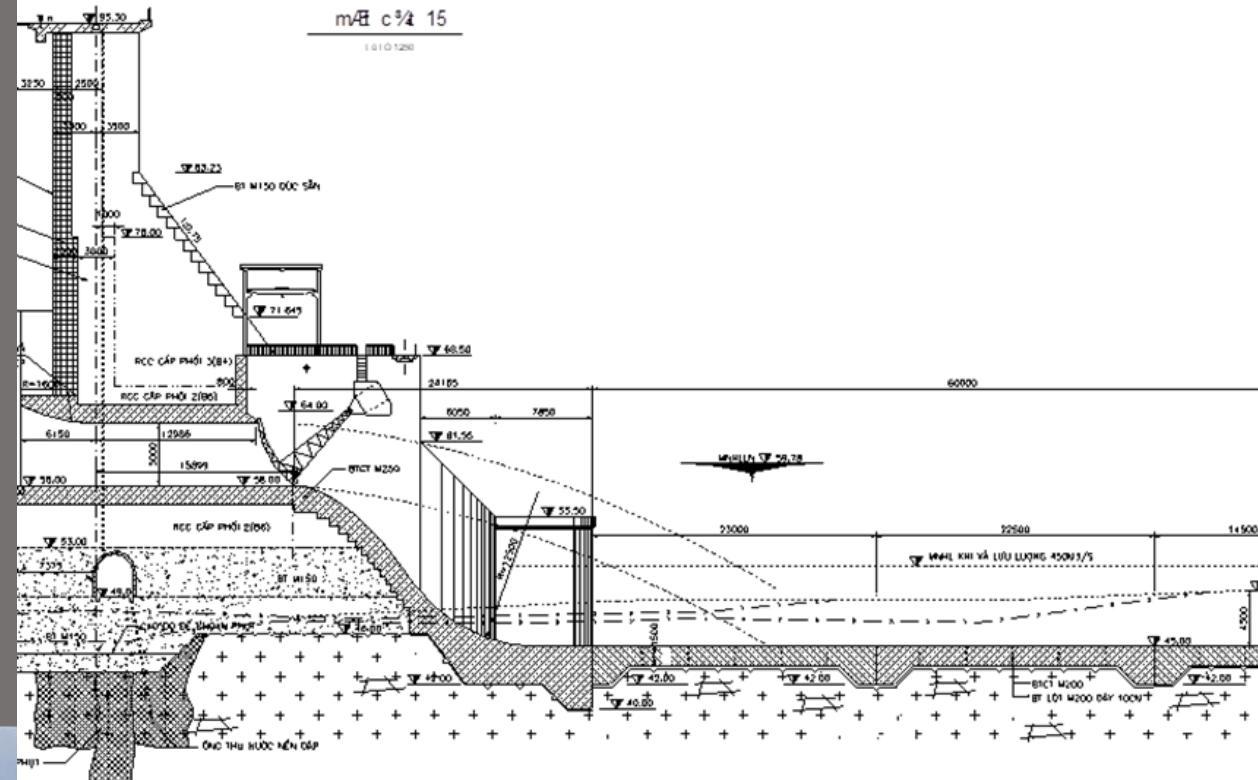
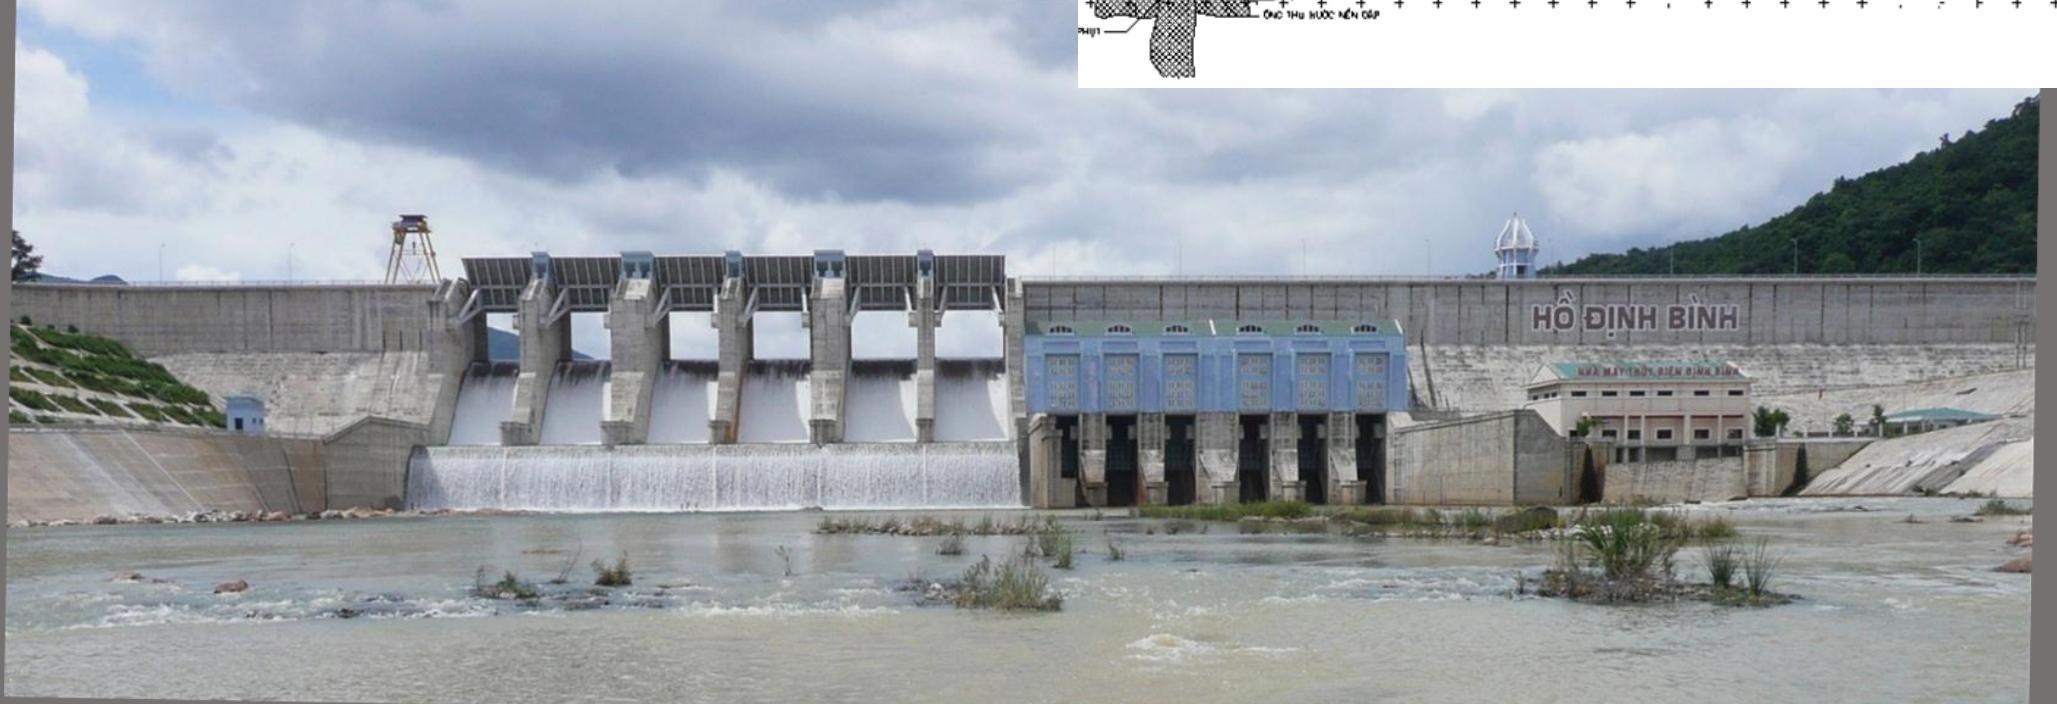
The Dinh Binh RCC gravity dam (2002-2007) (The 1st RCC dam in Vietnam). H= 55 m.

Degradation of the apron of the stilling pool downstream the bottom outlets 7 years after the commissioning of the dam.
