International Workshop on Embankment and Concrete Dams Overflowing Erosion

Dams in Vietnam Overflowing Erosion

M.Ho Ta Khanh (mhotakhanh@yahoo.com) CFBR- VNCOLD

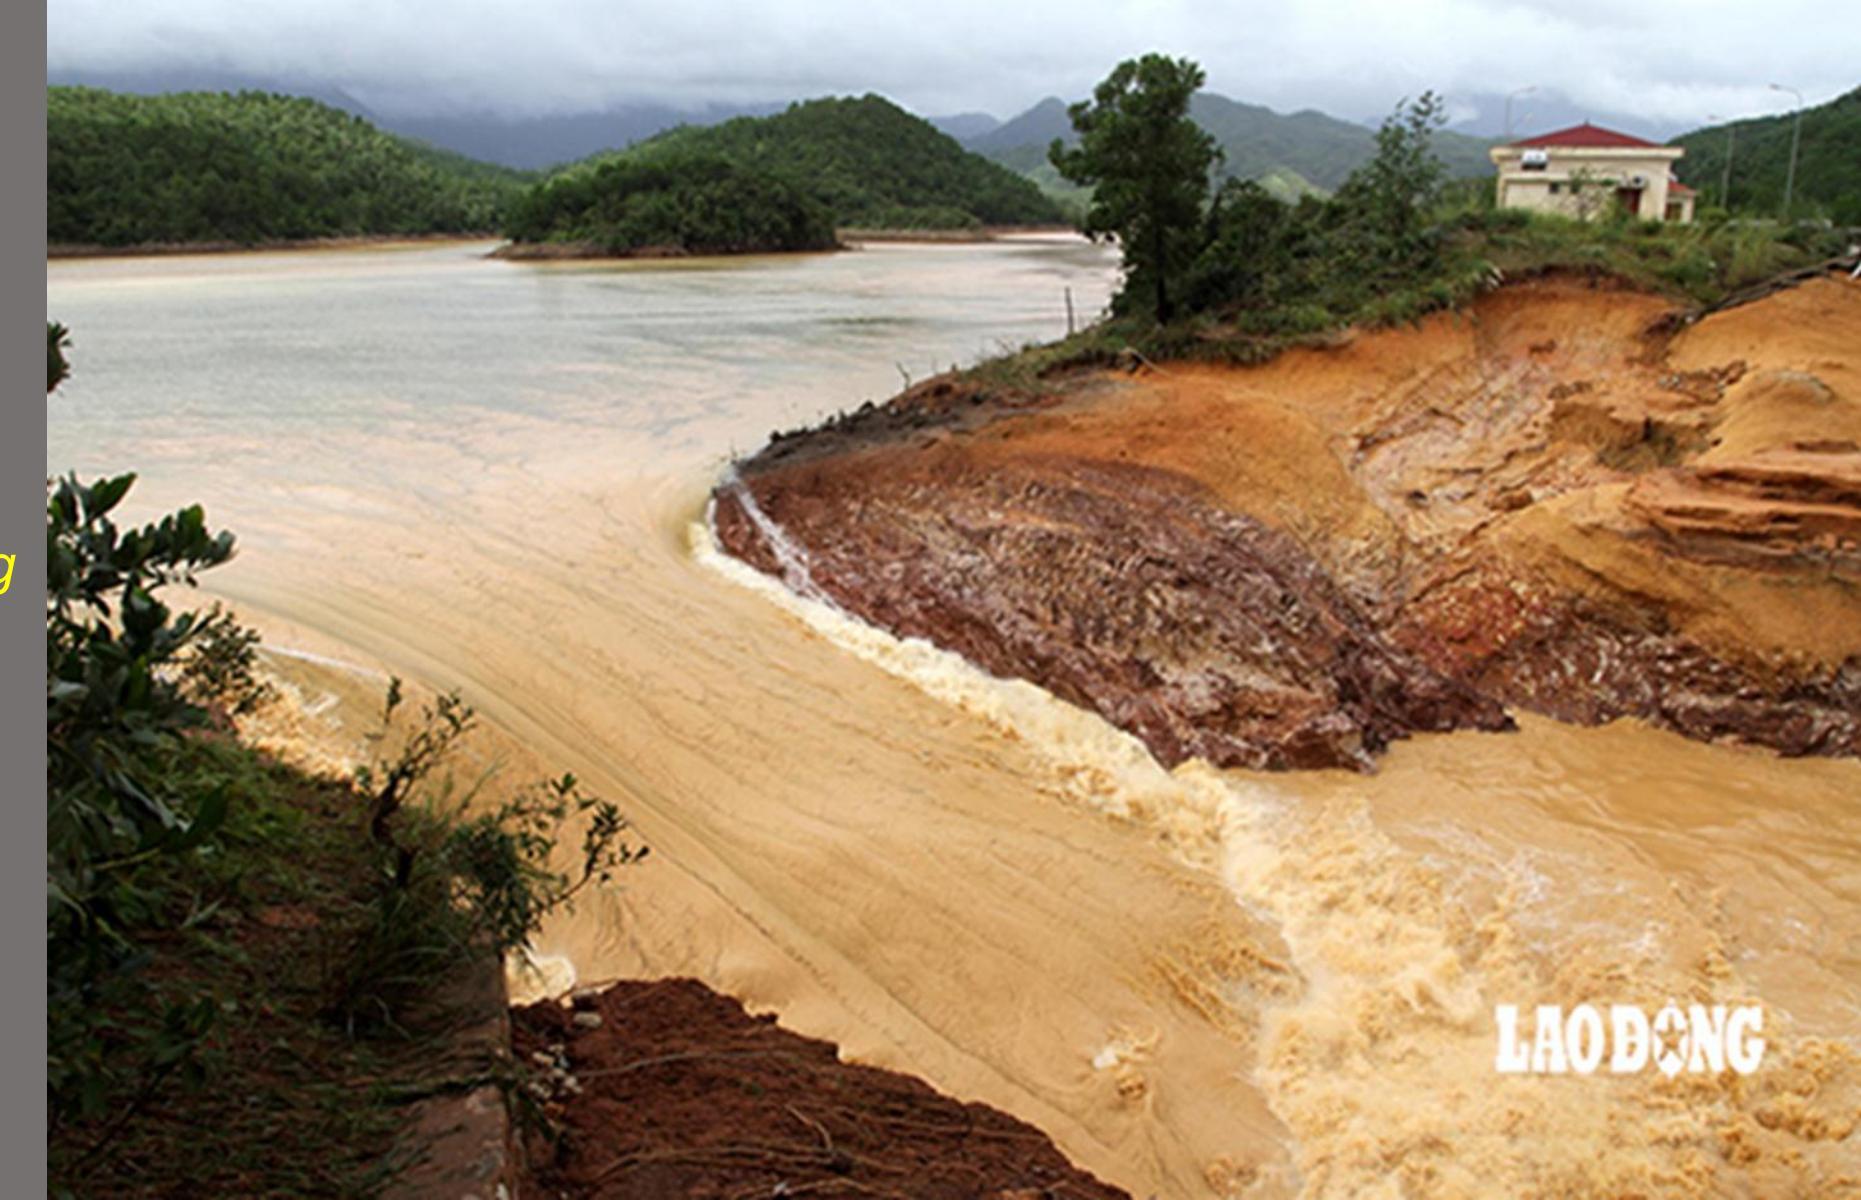
The collapse of one Ha Dong saddle dam by submersion.
