Erosion Testing of Zoned Rockfill Embankments

Tony L. Wahl

Hydraulics Laboratory, Denver, Colorado

U.S. Department of the Interior Bureau of Reclamation

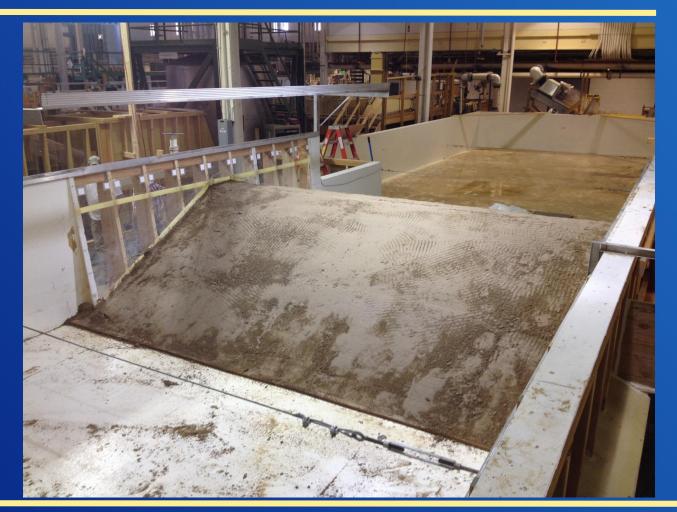
Dam Breach Test Facility Denver, Colorado

- 13-ft wide, 3-ft high embankment
- Inclined abutment (1:10), acrylic for viewing
- Large tailbox to contain breach outflow
- Headbox spillway with adjustable crest to maintain steady reservoir level

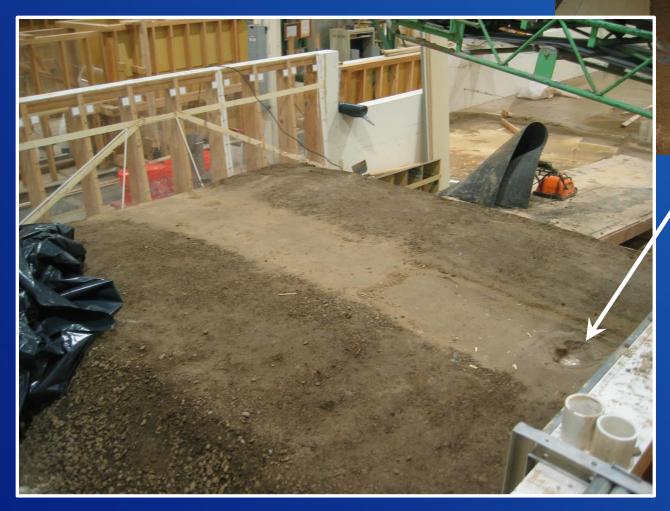
JET test of core

Sand cone tests also performed to measure density of core and gravel zones

Approx. 100% of standard Proctor for all zones

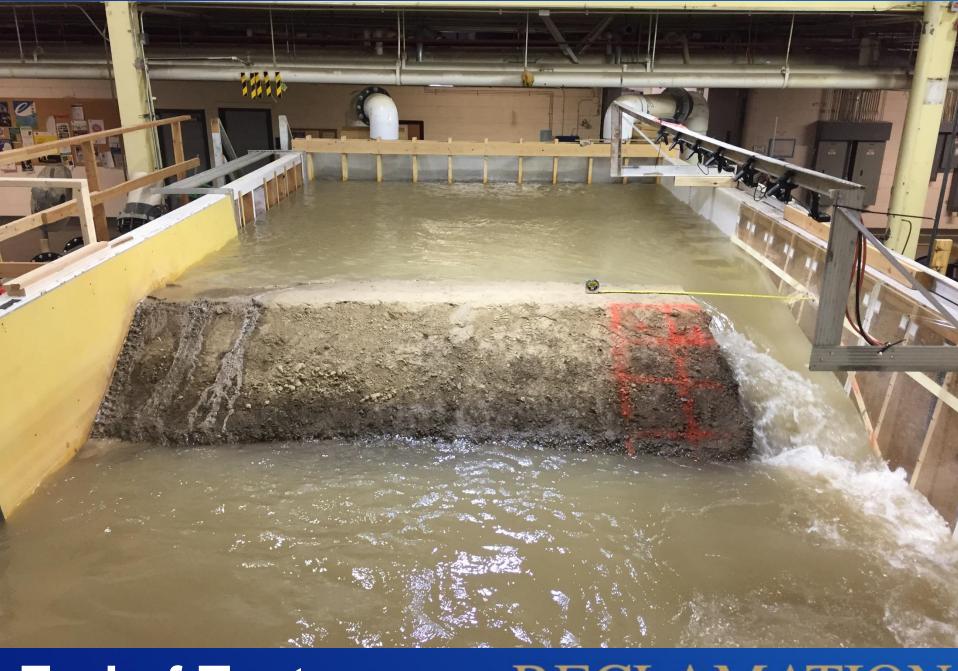
End of Test

- Although core and gravel zones both showed cohesive behavior (near-vertical sidewalls), erosion did not adopt a headcut pattern
- Surface erosion was dominant
 - Lack of tailwater pool to provide recirculation and accelerate erosion at toe

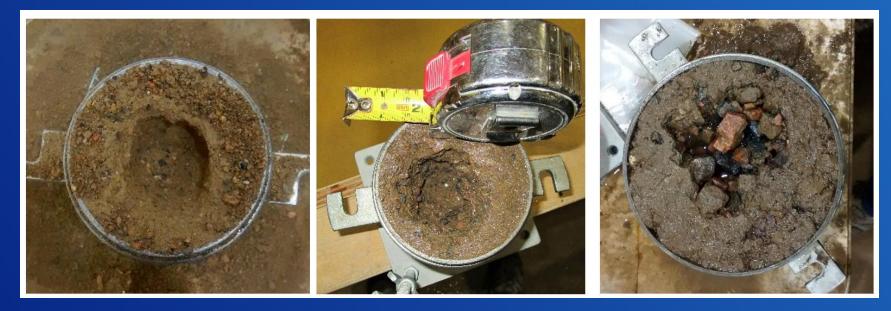
Full gravel specimen was more erodible again, but still close to range of estimates for embankment rockfill zone. This specimen is probably pushing the limits for doing a valid JET test (too much gravel, too big).

Minus No. 4 (3/16")

minus 3/8"

full gravel up to 3/4"
