# Downstream Spillway Erosion in EDP Dams

**EDP Produção**  
**Dam Engineering Division**

International Workshop  
Overflowing Erosion of Dams and Dikes  
11-14th December 2017  
Aussois, France

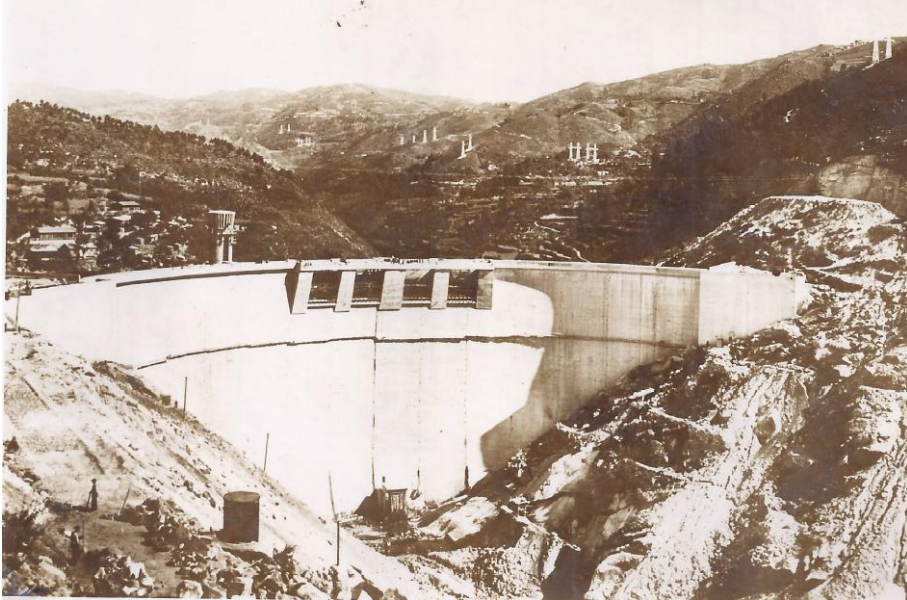
# Cançada Dam - Original Situation

- Year of completion: 1955
- Dam type: Thin arch
- Height: 76 m
- Foundation: Granite
- Spillway type: Controlled; free falling jet
- Maximum discharge capacity: 1700 m<sup>3</sup>/s

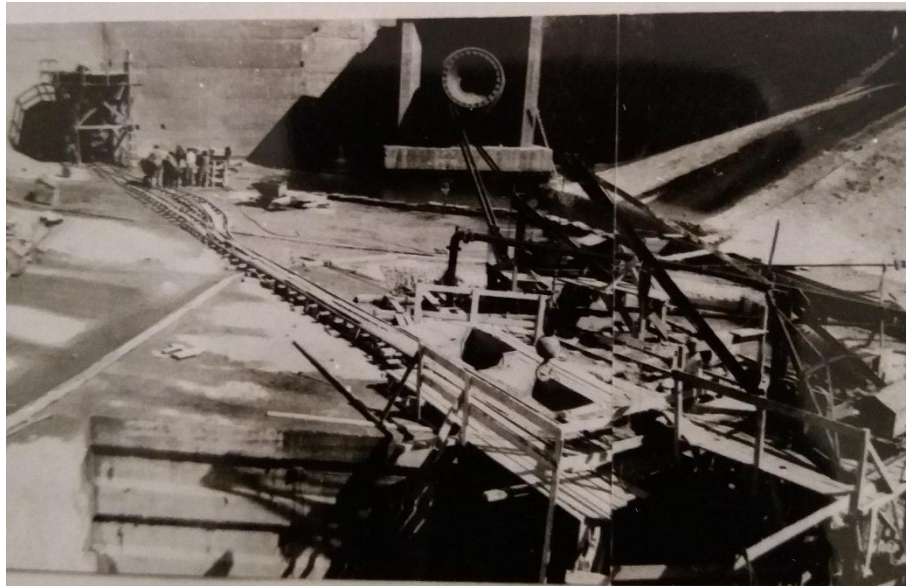
# Cançada dam – Repair Works in 1960-61

Weir: 115 m  
downstream the dam

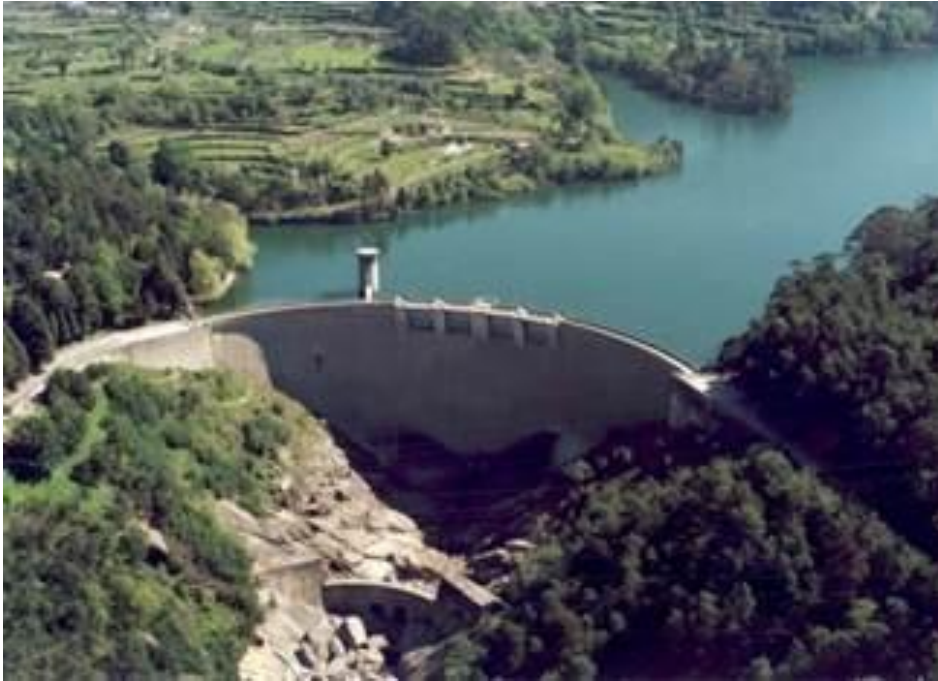
# Caniçada Dam – After the Execution of the Downstream Weir

Free falling jet discharging into a plunge pool

Cross section

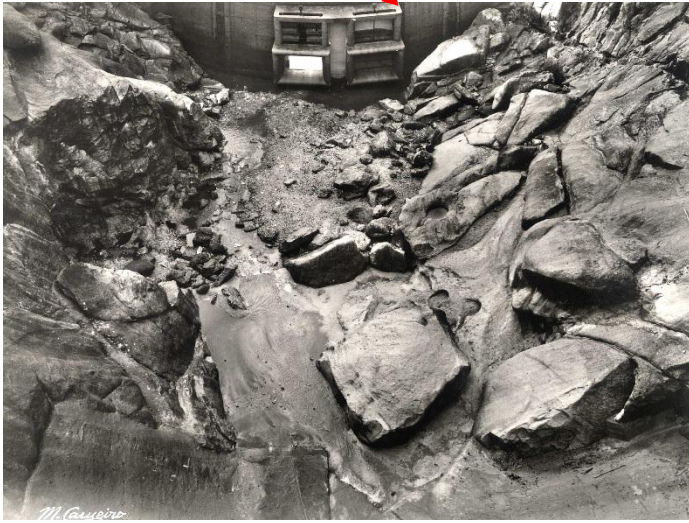
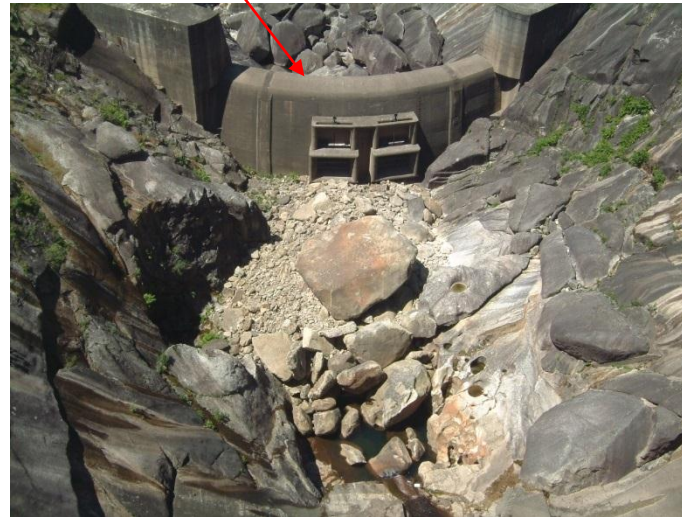
# Cançada Dam – Downstream River Bed

Weir

1970

2004

2017

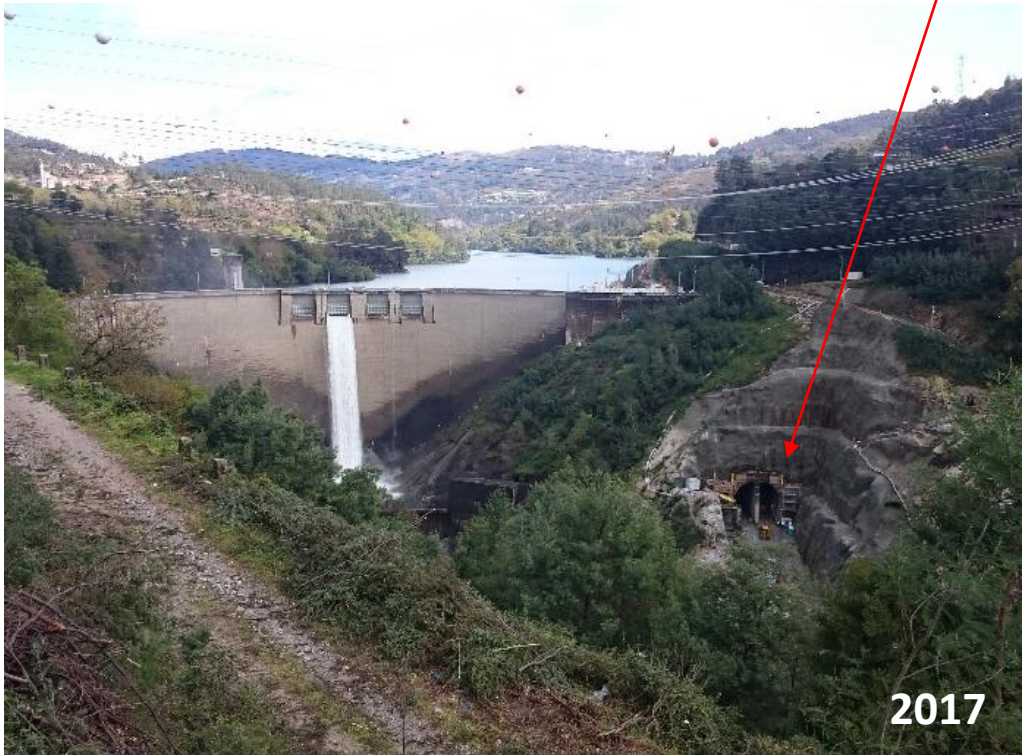
Caniçada dam

Complementary spillways

1700 m<sup>3</sup>/s + 2000 m<sup>3</sup>/s

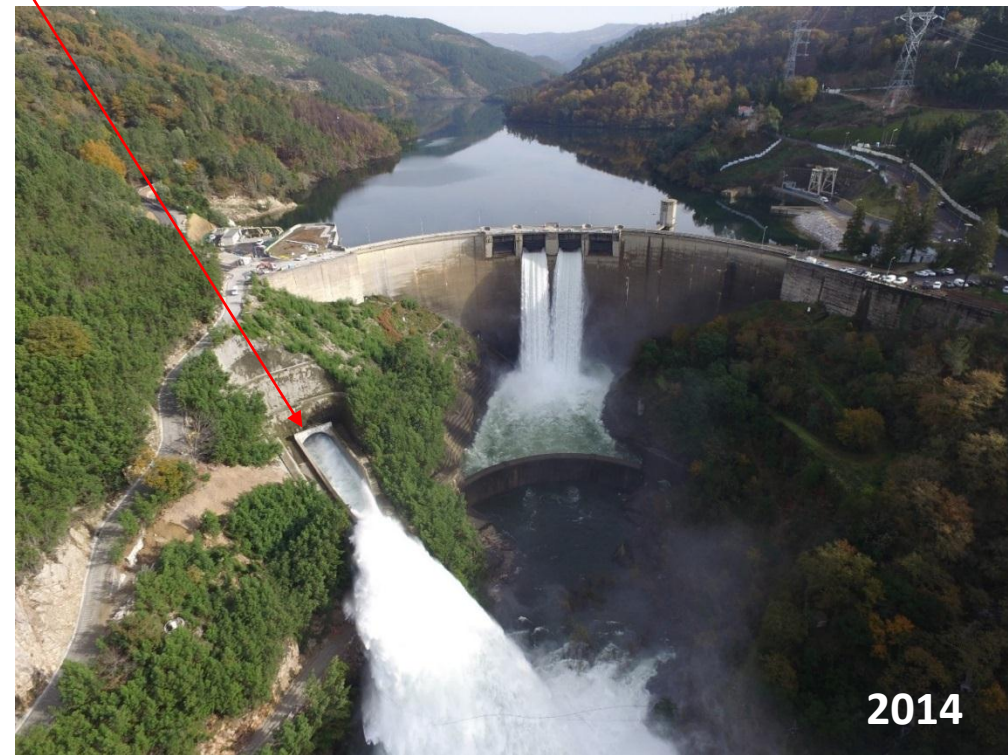
Salamonde dam

1700 m<sup>3</sup>/s + 1000 m<sup>3</sup>/s

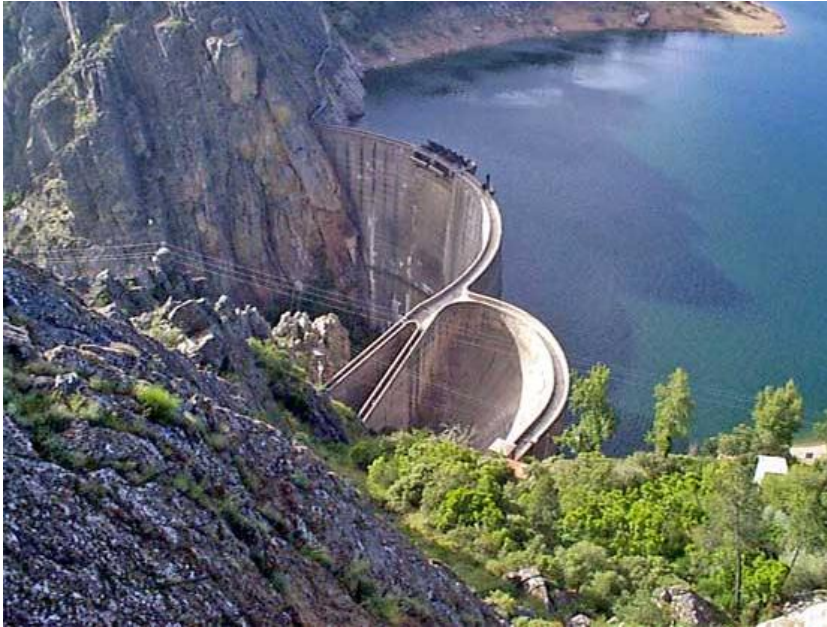
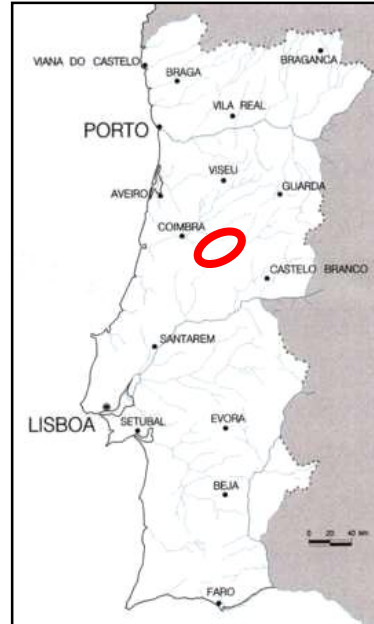
# Santa Luzia Dam

Upstream view

- Year of completion: 1942
- Dam type: Thin arch
- Height: 76 m
- Foundation: Quartzite
- Spillway type: Controlled; free falling jet
- Maximum discharge capacity: 120 m<sup>3</sup>/s

Plan

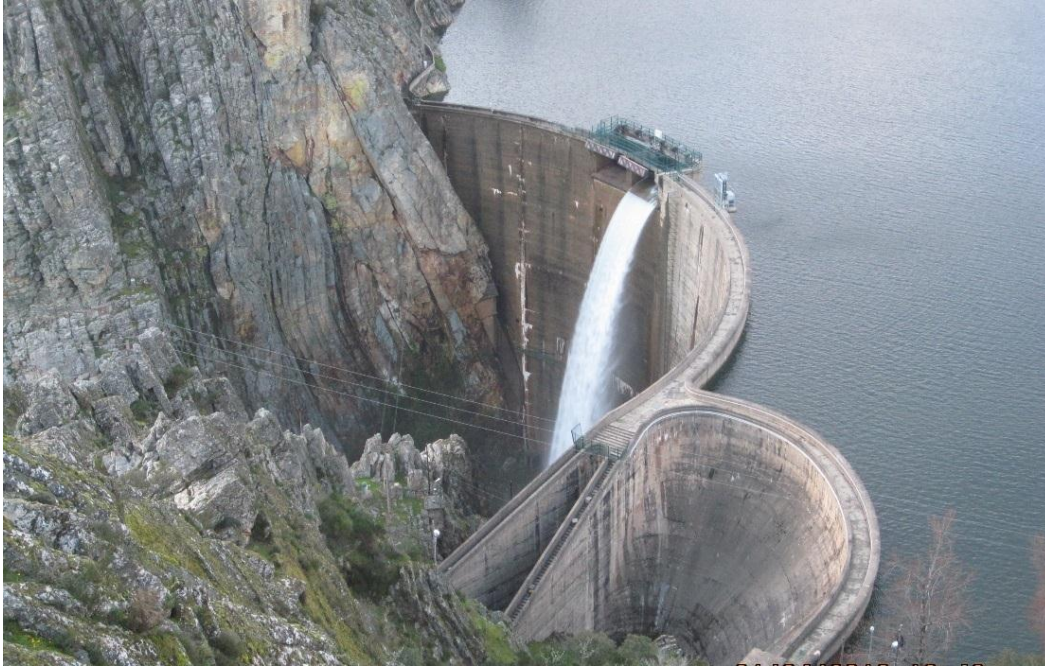
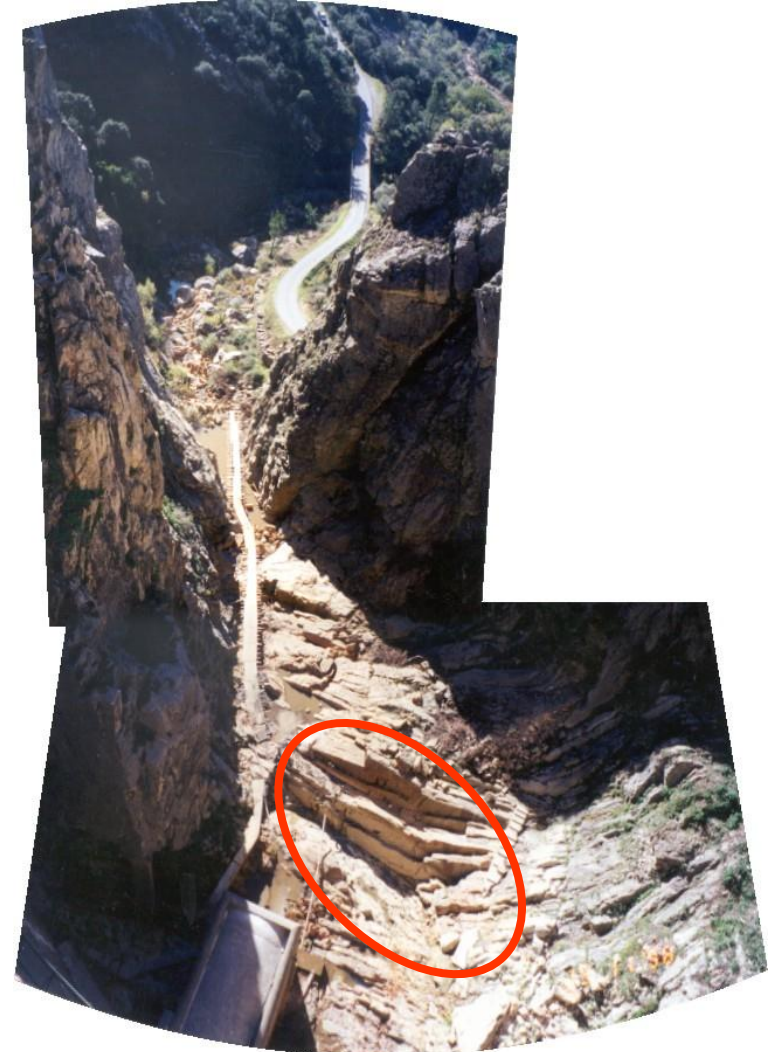
# Santa Luzia Dam – Downstream Spillway Erosion

- Until 1997: scour depth 3m
- Between 1998 and 2001: scour depth 7m

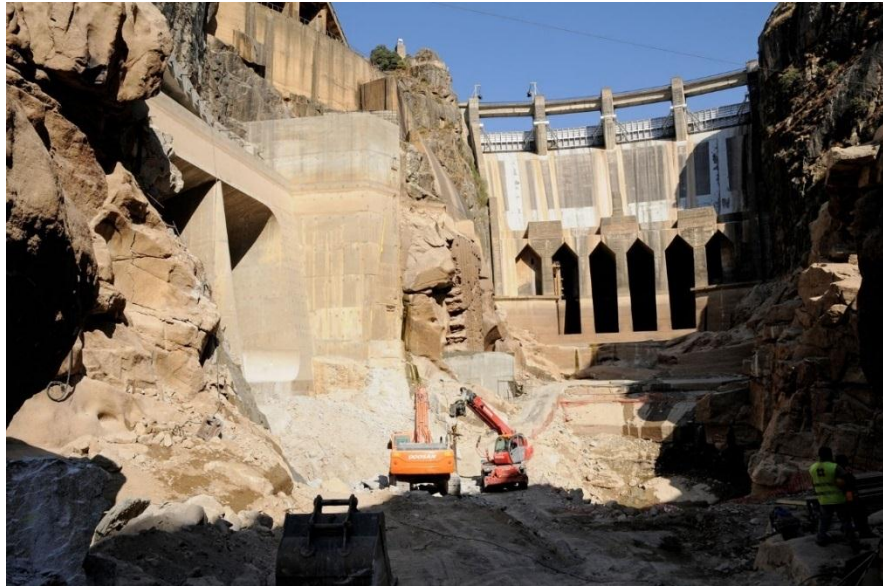
# Picote Dam – Repowering (2007-2011)

- Original scheme
- Repowering

Longitudinal profile

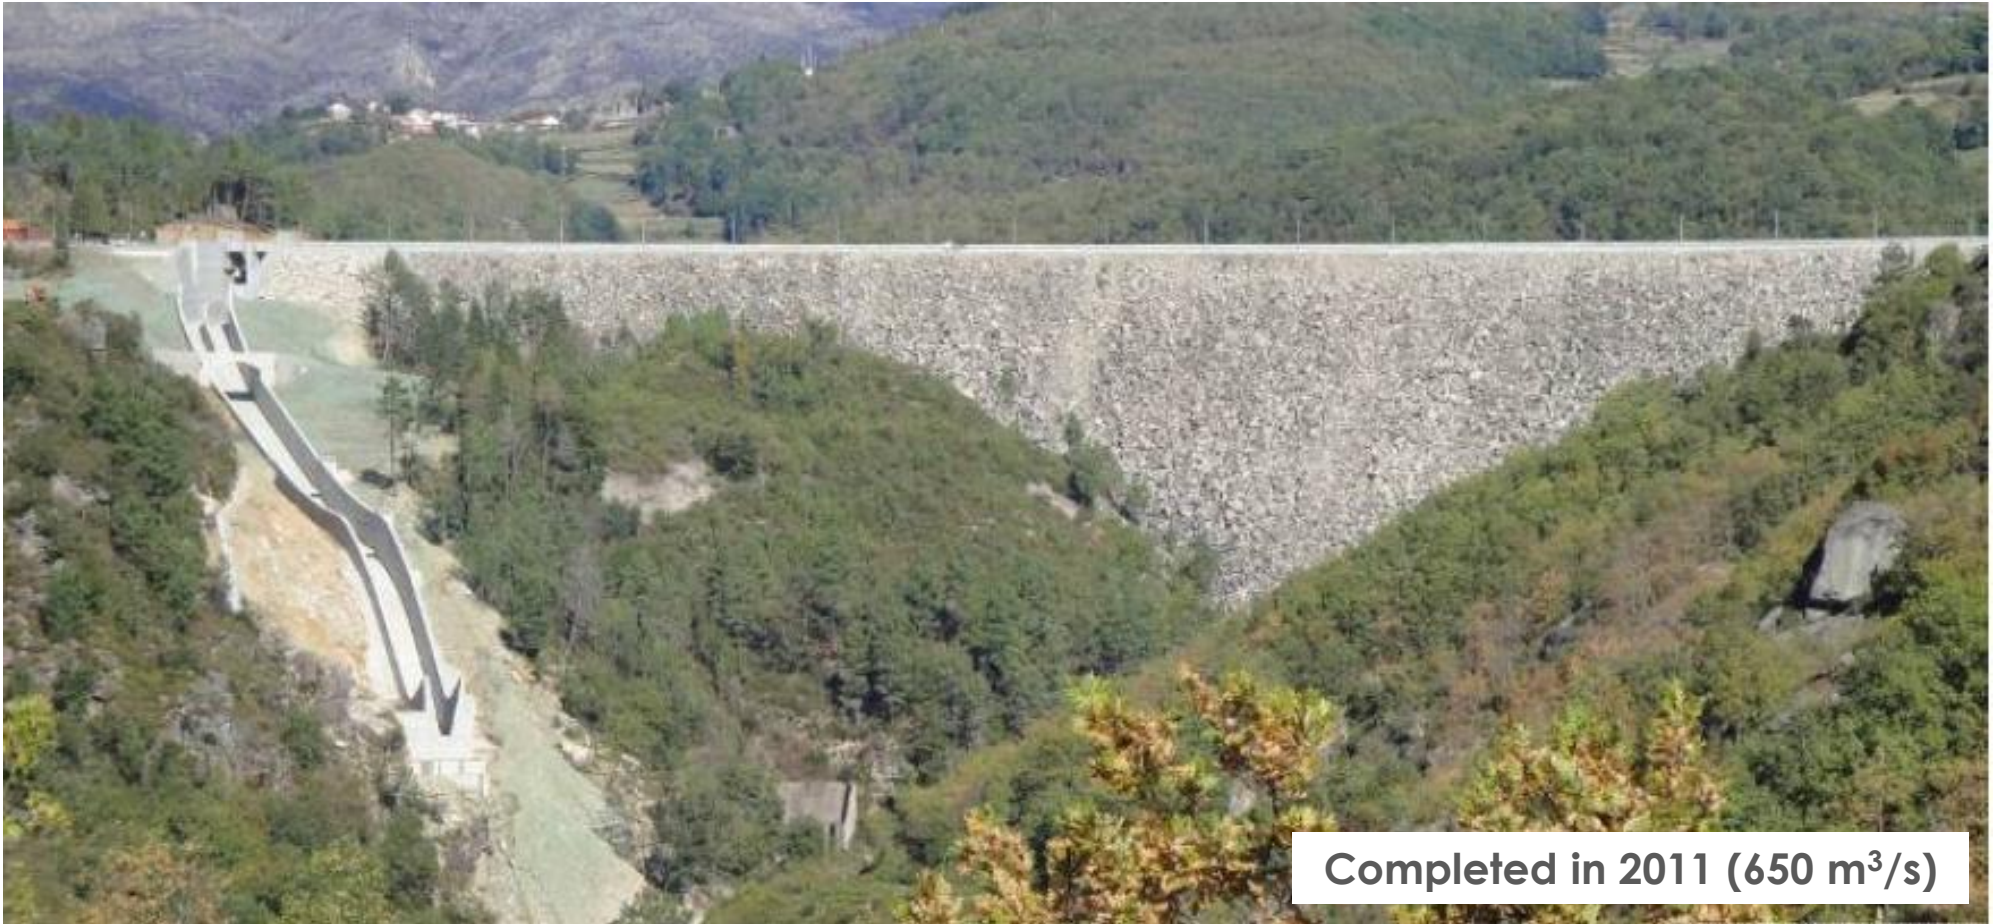
# Paradela Dam – New Spillway

Completed in 2011 (650 m<sup>3</sup>/s)

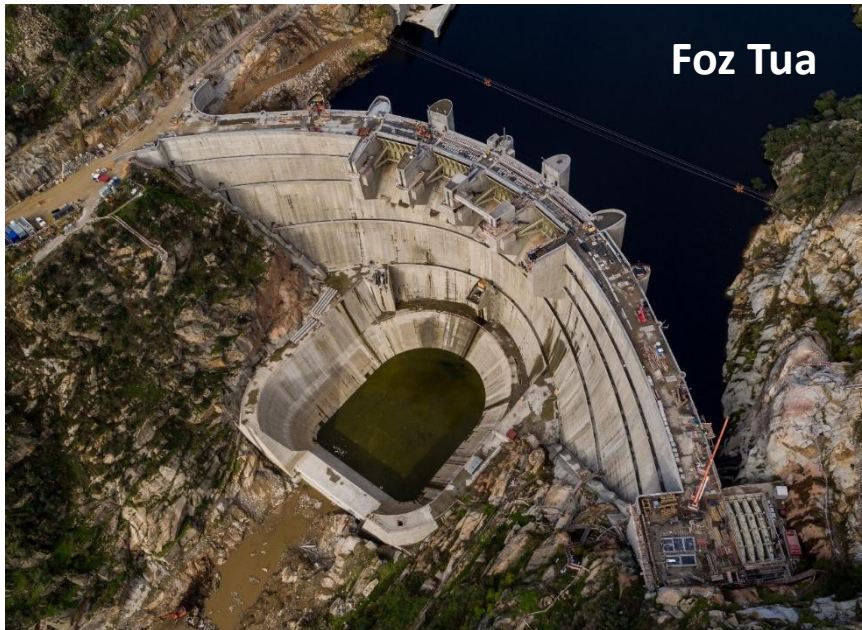
# Recent Dams – Foz Tua and Baixo Sabor

- Year of completion: 2017
- Dam type: Arch
- Height: 108 m
- Foundation: Granite
- Spillway type: Controlled; free falling jet
- Maximum discharge capacity: 5500 m<sup>3</sup>/s

Pressure transducers  
Velocity transducers

- In **recente dams**, despite careful studies, design and construction, what kind of **erosion problems can be expected in the impact stilling basin**? Would it be possible to **optimize** this type of solution? Is there any **experience of pressure and velocity measurements in prototypes**?
