The Oroville Dam Spillway Incident

International Workshop on
Overflowing Erosion of Dams
and Dikes

John W. France, PE, D.GE, D.WRE
AECOM, Forensic Team Leader

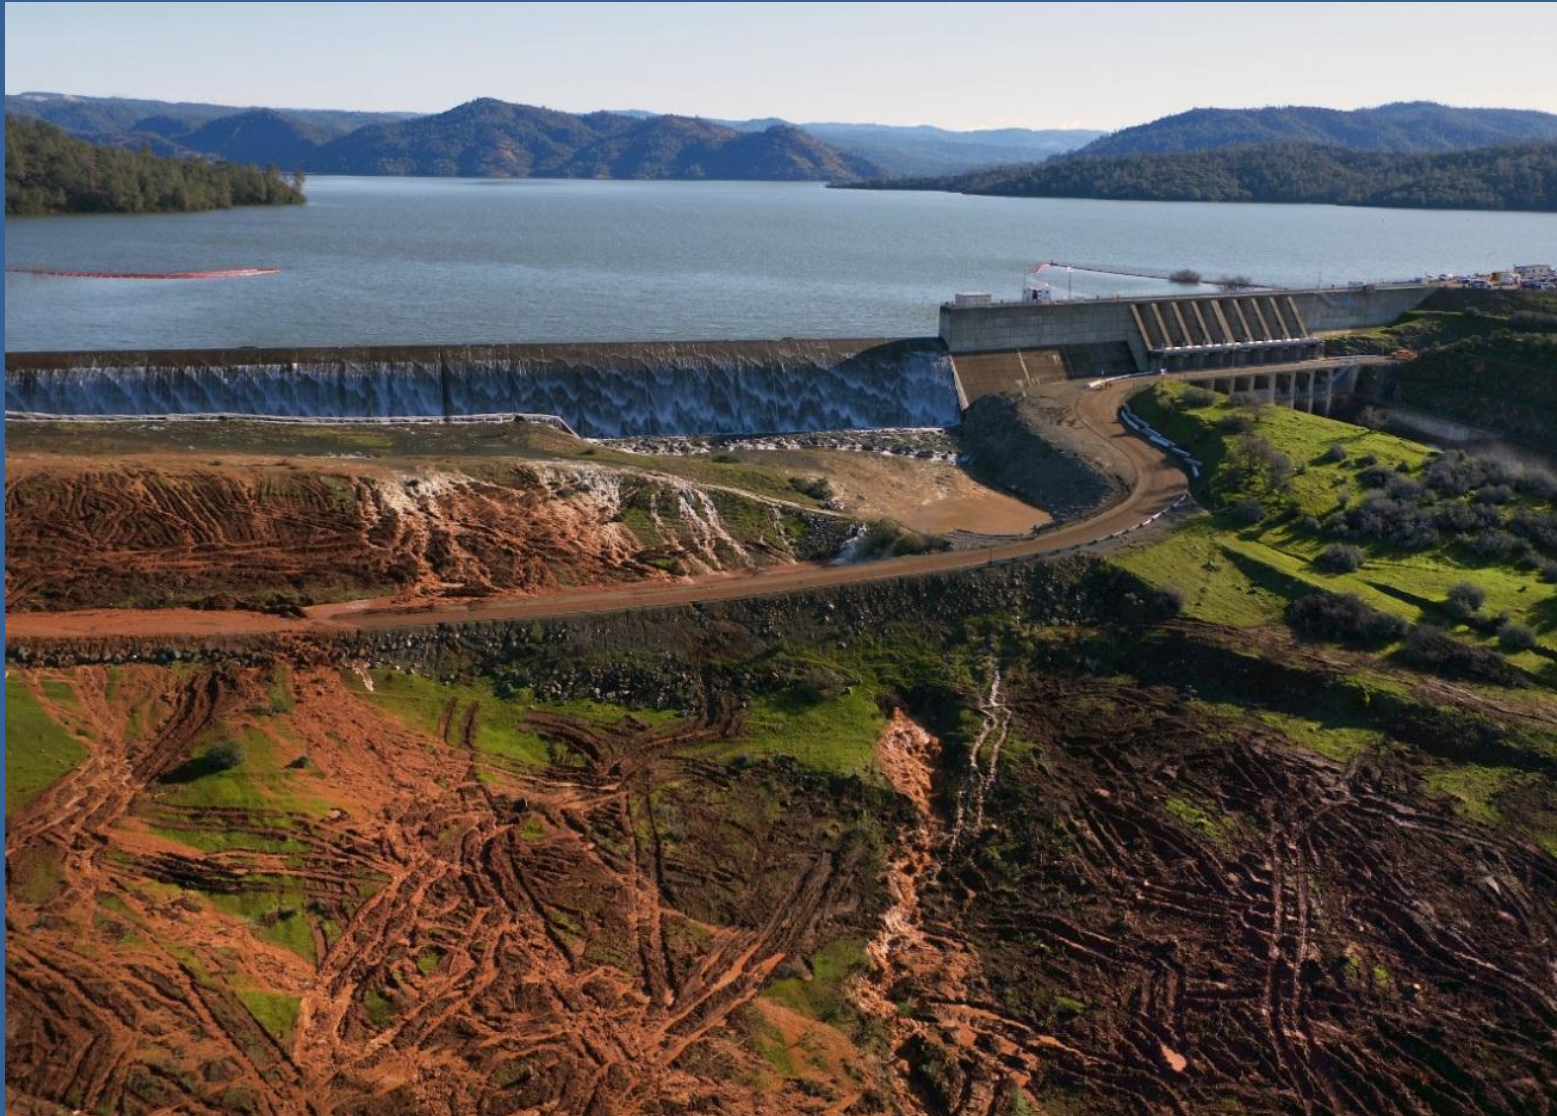
Flow Begins Over Emergency Spillway

- Duration of 36 hours
- Maximum depth of 1.6 feet (0.5 m)
- Maximum discharge of 12,500 cfs (354 cms) – about 3.5 percent of estimated PMF discharge

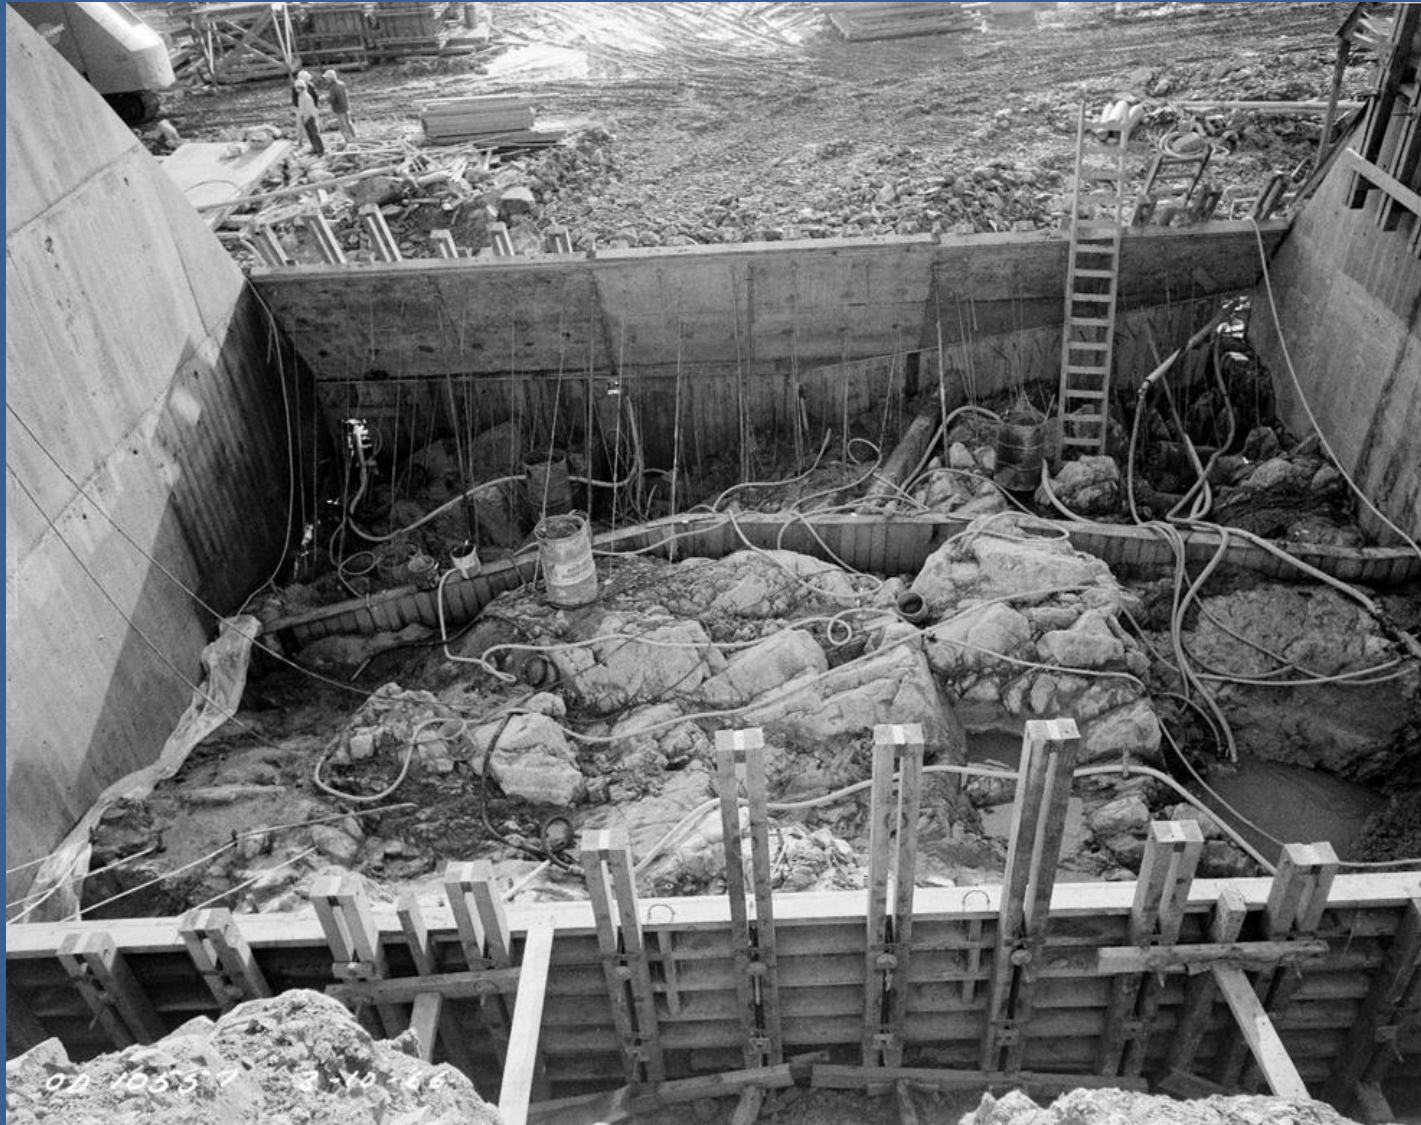
Foundation Preparation

- Conditions varied
- Areas of “compacted clayey fines”
- Areas of severely weathered and decomposed rock

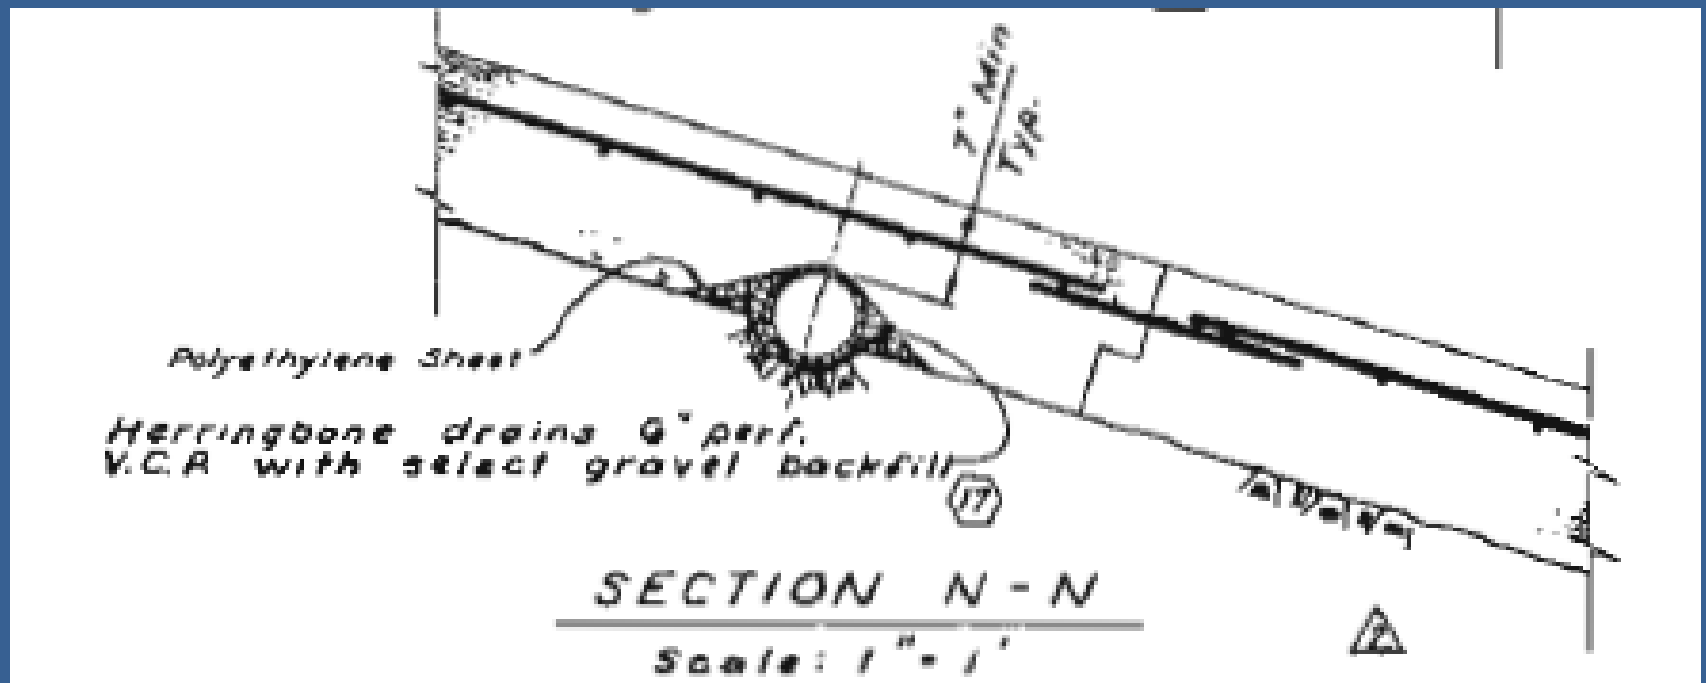
Drain and Joint Details

- Nominal 15-inch (0.38 m) thickness
- No waterstops in joints
- Unbonded dowels in joints
- Lapped keys in lateral joints
- VCP drains protruding into the slab
- Foundation anchors at 10-foot (3.05-m) spacing
