International Workshop on Embankment and Concrete Dams Overflowing Erosion

Dams in Vietnam Overflowing Erosion

M.Ho Ta Khanh (mhotakhanh@yahoo.com) CFBR- VNCOLD

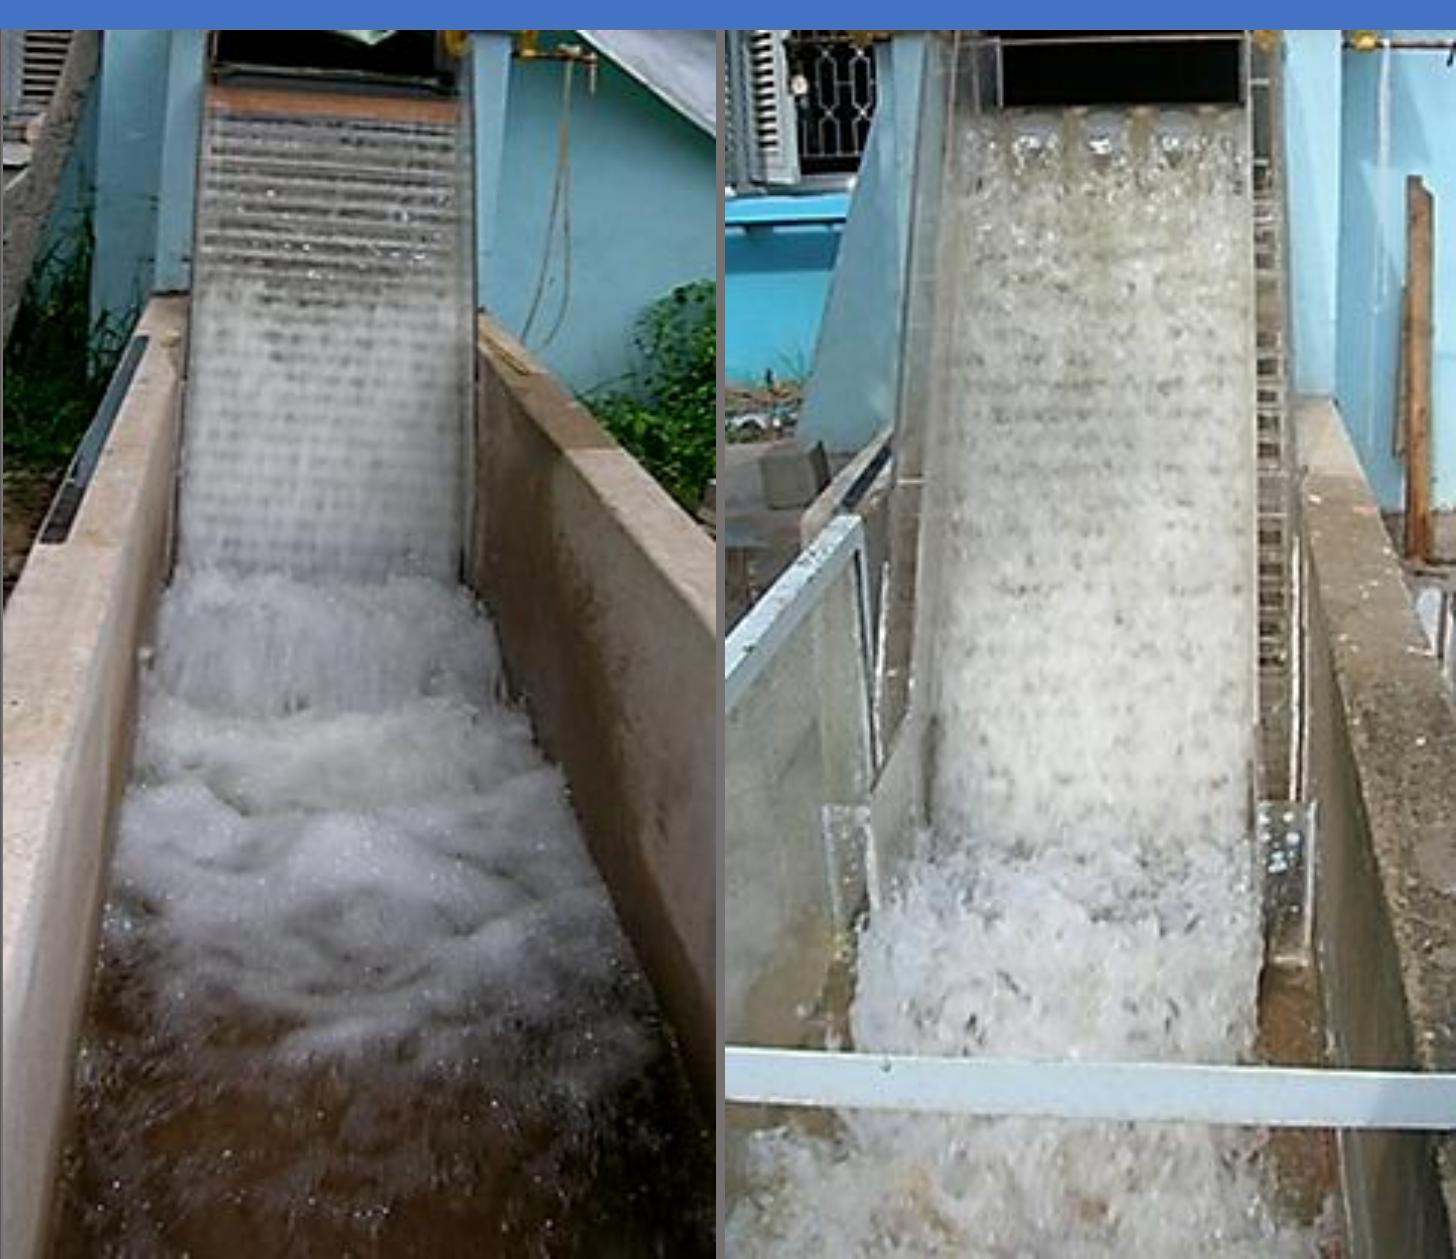
7.1 Comparison of scours at the toe of a gravity dam, with a Creager weir and a PKW weir installed on the crest.

With the PKW, it was observed a better aeration of the flows on the stepped spillway, compared with the Creager weir, but surprisingly the scours were not always significantly reduced by this better aeration, for different values of the flow discharges.

These results should be checked by other tests with different types of impact jets, air entrainment concentration, nature of the foundation and representativity of the models.

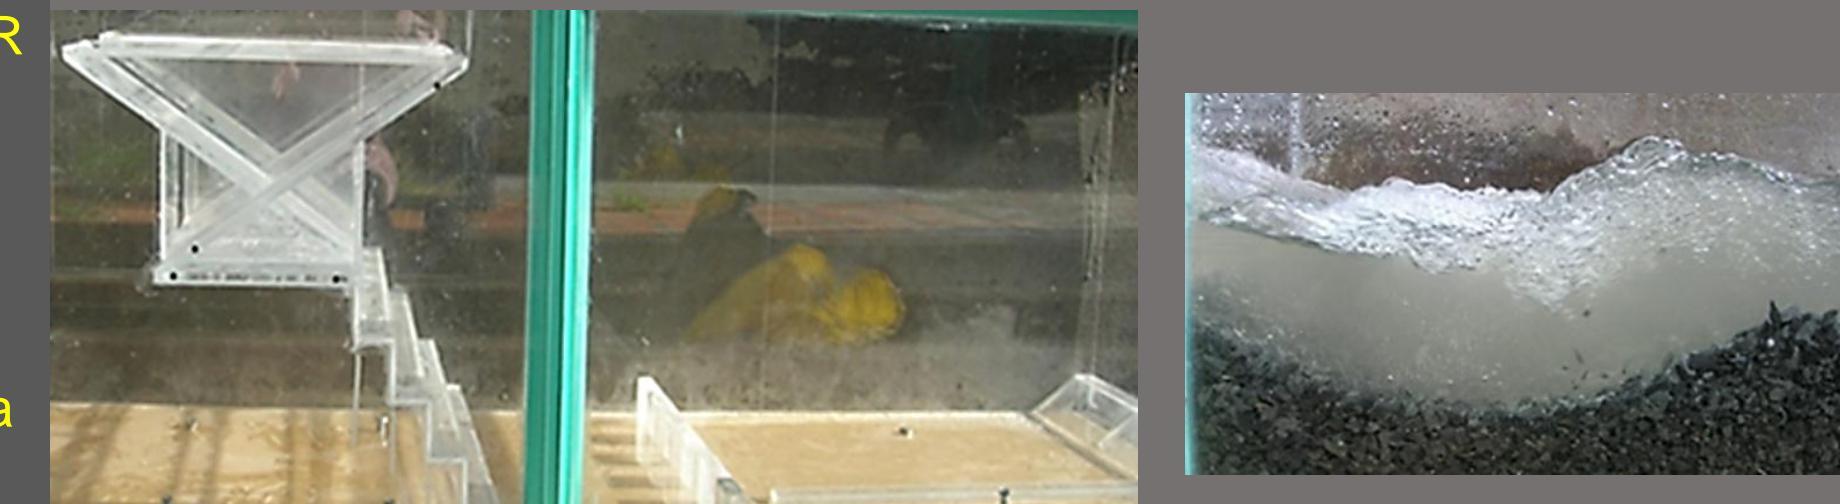
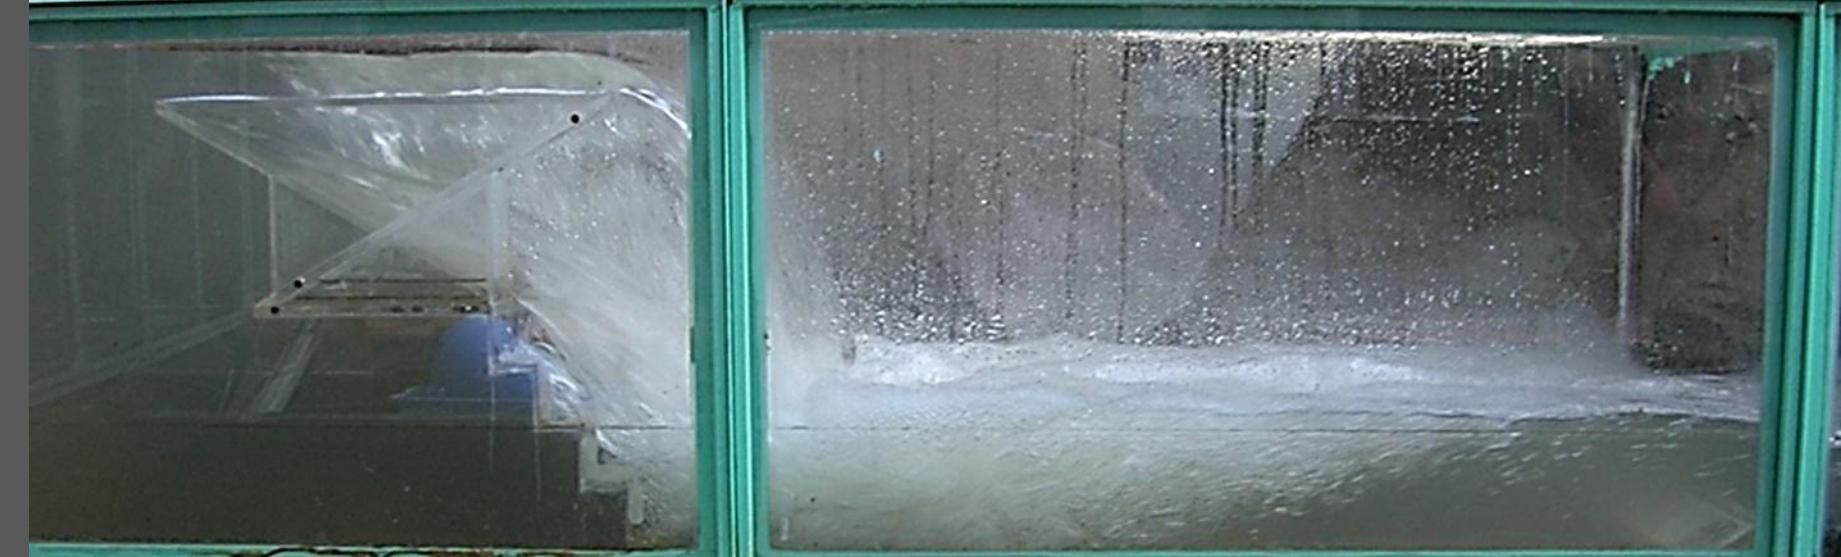
7.2 Protection of the river bed downstream a P.K weir with utilization of a baffle basin

The tests were performed with a baffle basin type USBR at the toe of a small gravity dam with a P.K weir on the crest.

The scours were observed downstream the baffle basin, on a mobile bed model with a protected rockfill layer.

Results show that the stilling basin is very efficient for reducing the scour if the end sill is enough high and the rockfill size sufficiently large.

But this solution is generally too expensive compared with other methods.
