CONCRETE DAMS OVERTOPPING EROSION

Hydro-Québec Perspectives : Issues and Engineering Needs

Marco Quirion, P. Eng., Ph.D

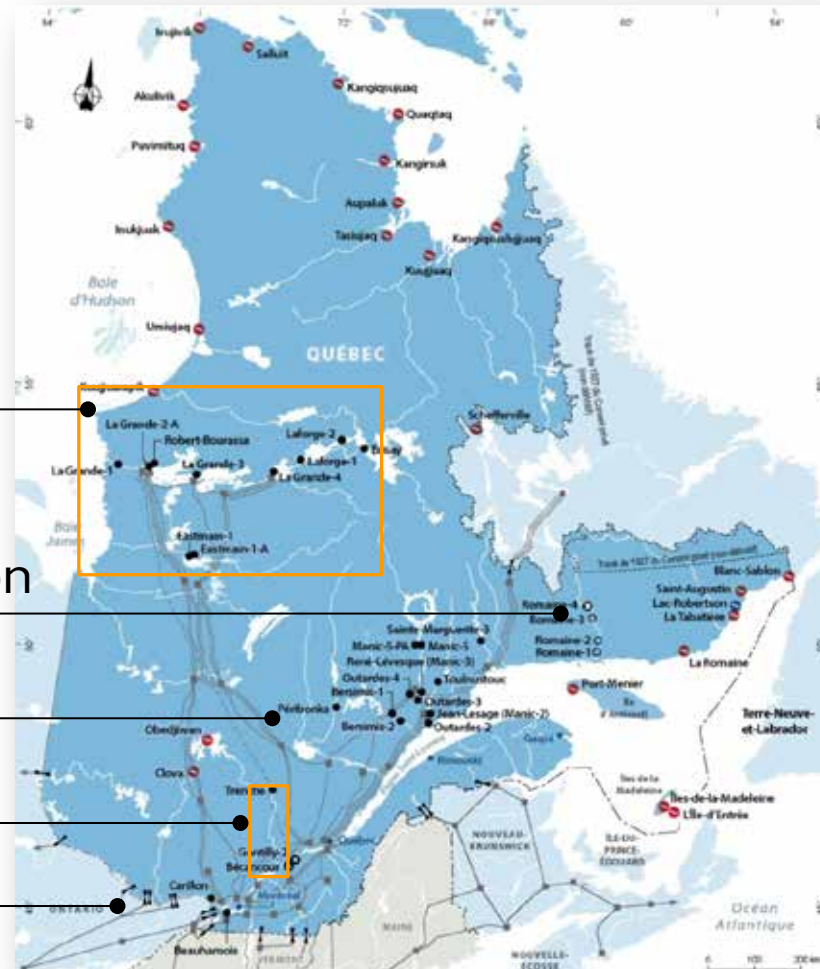
Unlined Spillways Impacted by Erosion

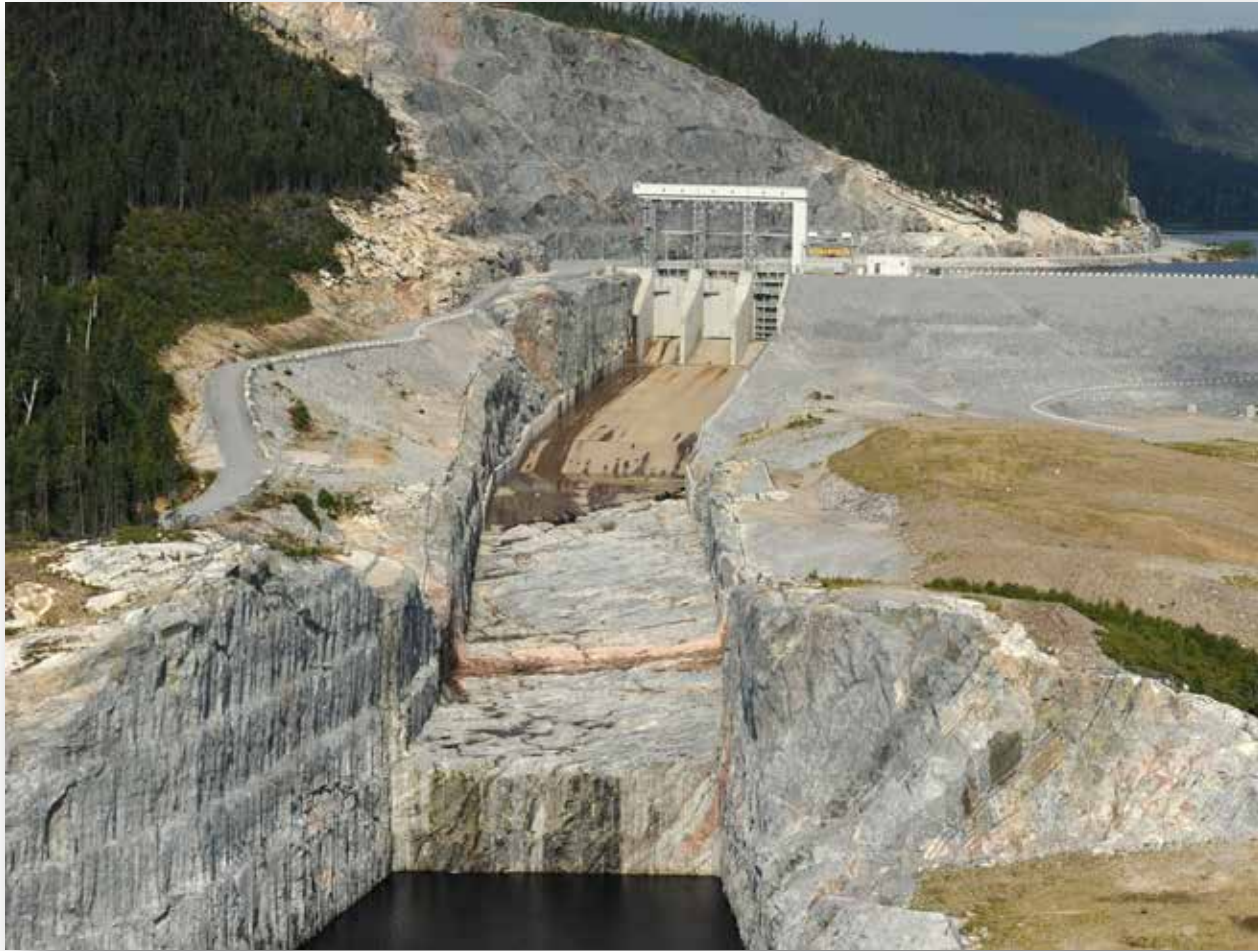
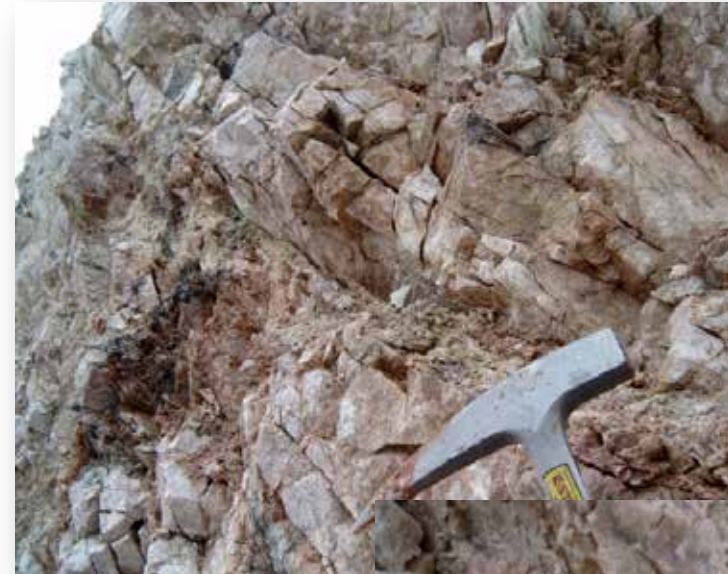
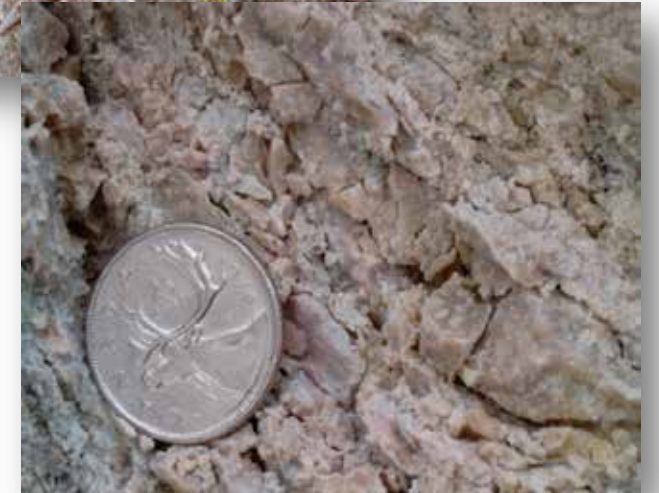
Saguenay Region (2007)

Baskatong Reservoir (2007)

- Addition of a powerhouse starting in 2004
- Flood in 2007 evacuated by the bottom outlet during construction
- Boulders accumulation downstream
- Highlights
 - Outflow $400 \text{ m}^3/\text{s}$ during 4 months
 - Velocities above 20 m/s
 - Described as exceptional
