EMBANKMENT DAMS AND DYKES OVERTOPPING EROSION Hydro-Québec Perspectives : Issues and Engineering Needs

Annick Bigras, ing., M.Sc.A.

December 11,2017

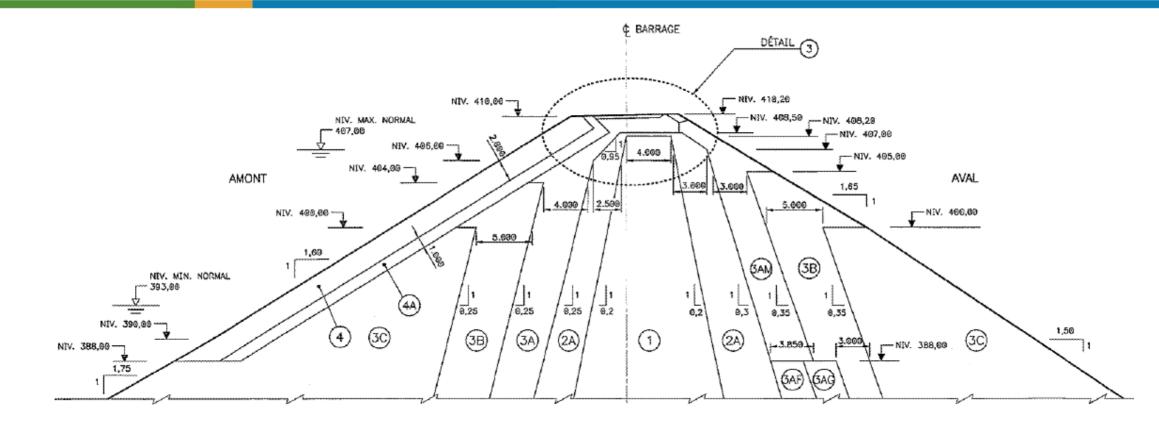
#### **Crest details**

New Dams: Laws and Regulations, ..., Quantity Optimization

Existing Dams: Dam Safety Reviews considering today's standards

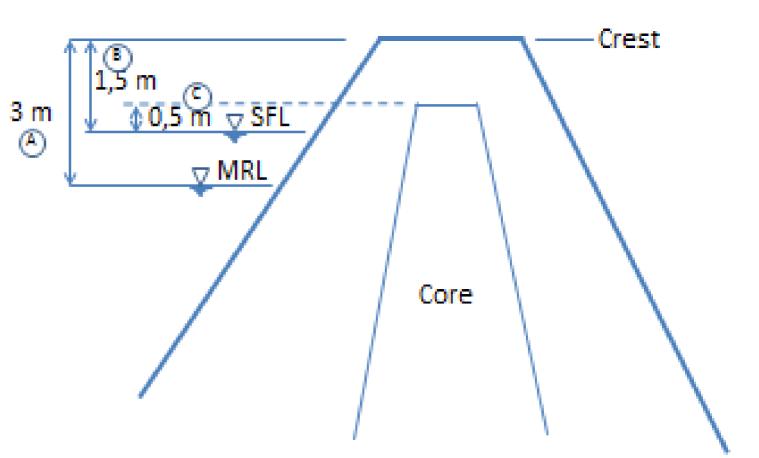
#### Freeboard

A Highest value between hydraulic freeboard and frost depth

B. Depending of the spillway capacity

To avoid core overtopping

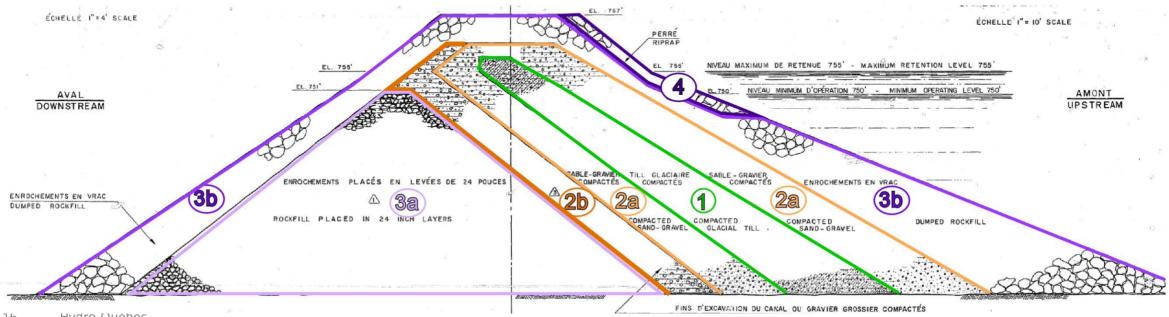
#### Core Overtopping (1991)

Rockfill dam – Till core

Length 500 m

Height 33 m

Foundation : rock (gneiss) and concrete

- Core overtopping : water level went up to the top of the filters but not in the rockfill (< 1m over the core for < 19 hrs)</p>
- Inspections during and after the event showed :
  - no deformation or instability;
  - inflow of 3-4L/s.
