Overflow erosion of embankments UK dam owner's perspective

Alan Brown – All Reservoirs Panel Engineer

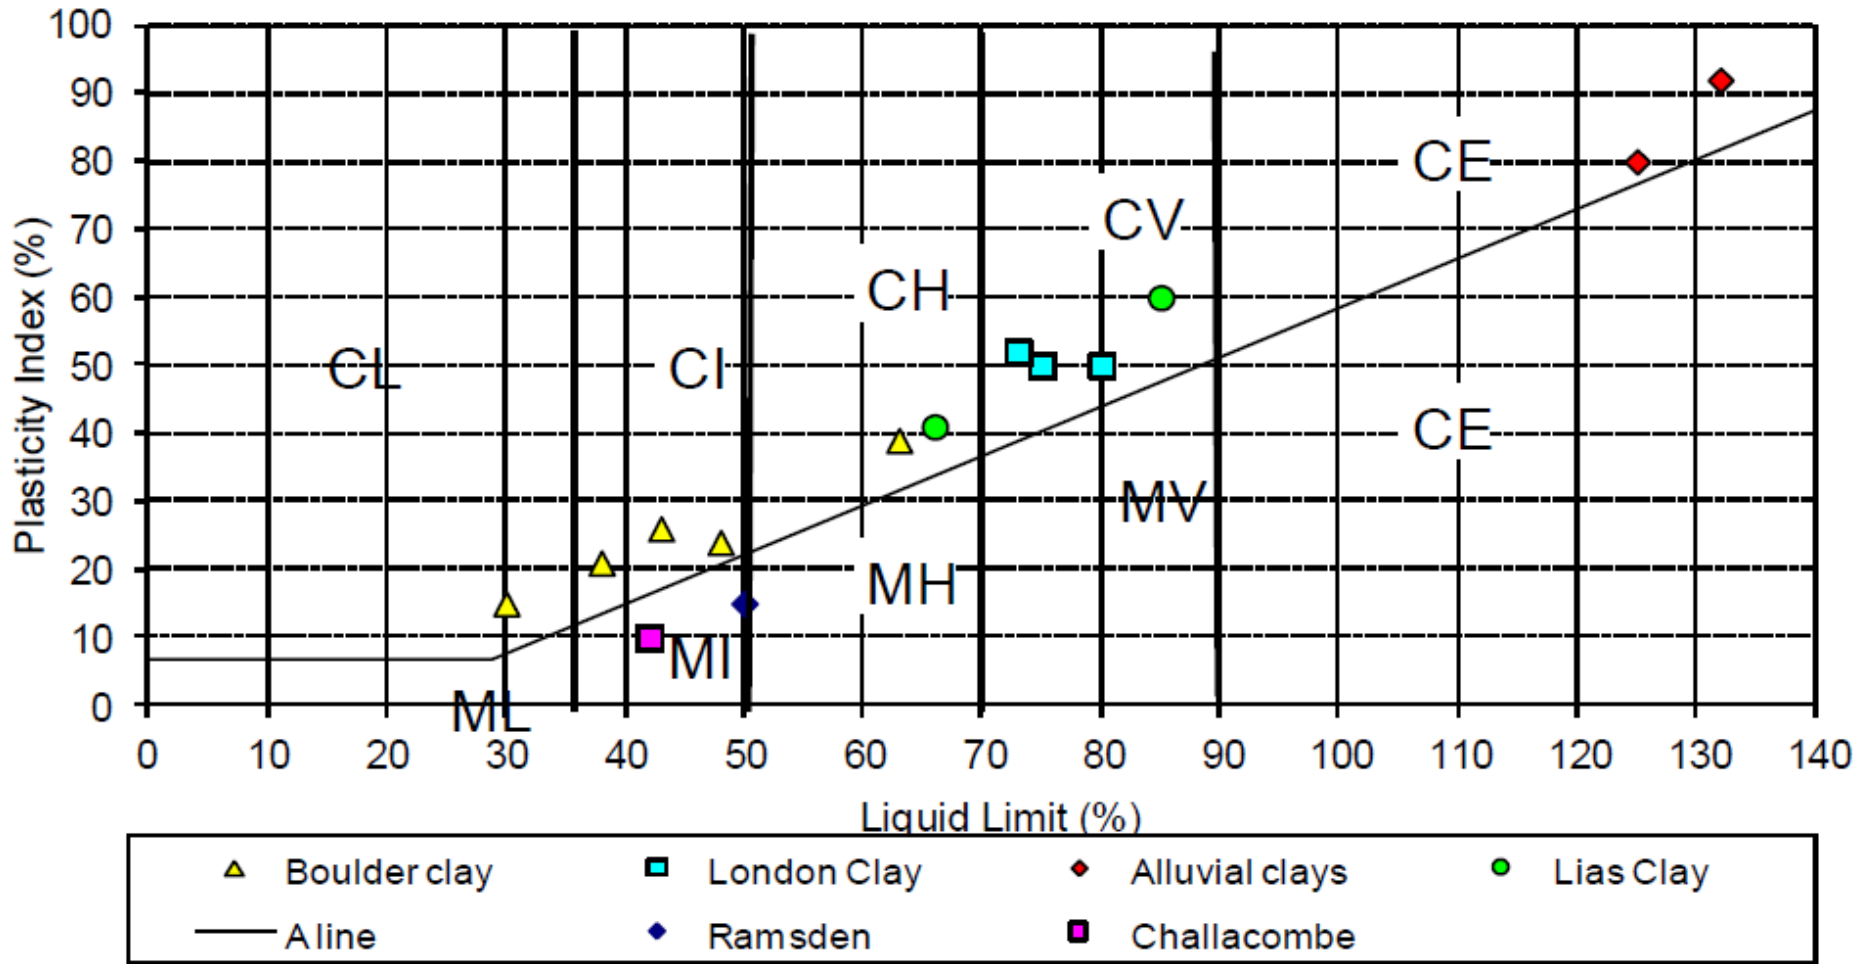
Plasticity of some "puddle clays" - as Table 3 of Moffat, 2002

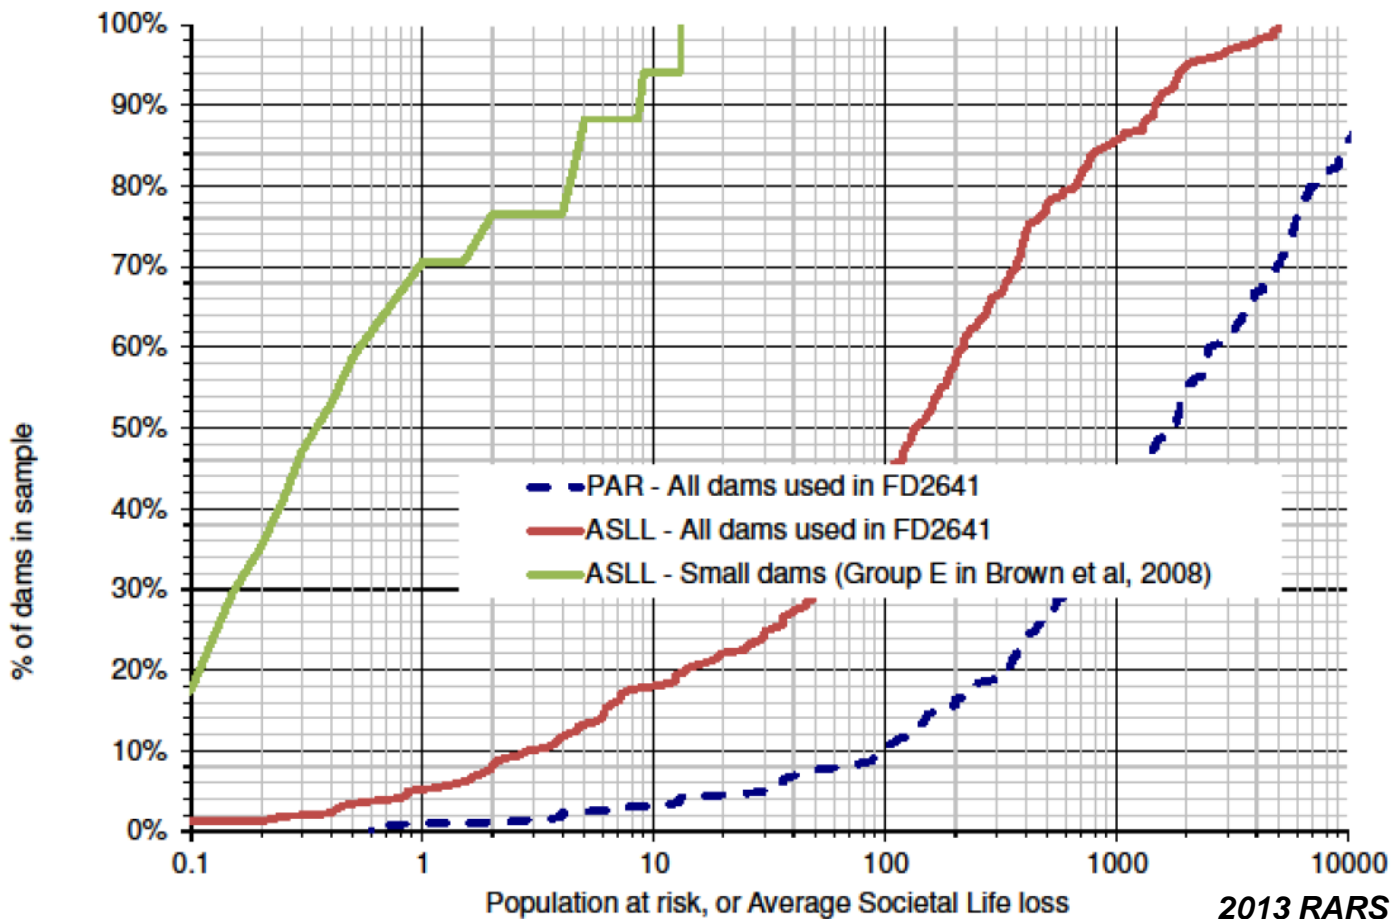
Figure 15.2 Indicative distribution of population at risk and average societal life loss (Defra and Environment Agency 2010. Unpub)

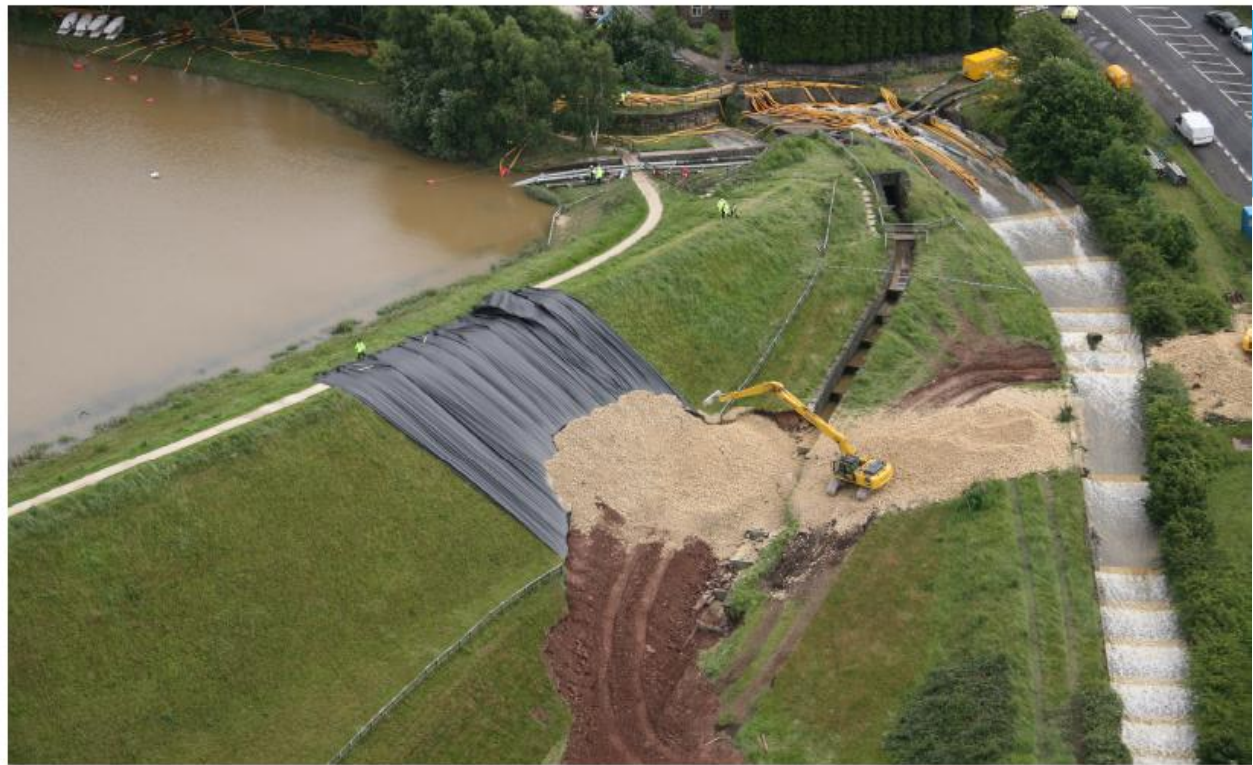
Ulley – an embankment scour incident

- **Ulley reservoir, Yorkshire 23 June 2007**
- Hundreds of people were evacuated from their homes in Yorkshire today after record rainfall led to a "significant risk" that a dam containing a reservoir could burst.

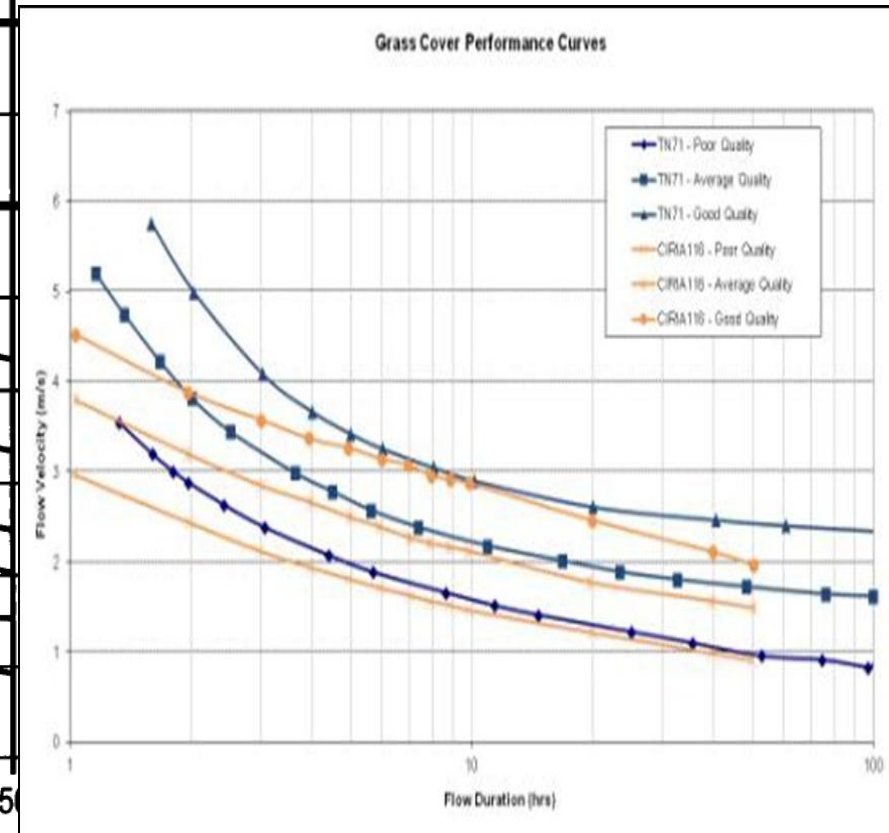
RARS Fig 8.5, CIRIA TN71

Figure 9 Recommended limiting values for erosion resistance of plain and reinforced grass
