Overtopping erosion of rockfill dams – Research in Norway

Leif Lia
Professor
NTNU

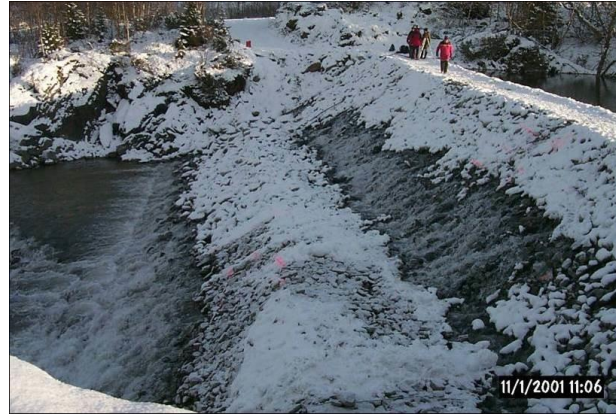
Figure 2, Downstream erosion on rockfill dams, Photo: EnFo

All the tests were run without any kind of riprap structure on the downstream slope, thus the seven full-scale test dams ($H = 6$ m) failed as a result of exposure to severe erosion processes. Further, the documented magnitudes of failure initiation overtopping flows were low, EBL (2007). The erosion propagated in a pattern influenced by the grain size distribution, briefly described in EBL (2007).

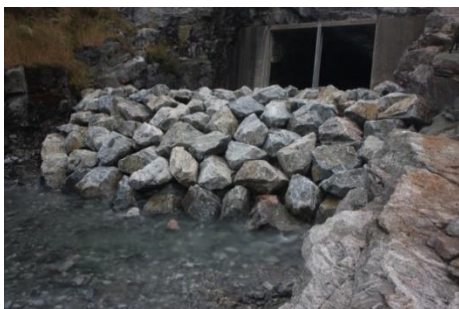
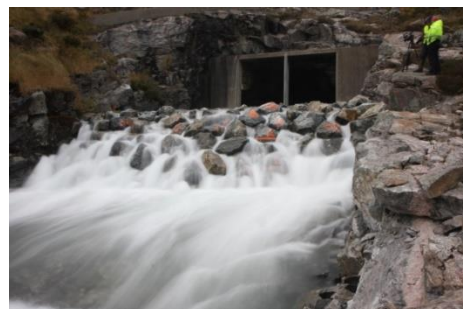
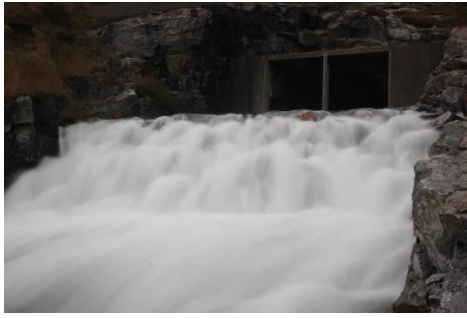
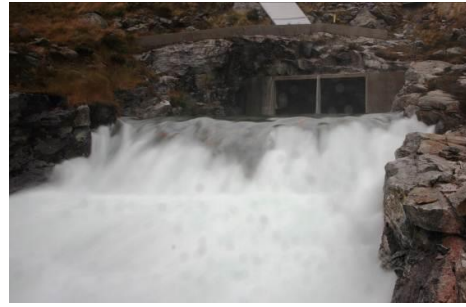
Step 1, Throughflow starts

Step 2, Throughflow without overtopping

Step 4, Overtopping 0,5 m

Step 5, Overtopping 1,5 m

Figure 4, Tests performed in Step 1 – 4, from Lia et.al. (2013)

The dams were first tested with throughflow, but the total discharge through the highly permeable dam body was in the range of 5 – 10% of the total discharge when the riprap failed and had minor influence on the capacity of the riprap. In the tests that followed, the ripraps were overtopped with a total discharge up to of $130 \text{ m}^3/\text{s}$. The discharge was controlled from a bottom outlet gate, and thus it was possible to monitor accurate discharges over the dams crest and downstream slope. Photos from the test are presented in Figure 4.

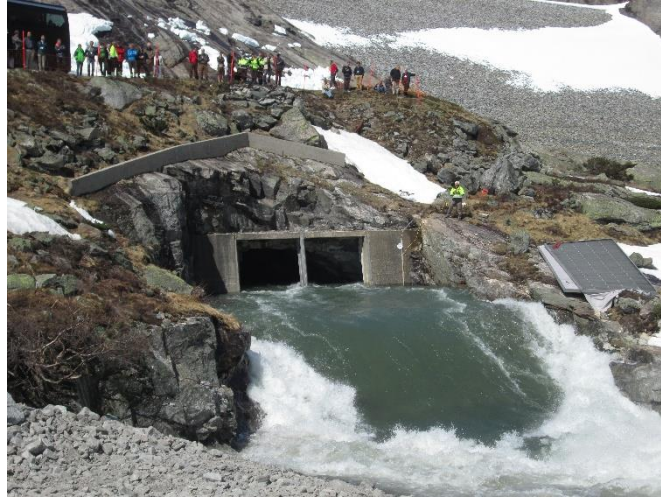
Figure 6, Test with full-scale riprap stones in 2015 (in the Stavanger ICOLD Congress Technical tour)

The field tests with large-scale riprap stones were executed at the same site as described in Chapter 3, in Sirdal, Norway. Test dams of approximately 3 m height and 12 m crest length (9.5 m bottom length) with a downstream slope of 1:1,5 were built with placed and dumped ripraps in the outlet channel of a tunnel spillway and overtopping tests were conducted. The test dams were constructed with excavators by placing a row of large stones across the channel on the clean bedrock as dam toe. Further, a permeable support fill consisting of angular stones was constructed upstream of the initial stone row. Finally, the test dams were covered with either placed or dumped riprap. During overtopping, the water surface elevation at the tunnel outlet was monitored by two ultrasonic sensors and numerous pressure sensors were installed within the test dams for stage and load measurements, Hiller (2017).

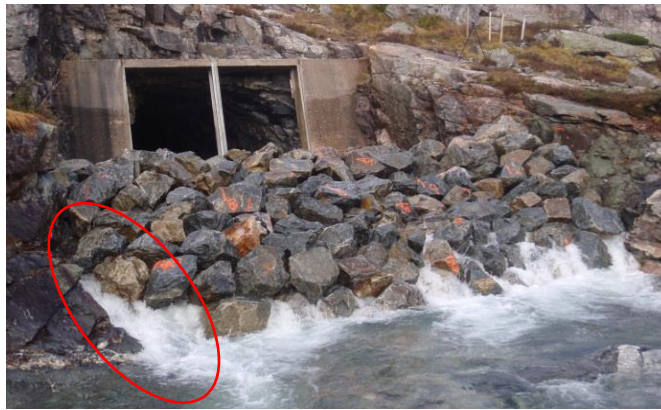
Figure 8, Red ellipse shows where two stones were dislodged from the riprap during overtopping.

A research project with the working title 'Rockfill dam safety under extreme loading conditions' favoring continuity from the recently concluded research on stability of placed ripraps PlaF was initiated by the research center HydroCen, Norway. The primary objective of this new project is to develop design criteria and construction specifications defining the optimum design and construction of dam toe and steep abutments of rockfill dams. Findings presented in Chapter 3 prove that stones along steep abutments are less stable when compared to other stones in the riprap, see Figure 8.
