Overtopping of Concrete Dams

Tony L. Wahl

Hydraulics Laboratory, Denver, Colorado

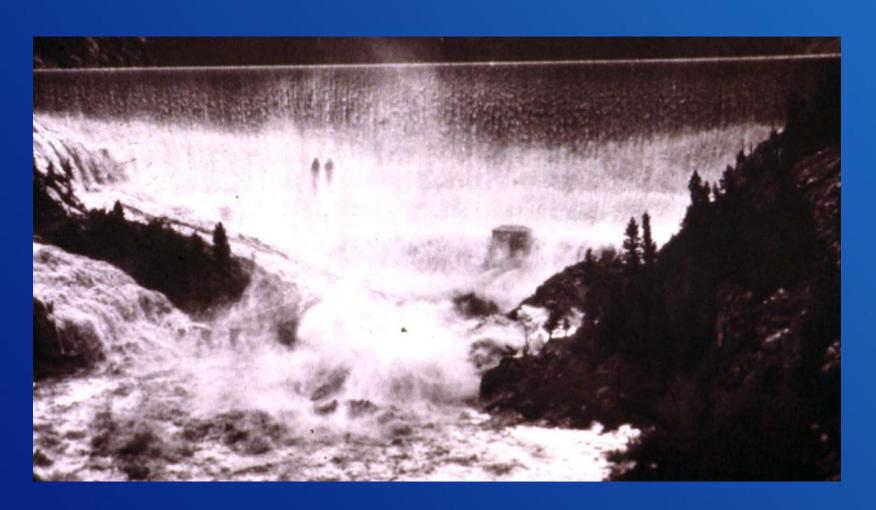
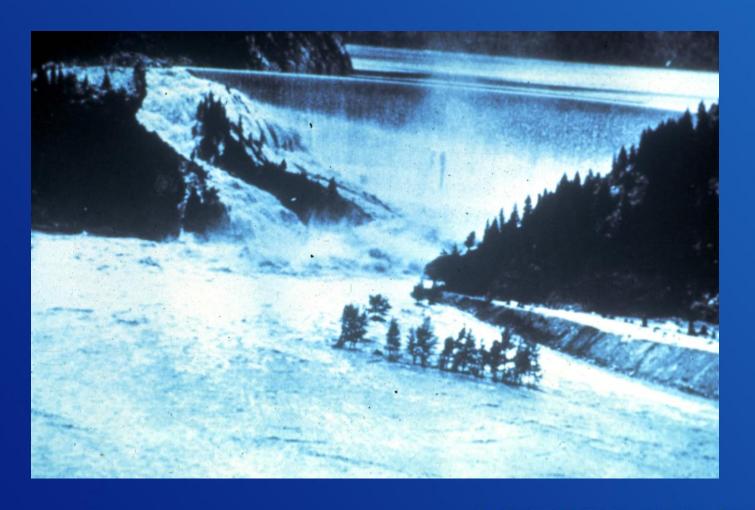
Gibson Dam, 1964

- June 6-8, 1964 record regional rainstorm in northern Montana
- Spillway radial gates not fully open, controls inaccessible
 - 2 gates fully open
 - 2 gates partially open
 - 2 gates closed
- 3 ft overtopping head over parapet for 20 hrs
 - Would have overtopped even with all gates open before June 1

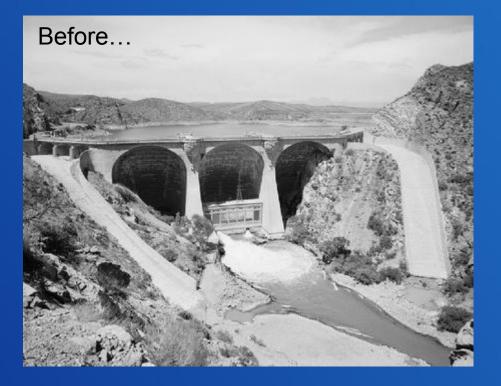
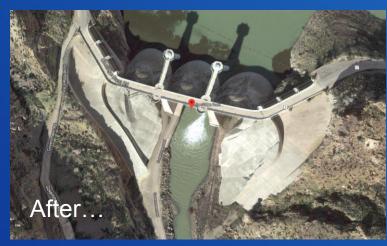
- Coolidge BIA (Bureau of Indian Affairs)
 - 1996 physical model (1:55), modified to pass PMF
 - 300,000 cfs over dam, 160,000 cfs through spillways
 - Extensive concrete blanketing of abutments
 - Spillways also modified with aeration ramps to mitigate potential for cavitation damage

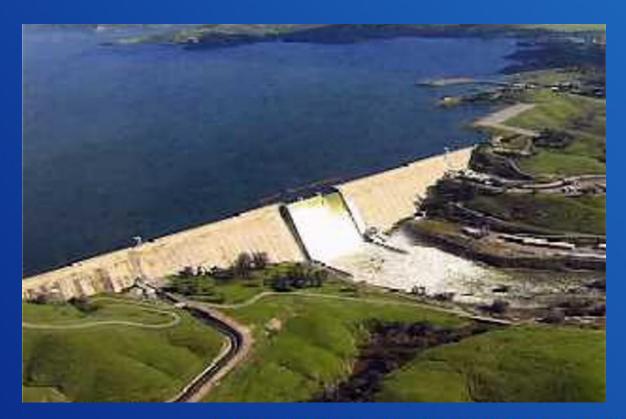
Friant Dam

Recent risk study considered erosion due to flow in groin areas during overtopping

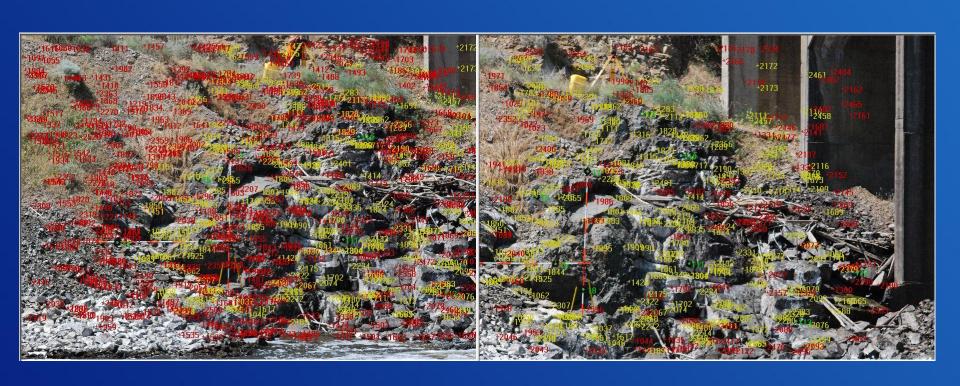
AdamTech processing of common points in photo image pairs
