Developments in research and practice: a Canadian perspective

Jonathan Fannin, PhD, PEng, FEIC
University of British Columbia

ICOLD, Ottawa

14 June 2019

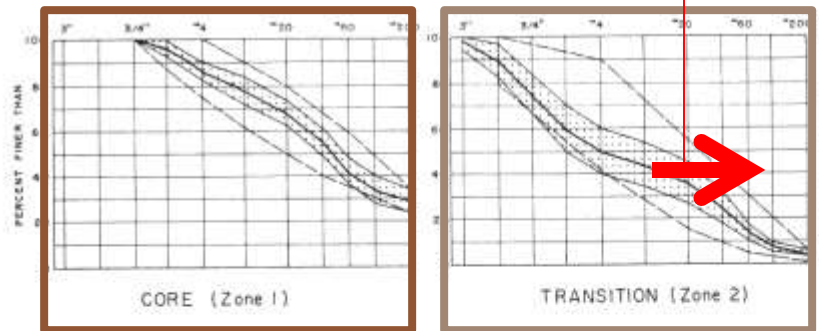
Internal instability: empirical criteria

Empirical screening tools:

eg. Kenney-Lau (K&L)

Li-Fannin (L&F) adaptation

Wan-Fell (W&F) adaptation

Internal instability: $(H/F)_{\min}$:

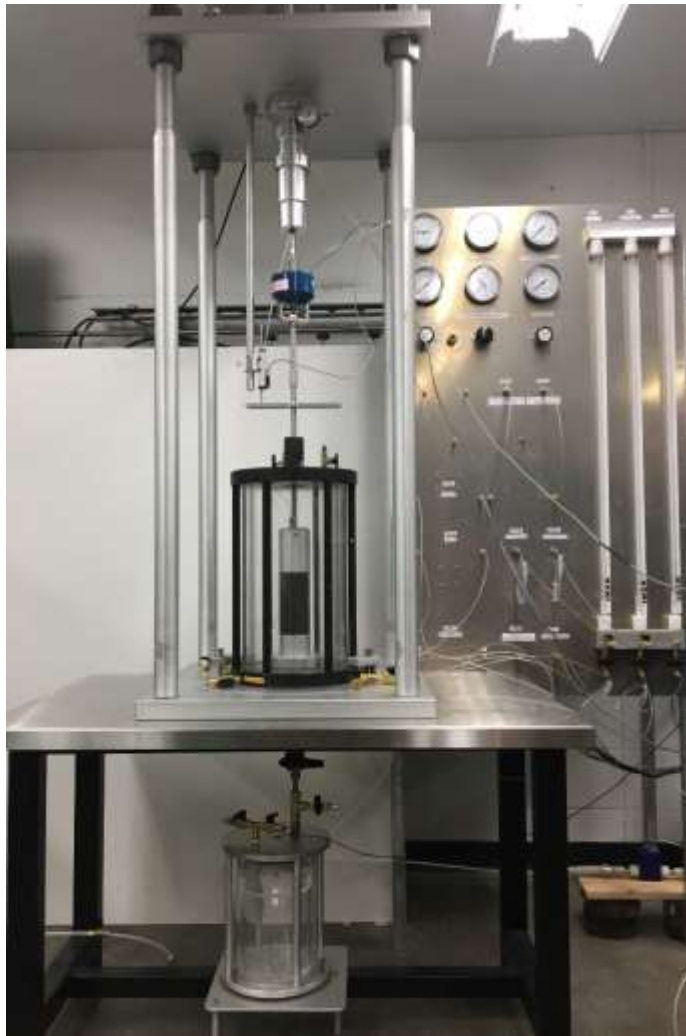
State-of-art: advanced triaxial-permeameter (TX-P)

Specimen reconstitution – consolidation – multi-stage seepage - shear

Mass Loss
Measurement Unit

Seepage Control
System

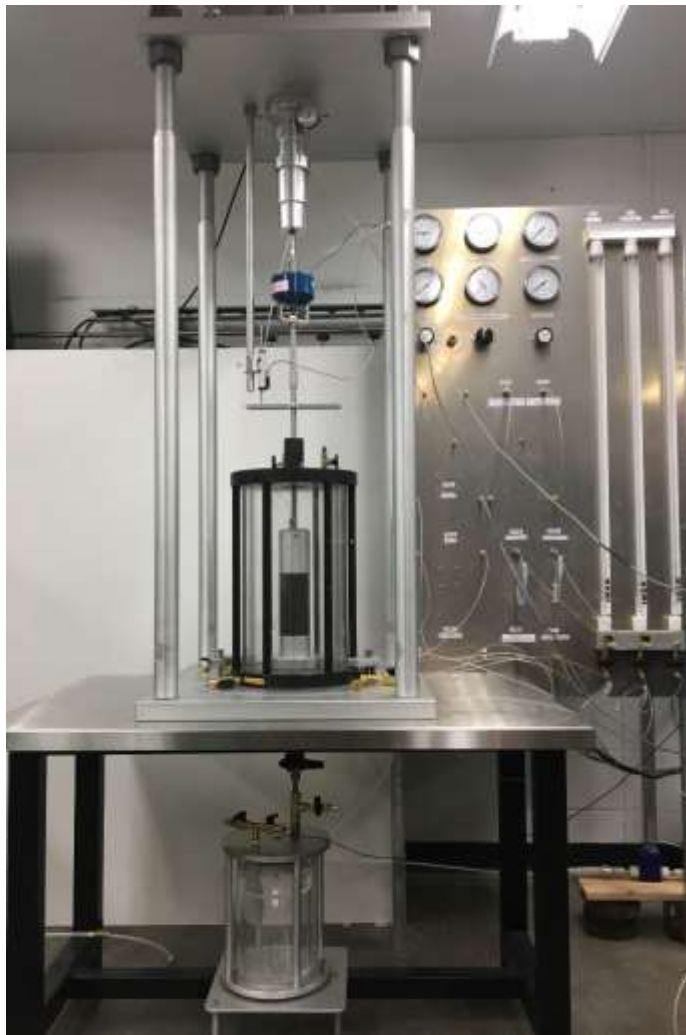
State-of-art: advanced triaxial-permeameter (TX-P)

Specimen reconstitution – consolidation – multi-stage seepage - shear

Mass Loss
Measurement Unit

Seepage Control
System

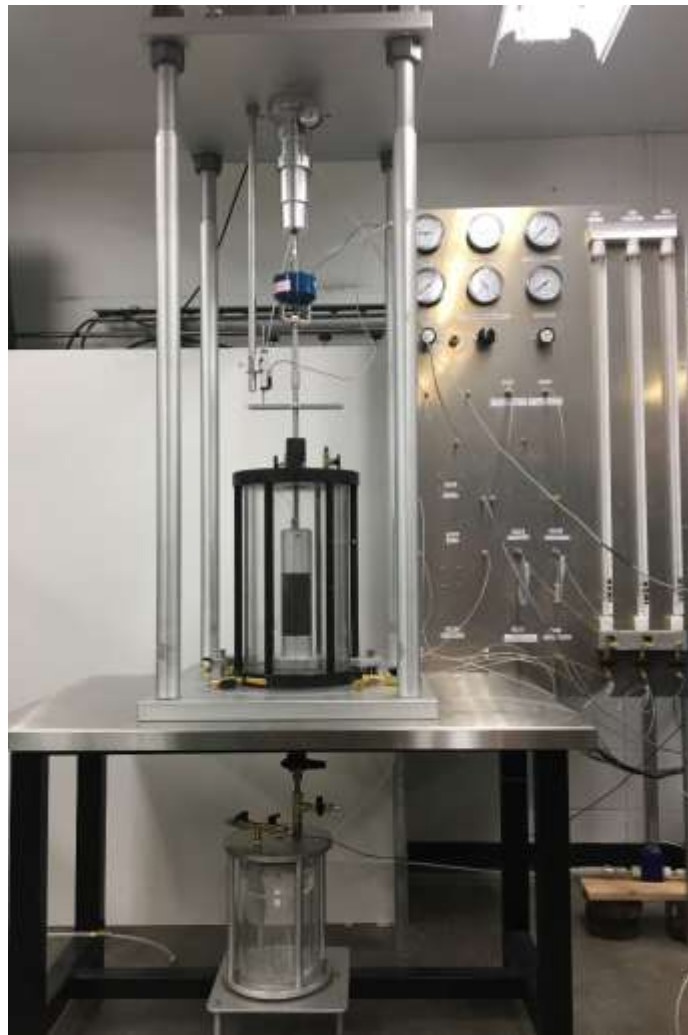
State-of-art: advanced triaxial-permeameter (TX-P)

Specimen reconstitution – consolidation – multi-stage seepage - shear

Mass Loss
Measurement Unit

Seepage Control
System
